RESIDENTIAL BUILDING SURVEY

XXXXX
XXXXXXXXXX
XXXXXXX
Shropshire SY6 XXX

**1950's/1960's
Detached Property**

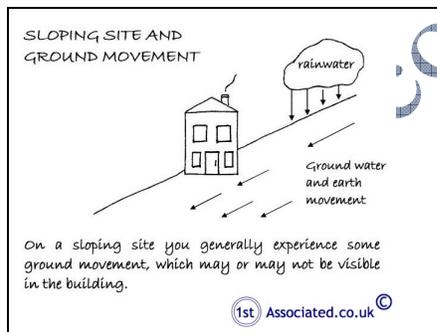
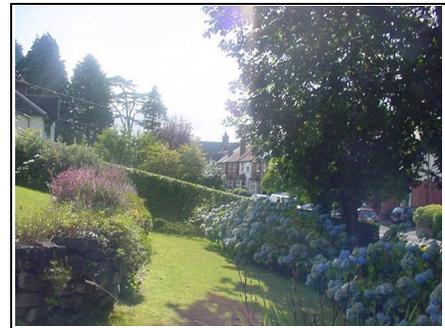
Any property on a sloping site is more susceptible than one on a flat site; it is simply the laws of gravity. Foundations normally allow for such occurrences, particularly in new properties. There can still be some minor movement. Rainwater and ground water will travel from the top to the bottom of the property, also discharging water on to the highway, which you will be liable for should there be any problems.

Sloping site

Sloping ground to the front

We much prefer to see a French drain or running gully around the property to give any rainwater a definite route. We also prefer to see where there are retaining walls that they have weep holes in, here we are particularly referring to the brick wall to the front of the property and the one adjacent to the rear, neither of which have weep holes in them and we were surprised they were in such good condition. Have they been rebuilt?

ACTION REQUIRED: Add a French drain around the property at high level and add weep holes to the retaining walls at low level.

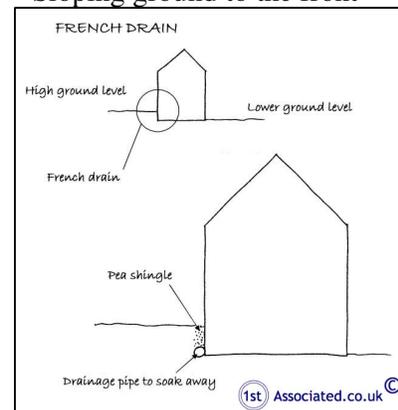
French drain

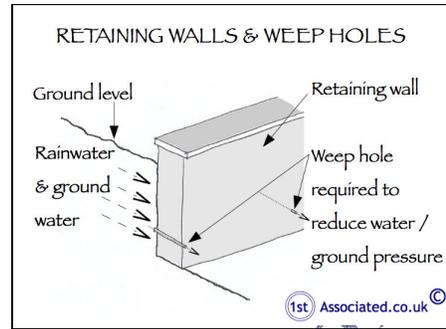
Weep holes in a retaining wall

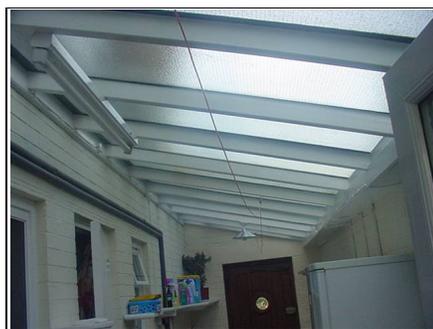
There is a glass roof, with box gutter, to the left hand side of the property. We would comment most of the glass roof panes have had repairs to them and we feel this area will be a problem area due to the difficulty of keeping the box gutter clear.

Underside of glass roof

ACTION REQUIRED: We would expect rain to get in through the glass panes and for them to need repair, which will be difficult due to access. You may wish to look at a more traditional roof or replacing of the ceiling joists, which would be expensive.

ANTICIPATED COST: In the region of £500 to £5,000, depending upon whether you are repairing or replacing. Please obtain quotations.

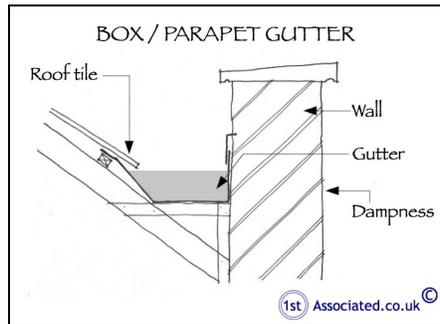
Box gutter

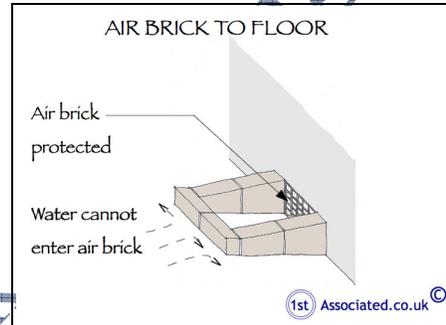
Protected airbrick

We would add a brick surround to the air bricks where possible.

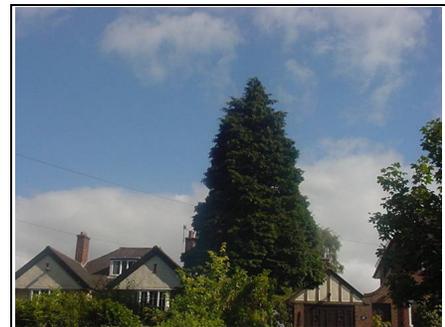
There is a tree to the left side of the property (all directions given as you face the property) adjacent to the garage, that is closer than most insurance companies would like. Whilst this may not affect the main house it may affect your premium.

Large tree

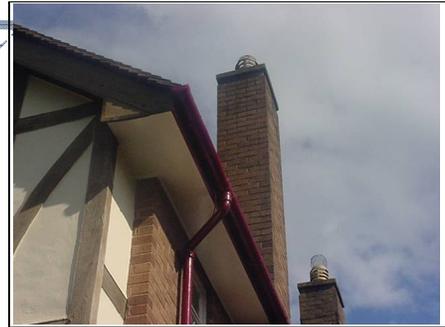
This large chimney is brick finished with a lead flashing and one chimney pot. From what we could see from ground level it looked in average condition considering its age, type and style although we have not been able to see the back of it during our inspection.

Front right chimney (front)

Unfortunately we were unable to see the top of the chimney properly known as the flaunching, we therefore cannot comment upon them.

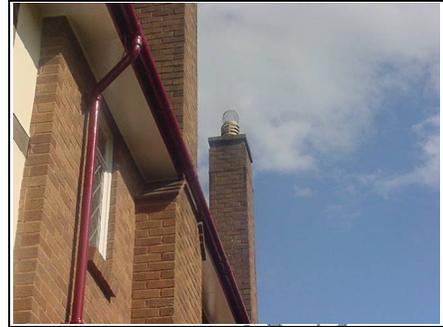
Right chimney

This large chimney is also brick built with a lead flashing and one chimney pot and is in average condition. Again, we have not been able to view the back of the chimney.

ACTION REQUIRED: Periodically inspect the chimney.

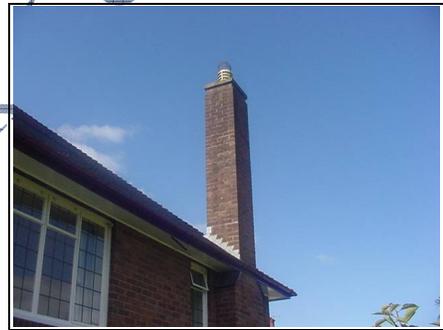
Rear left chimney

Again, this large chimney is brick built with one pot and a lead flashing and is also in average condition. Please note our comments with regard to movement in the structure; the slightest movement can affect the chimneys and roof coverings.

ACTION REQUIRED: Periodically inspect the chimney.

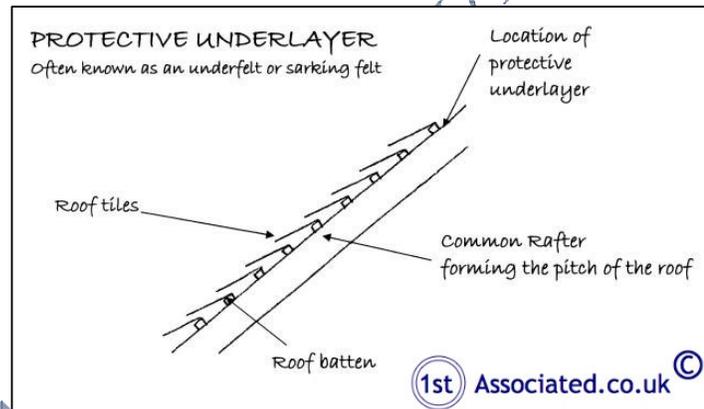
Protective Underlayer

When we inspected the loft space we found it has a building paper underlayer, which is in poor condition.

Building paper is deteriorating and we can see battens behind

ACTION REQUIRED: Please see our recommendations in the Executive Summary.

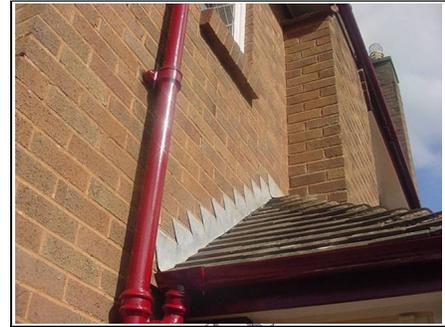
Porch roof

There is a pitched porch roof to the front of the property, clad with nibbed clay tiles which are in average condition.

ACTION REQUIRED: Periodic check of tiles.

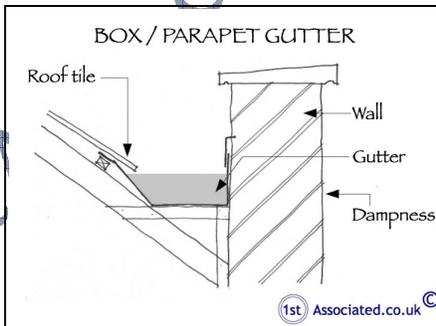
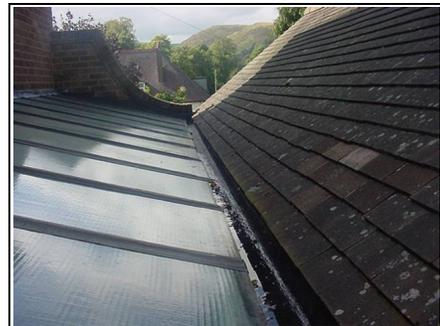
Box gutter

There is a glass roof, with box gutter, to the side of the property.

ACTION REQUIRED: Please see our comments in the Executive Summary.

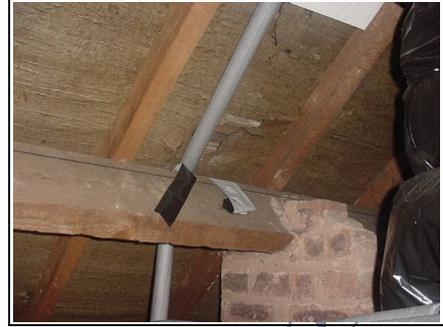
Close up purlin

Our examination was limited by the general configuration of the roof and the mass of insulation and stored items. What we could see was generally found to be in average condition for its age, type and style. It is, however, feasible that there are problems in the roof that are hidden.

ACTION REQUIRED: The only way to be 100 per cent certain is to have the roof cleared and checked.

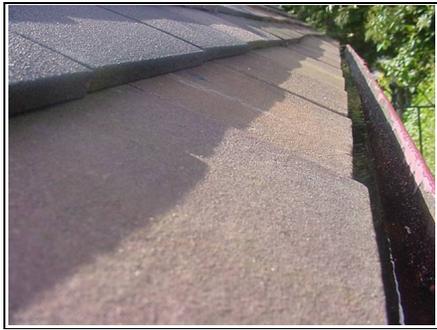
Gutter needs cleaning

We also recommend that the gutters and downpipes are cleaned out, the joints are checked and the alignment checked to ensure that the gutters fall towards the downpipes.

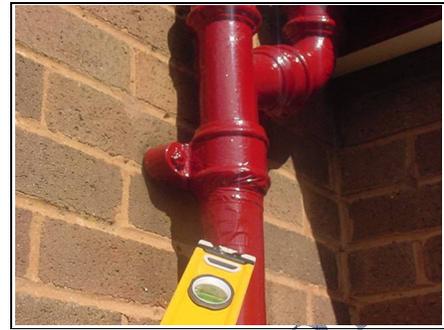
Bandaged cast iron downpipe

These have been some problems painted over, which we can see to the front right hand side and there may be other problems that have been painted over at high level.

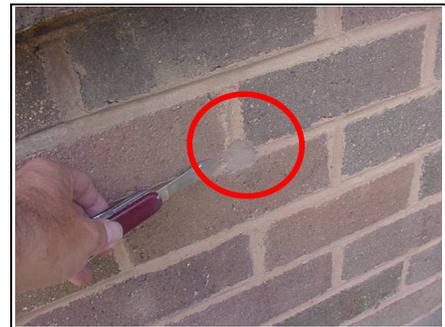
We are also aware that if cavity wall insulation is added on an older style cavity wall such as this it may accelerate the deterioration of the wall ties.

Cavity wall insulation has been added

ACTION REQUIRED: We would like information with regard to what inspection was carried out of the cavities (via endoscopes, any photos that have been taken) and for these to be forwarded on to us to comment further.

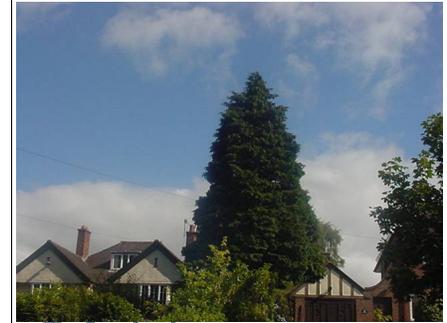
There are trees to the front and rear within what insurance companies would term as influencing distance but you do need to speak to your insurance company as they may have a different interpretation for insurance reasons.

Large tree to left near to garage

We would recommend an arboriculturalist (not a tree surgeon) is asked to view the property and give a ten year plan for maintenance. This should help with any insurance premiums that you may be charged.

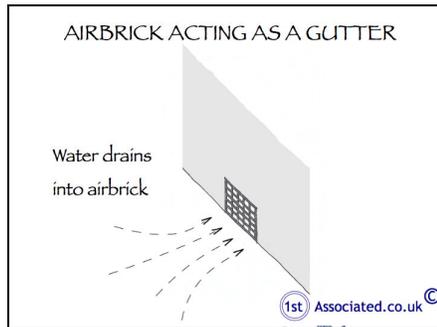
Air bricks are essential to have a through flow of air as this helps to reduce the chances of wet rot, dry rot and woodworm. In this case they are acting as gutters.

Air brick acting as a gutter

Protect air bricks. Ensure the airbricks are clear. Please see our comments in the Executive Summary.

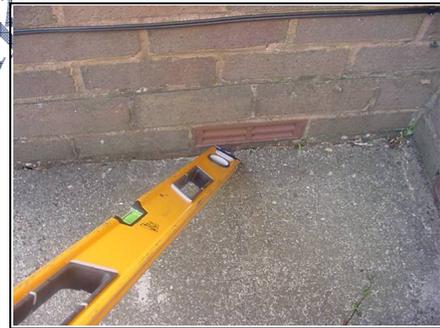
Air brick to front acting as a gutter

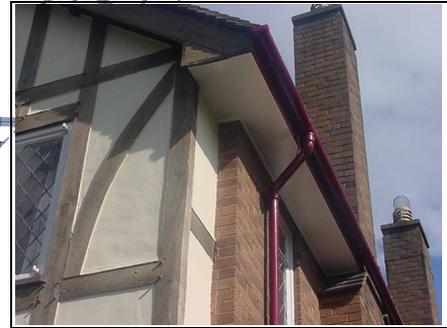
Fascias and soffits

The fascias and soffits are timber. In this era of property they were often asbestos and we cannot be certain in this instance. They are painted and we would comment they are in average condition for their age, type and style.

ACTION REQUIRED: Ask the existing owner. We assume they will have painted them many times, whether they are asbestos or not.

If there is any suggestion whatsoever that they may be asbestos then you need to have an asbestos test carried out. We would always recommend removal of asbestos as it can affect the value of the property.

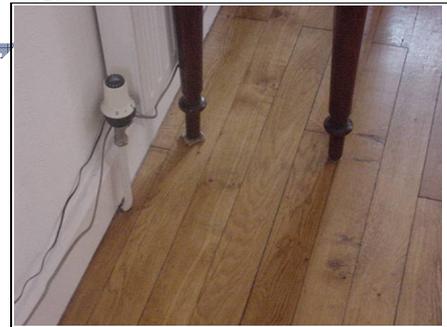
Uneven floor

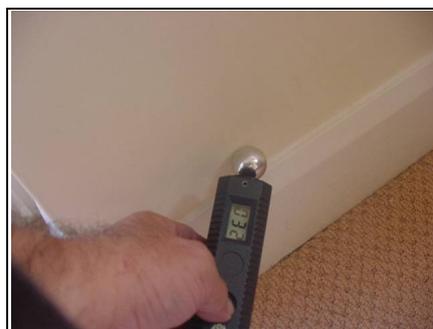
Testing for rising damp

A visual inspection and tests with a moisture meter have been taken to the perimeter walls. In this particular case we have found no significant rising damp, which we were slightly surprised about as we thought we would find some, particularly to the rear.

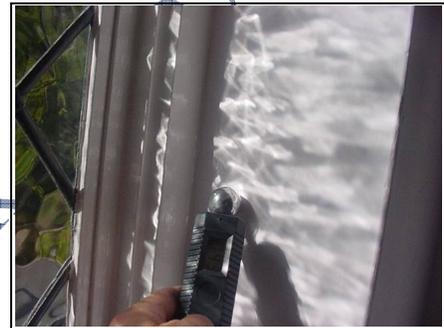
Testing for lateral dampness

We used a resistance meter on the external walls. Again, we have not found significant dampness and again we thought we would find some around the windows, although we did find slightly higher readings in this area.

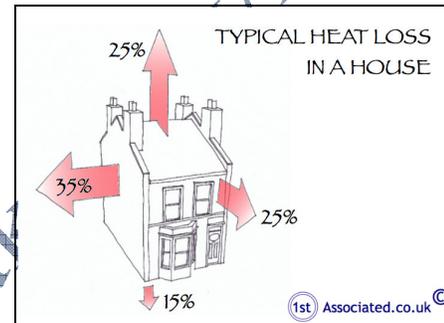
Typical heat loss

Some roof insulation was present although not to current Building Regulations requirements of 300mm. In this instance there is at least 300mm.

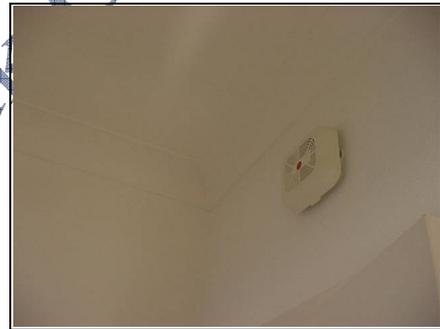
Smoke alarm

Some smoke detectors were noted, we believe these to be battery operated. The current Building Regulations require that they be wired into the main power supply.

ACTION REQUIRED: We would recommend, for your own safety, that additional smoke detectors are installed.

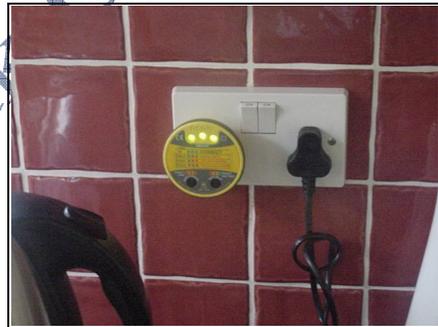
Earth Test

We carried out an earth test in the kitchen area to the socket point that is normally used for the kettle, this proved satisfactory.

ACTION REQUIRED: Ideally replace with a modern fuseboard. As the property is changing occupancy an Institute of Electrical Engineers (IEE) test and report should be carried out by a NICEIC registered and approved electrical contractor or equivalent.

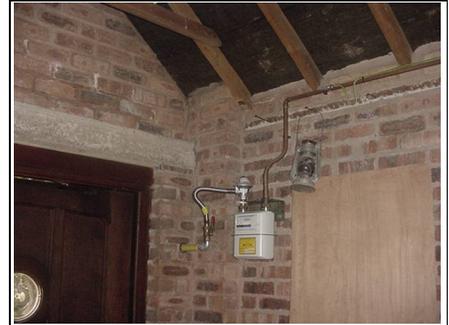
Gas meter

The property has mains gas. The consumer unit is located in the garage.

ACTION REQUIRED: As a matter of course it is recommended that the entire gas installation is inspected and made good, as necessary, by a Gas Safe registered contractor. Thereafter the installation should be serviced annually.

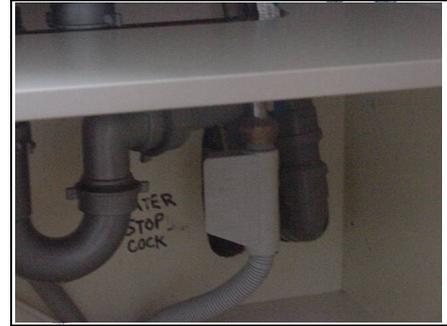
Stopcock

The controlling stopcock is located under the sink in the kitchen. It is important that its presence is established in case of bursts or leaks. The stopcock and other controlling valves have not been inspected or tested for operational effectiveness.

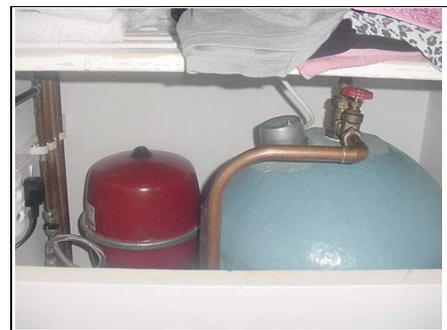
Hot water cylinder

There is a hot water cylinder located in the bathroom. It is factory insulated, which indicates that it is relatively new (in this case we mean in the last 30 years). This cylinder will therefore have a good thermal efficiency, although not as good as the more modern hot water cylinders.

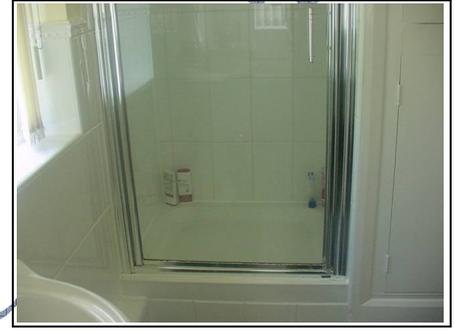
Shower

The property has a four piece bathroom suite, consisting of a bath, shower, wash hand basin and WC, which looks in average condition, subject to some day-to-day wear and tear, as one would expect.

Finally, although we may have already mentioned it above we would reiterate that it is important to ensure that seals are properly made and maintained at the junctions between wall surfaces and baths and showers etc. We normally recommend that it is one of the first jobs that you carry out as part of your DIY on the property, as water getting behind sanitary fittings can lead to unseen deterioration that can be costly, inconvenient and difficult to repair.

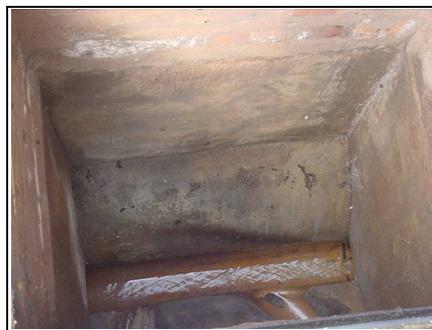
Manhole to front

We duly lifted the cover and found it to be free flowing at the time of our inspection.

From what we could see it is concrete built. It is rather unusual to have a concrete manhole as they would have been originally built in brick.

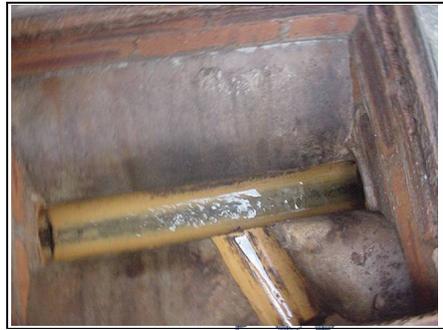
Manhole to rear

We duly lifted the cover and found it to be free flowing at the time of our inspection.

Again from what we could see it is concrete and we were slightly concerned as it looked newer than the property as a whole with regard to the brickwork and concrete.

ACTION REQUIRED: Your legal adviser to specifically ask the existing owners if there have been any problems in relation to the drains, or any work in relation to the drains.

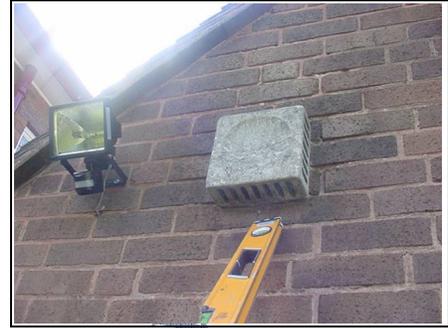
Asbestos flue

In a property of this age there may well be some asbestos. In this case we have noted a small amount of asbestos to the rear of the garage where there is an old boiler flue and this does highlight how asbestos was used very commonly. It may also be to the fascias and soffits and ductwork (please see adjoining sketch).

There is an old asbestos flue to the rear of the garage where an old boiler once was. There is possibly asbestos to the back of the door in what was the boiler room, but we were not certain as it was hard visually to confirm.

ACTION REQUIRED: Please see our comments in the Asbestos Section of the report.

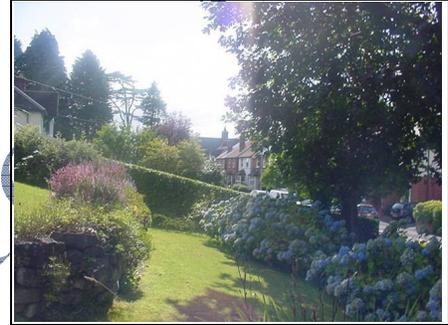
Front Garden

There is a large front garden, sloping down towards the road.

ACTION REQUIRED: Please see our comments in the Executive Summary about the lack of weep holes to the front retaining wall.

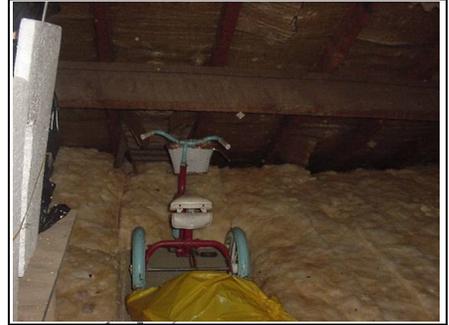
Mass of insulation

- 1) Our view of the roof was limited due to the mass of insulation.
- 2) We did not open up the ground floor or the first floor as we could not see a way to do it without causing damage.
- 3) We didn't have the benefit of meeting you at the property to talk about your specific requirements.
