JOB REFERENCE: XXXX

RESIDENTIAL BUILDING SURVEY

Potters Bar
Hertfordshire
EN6 XXX

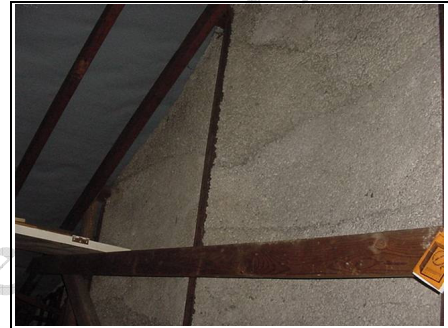
As discussed this is a non traditional building, by this we mean that the property was constructed after the War using production style techniques. Further to this it is a non traditional building which had a very limited number built using this technique which means that many banks, buildings societies and mortgage lenders will not have investigated this type of construction sufficiently for them to offer mortgages on them.

Inside of the walls taken from the roof space

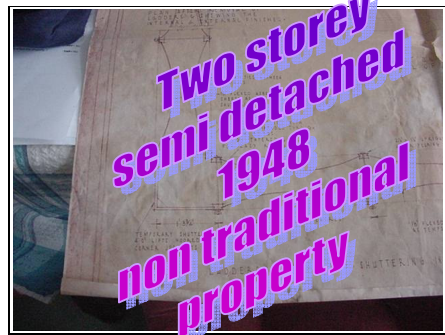
Drawing of non traditional building

ACTION REQUIRED: You need to speak to mortgage companies to see if you could get a mortgage (we understand you said you do not need one) on this property and talking to a neighbour you are aware that Abbey

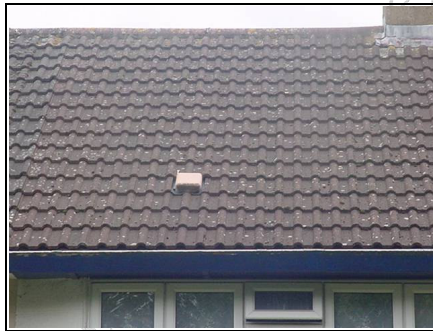
Vent in rear roof

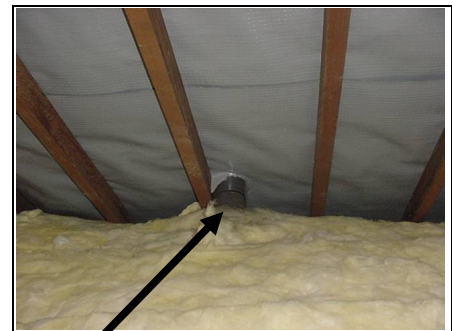
Vent from within roof space

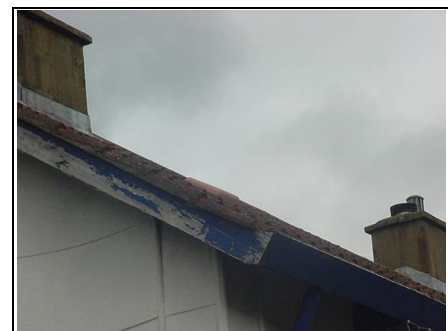
The bargeboard which looks to be timber has flaking paintwork which requires redecoration.

Bargeboard with flaking paintwork

ACTION REQUIRED:
Redecorate.

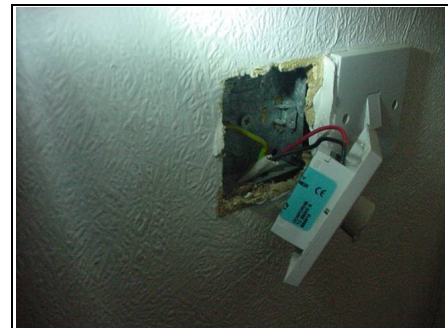
To try to try to check what the construction of the walls was we took some socket points off in an area where the owners thought we would be able to see the construction but unfortunately this was not possible.

Checking via socket point wall construction but unable to be certain

ACTION REQUIRED: As mentioned we would recommend taking samples of the walls.

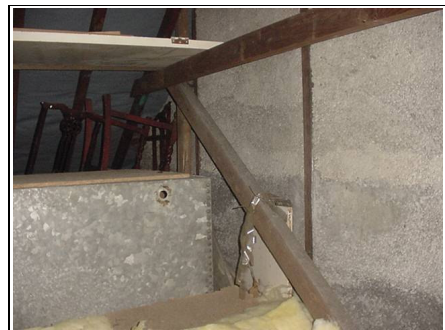
From the drawings the current owner showed us and from our research the walls appear to be an asbestos mould known as form work which has then had an insitu concrete poured into it. The owners advised us that they had seen a straw like material which may well be what was known as stramit board which was a mixture of concrete and straw which made a very strong boarding (unless the boarding gets wet).

Non traditional walls internally

In summary we simply are not one hundred percent certain of what the walls are constructed of; further investigation is required particularly in relation to asbestos.

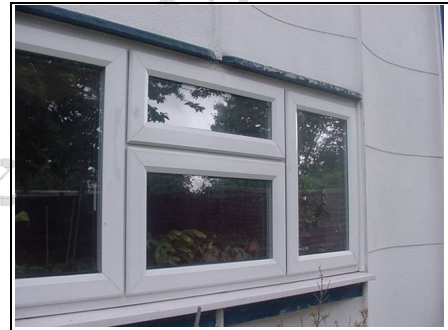
The property has plastic double glazed windows which we would term from the cheaper end of the market as they do not have trickle vents which have been a requirement for many years to give an airflow in a building. If trickle vents are not present and thereby no airflow this will promote condensation.

Window without trickle vent

ACTION REQUIRED: Add trickle vents to windows if possible alternatively ensure that the house is aired regularly.

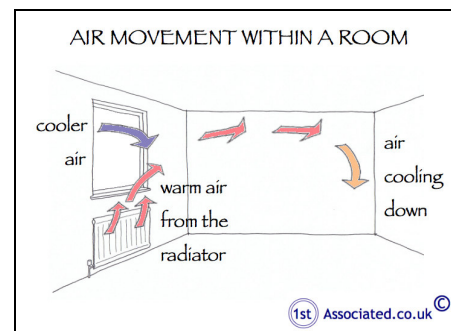
Some of the radiators are not positioned under the windows which does mean that there will not be a good airflow in the property which can promote condensation.

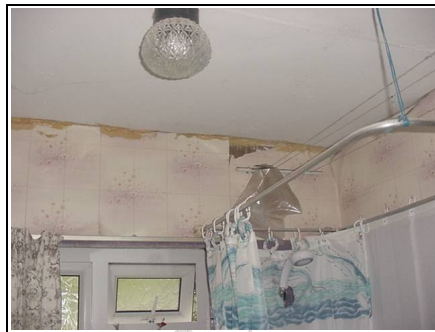
The Bathroom and separate WC area are in need of replacement/upgrade, in our opinion and we would also recommend that humidity controlled extract fans are added to both the bathroom and the kitchen to help vent the property and reduce the chances of condensation.

Condensation in bathroom

ACTION REQUIRED: Replace Bathroom and WC and completely redecorate. Add humidity controlled extract fans to bathroom, WC and kitchen areas.

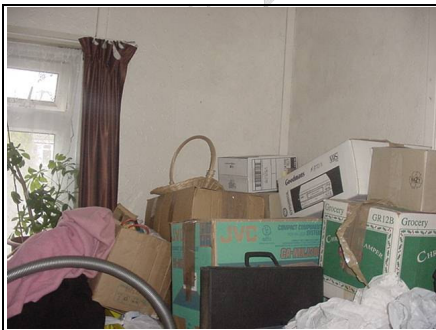
As you are aware there were many items boxed and stored at the time of our inspection which limited our view.

Many boxed items

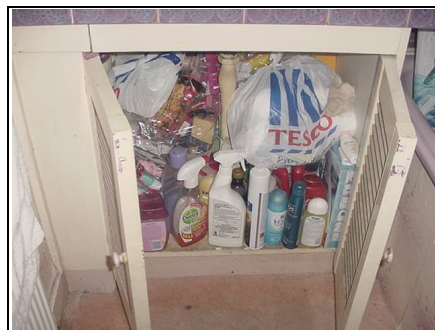
Many items stored in cupboards

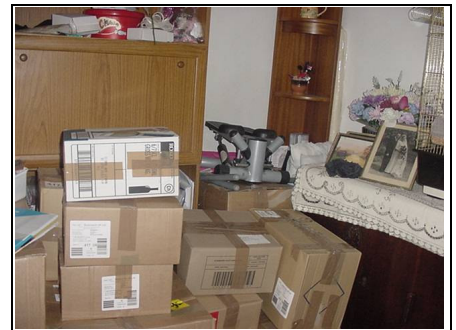
Mass of boxes

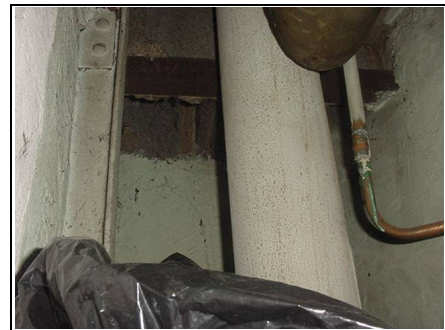
The old flue pipe from the old boiler possibly is asbestos. Further investigation to be carried out.

Old flue pipe from old boiler

ACTION REQUIRED:
Asbestos report to be carried out.

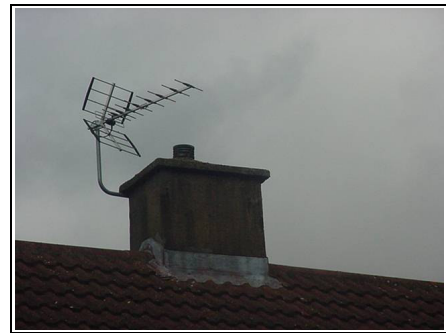
This chimney is blockwork with render on the outside (it could be prefabricated with almost anything as this is a non traditional property and were often asbestos lined) finished with a lead flashing and one chimney pot; from what we could see this chimney pot relates to an old flue to an old boiler that would have been within the cupboard off the kitchen area. From what we could see from ground the chimney looked in average condition considering its age, type and style.

Chimney

Unfortunately we were unable to see the top of the chimney known as the flaunching, we therefore cannot comment upon them.

ACTION REQUIRED: Periodically inspect the chimney.

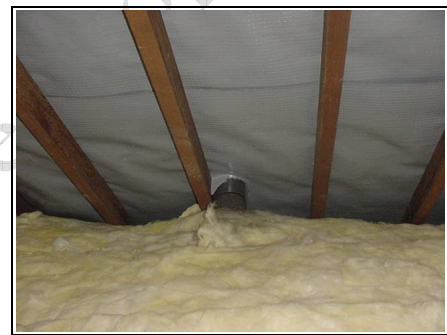
We found a plastic protective underlayer when we inspected the loft space. This type of membrane has been used in the 1970s for a relatively short period of time before, we believe, problems with condensation were discovered. We have been in a roof where it literally felt like a rainforest with condensation dripping off the plastic protective underlayers. Due to the new insulation which has been installed in the roof space we could not see any previous staining. We would normally have looked for staining on the ceiling joists. You may recall we spoke about an analogy to a cagoule raincoat that Mums make their children wear! and how the house effectively sweats in a similar way/condensation. Of course, this house is held together, from what we understand, by metal ties which can rust in this age of property.

This photo shows the common rafters (the ones that form the pitch of the roof) and the white area between is the underlayer.

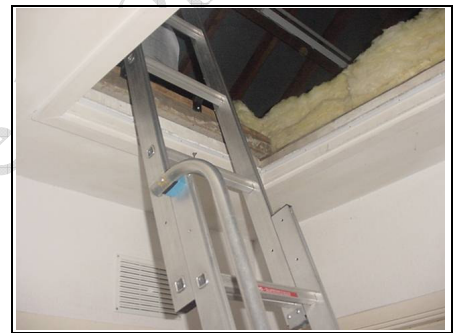
Roof ladder

The main roof is accessed via the loft hatch located landing. There is a loft ladder but no electric light or secured floorboards. We recommend that these be added, as it will make the loft space safer and easier to use.

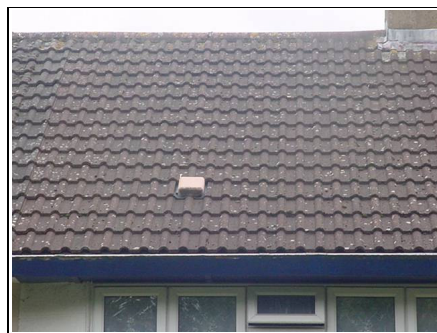
Vent in rear roof

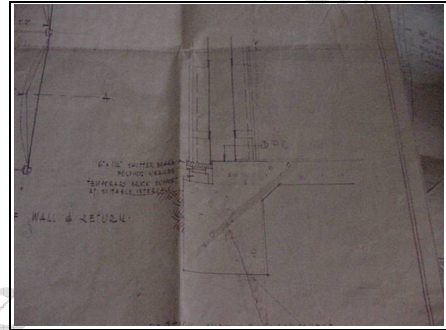
From speaking to the next door neighbour's they thought that the property was on a raft foundation however having looked at drawings provided by the owners of your property it looks like there is a trench filled concrete foundation to the perimeter of the building.

Drawings of the foundations
albeit poor quality.

We would add in our experience drawings very rarely follow what was actually carried out on properties. You do need to open up the structure to investigate further to be one hundred per cent certain which may be a requirement of a mortgage company.

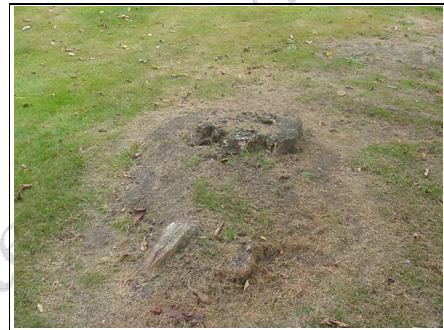
Tree previously cut down

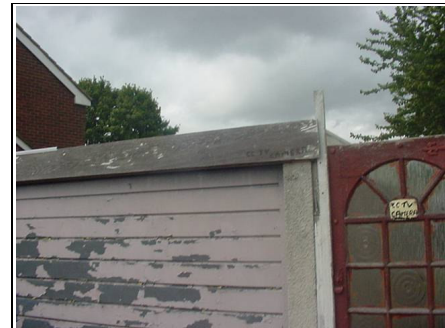
Garage has flaking paint

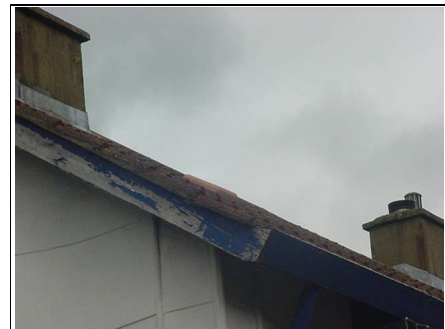
Bargeboard with flaking paintwork

Again, we have not visually seen any wet rot during the course of our inspection. There is likely to be some wet rot to the fascias and soffits and the bargeboards which look like they have not been decorated for a long time.

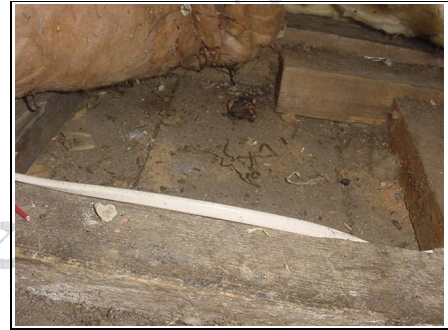
From our visual inspection of the ceilings and our general knowledge of this age and type of construction we believe that the ceilings are likely to be proprietary system i.e. one off. We can see that a board has been used from the straight cracking that we could see internally. We believe that the cracking relates to condensation problems in the property and general lack of redecoration. We could also see that there looks to have been a water leak to the rear of the property (we could still see water staining on the purlins).

Boarding ceiling

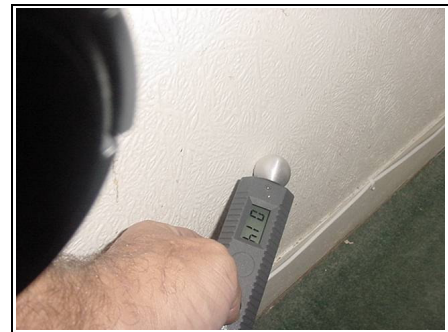
A visual inspection and tests with a moisture meter have been taken to the perimeter walls. In this particular case we have found no rising damp as we were unable to take damp readings due to the presence of dry lining/false walls. Much evidence points towards there being true rising damp in only very rare cases.

Testing for rising damp

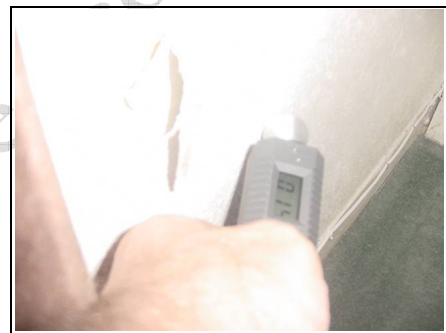
We used a damp meter on the external walls. We have not found dampness as we were unable to take damp readings due to the presence of dry lining/false walls. We found it to be in line with what we would expect for this age, type and style of property.

Testing for lateral dampness

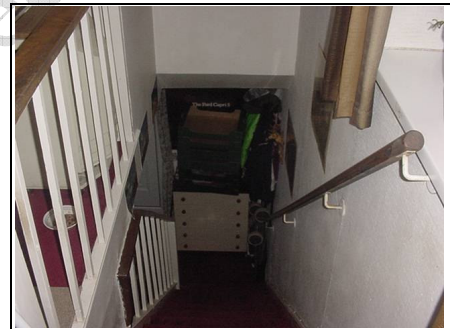
Stairs

We were unable to examine the underside of the stair timbers due to it being lined, which precluded our inspection, so we cannot comment further upon the stair structure. We can, however, say that the lining gives a resistance to the spread of fire if such circumstances were to occur.

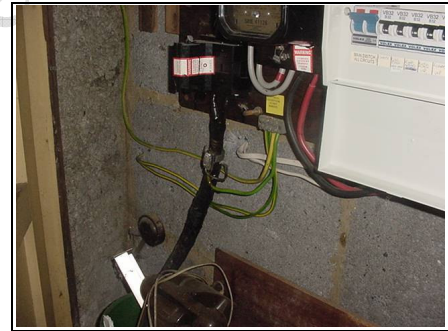
Fuse Board

The electric fuses and consumer units were located under the stairs. The fuse board looked from the 1980s/1990s although we are advised that work has been carried out on the fuse board in the 2000s.

ACTION REQUIRED: As the owner advised he has carried out work he should be able to provide certificates. In any case as the property is changing occupancy an Institute of Electrical

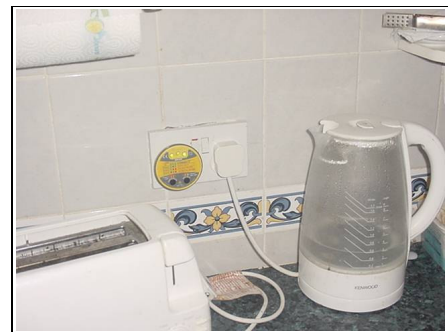
Earth Test

We carried out an earth test in the kitchen area to the socket point that is normally used for the kettle, this proved satisfactory.

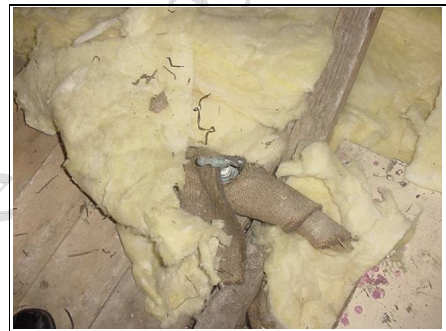
We do not think we have located the controlling stopcock.

Stopcock in roof space.

ACTION REQUIRED: Ask the owners to show you where it is and see the water actually turned off.

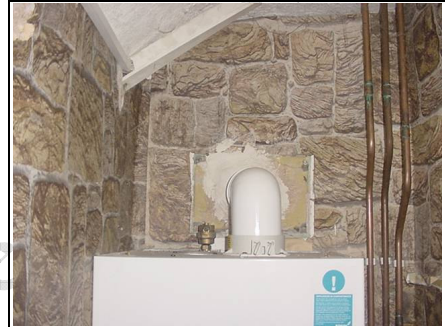
The wall mounted boiler was located in the cupboard off the from the kitchen it is manufactured by Potterton. The owner had details of the boiler which you should ask for.

Our limited inspection of the hot water and central heating system revealed no evidence to suggest any serious defects but we would nevertheless recommend that the system be tested and overhauled before exchange of contracts and that a regular maintenance contract be placed with an approved heating engineer.

Potterton boiler

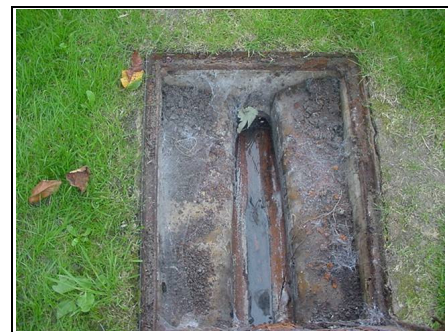
We duly lifted the cover and found it to be free flowing at the time of our inspection.

From what we could see it is concrete built.

Manhole to the rear of the property

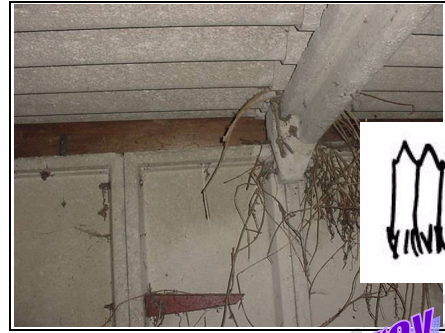
Asbestos roof to garage

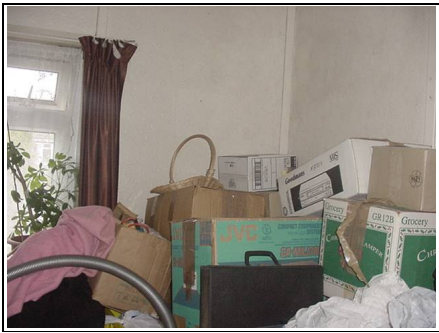
Many boxes limited our view

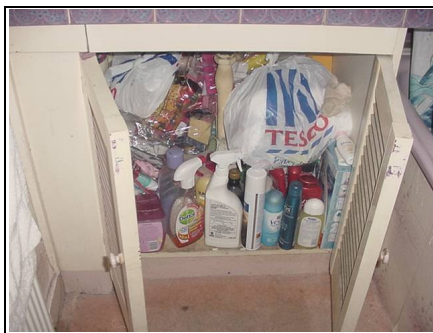
Cupboard full of items

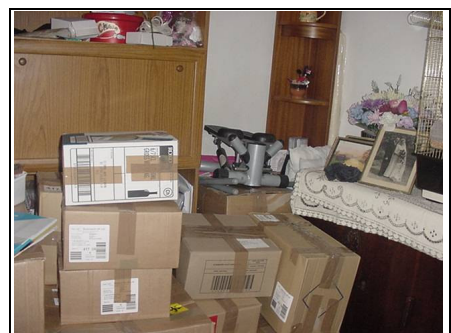
Many boxes

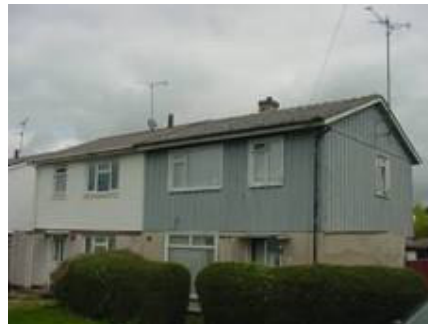
Asbestos roof on BISF house

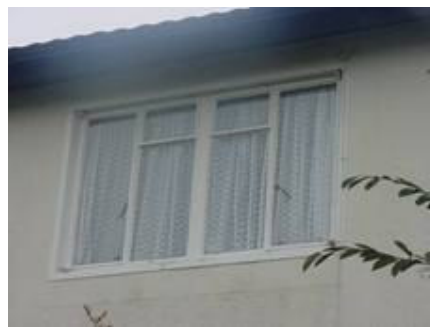
Close up of old metal windows in a non-traditional house

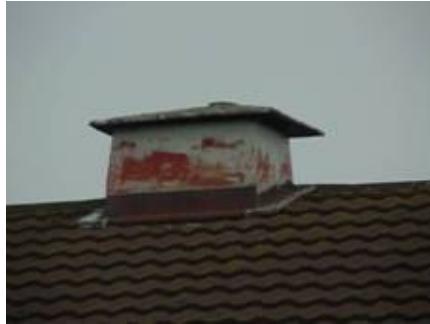
Asbestos original chimney non traditional house

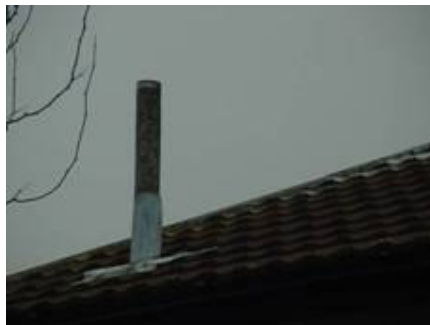
Original asbestos soil and vent pipe on a non-traditional house

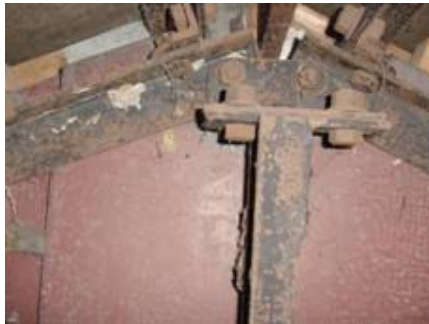
Rusting to a lightweight metal frame or damage or deterioration to the metal frame of a non-traditional house

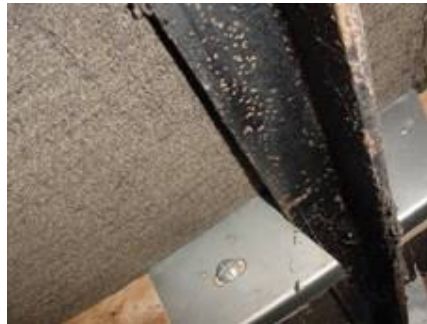
Some fixings replacements/repairs to a non-traditional house

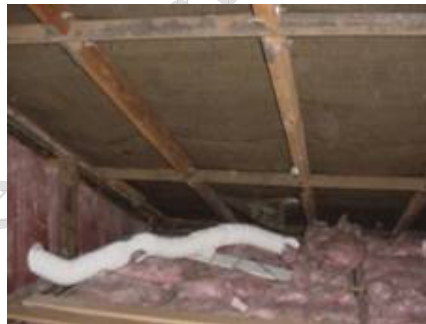
It is very common these days to have a shower/ bathroom with an extract system. Does that extract system discharge into the roof or does it discharge out of the building? If it discharges into the roof then there can be problems with rusting and corroding of metal and dampness to timber.

Extract vent to outside often discharges into roof which is essential that they do not in this type of roof
