RESIDENTIAL BUILDING SURVEY

Tewkesbury,
Gloucestershire GL20

Mr & Mrs H

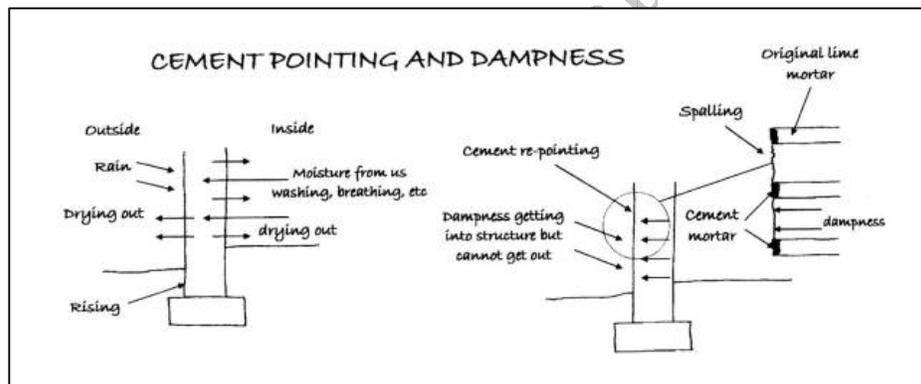
2) Stonework deteriorating

We can see that the face of the stonework is deteriorating. This we feel is due to the pointing being a cement mortar rather than a lime mortar and gutters leaking.

As we discussed with you, a lime mortar allows the property to breathe and gives a gortex type breathable structure, whereas a cement mortar has more of a raincoat type affect, causing the rain to deteriorate the stonework.

Deteriorating stonework

ACTION REQUIRED: Repoint all areas with a lime mortar rather than cement mortar.

ANTICIPATED COST: This is labour intensive work and likely to require scaffolding. You may be best off buying your own tower scaffolding. Costs in the region of £20,000 to £30,000. Care will have to be taken as this is a Listed building, as well as consultation with the Conservation Officer. Please obtain quotations.

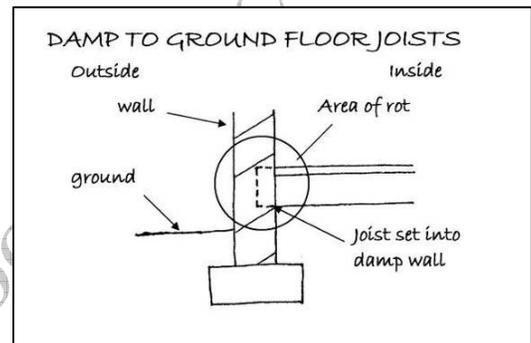
Part of the property has a timber frame structure which we feel is in need of repair, for example to the cellar area and the dining room above and the middle bedroom, all of which show wet rot defects and woodworm defects. It is also likely to be due in part to the embedded timbers, as shown in the sketch.

Timber frame structure

As the building is Listed the work will have to be carried out with the Conservation Officer's approval. We feel there is a lot of cement mortar that can be removed from the property with effect that there will always be some wet rot and woodworm discovered in the timber frame structure as the repointing is carried out which will need repair.

We believe we could see some active woodworm to the gable end, although this is very difficult to comment on as it was at high level.

ACTION REQUIRED: General repairs and repointing in a lime mortar and timber repairs as necessary.

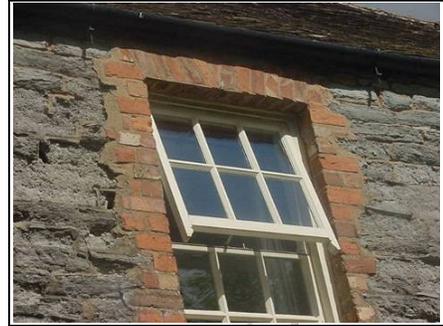
There are relatively new double glazed windows in the building. Double glazing generally requires consent, particularly in a Listed building. We discussed this with the owner who did not think (did not know if) they had Conservation Approval / Listed Building Consent, which normally means they do not have. He advised that the windows followed the pattern of the original windows. You can see, for example, the sliding sash opposite has a modern opening casement style.

Double glazed windows
- sliding sash look with a modern sash style

On a technical point of view some of the double glazed units are missing up. This is often due to movement in the structure which double glazing cannot accommodate.

ACTION REQUIRED: We feel it is best you discuss the double glazed windows with the Conservation officers as soon as possible and voice concerns that they are double glazed. In many cases Listed Building Officers will not require you to do anything, however this is down to the Listed Building Officer in question.

ACTION REQUIRED: You will have to replace the double glazed units

ANTICIPATED COST: Set aside the sum of £10,000 for dealing with the worst case scenario with the Conservation Officer. They may have photographic records of how the windows were and wish you to replace them as this standard. This would be a liability in the tens of thousands.

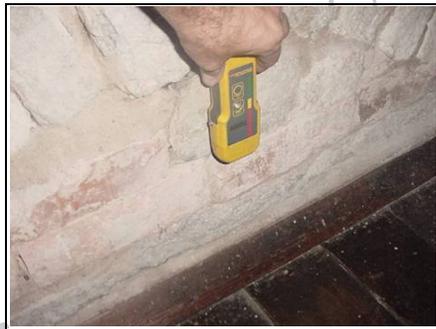
We are finding high levels of dampness. Whilst this is partly to do with the cement mortar it is also in part to do with the high ground levels around the property which we recommend are lowered and ideally a French drain is added (subject to Conservations Officer's approval), discharging into the septic tank.

Finding rising damp

ACTION REQUIRED: In all properties it is very important to ensure that dampness does not get into them. In this case you have dampness coming in at high level via the gutters and downpipes and in some areas the roof detailing with cement flashing. In other areas you have rising damp due to the ground level being too high and downpipes discharging against the property.

ANTICIPATED COST: Set aside the sum of £10,000 to £20,000 for general making watertight repairs; please obtain quotations.

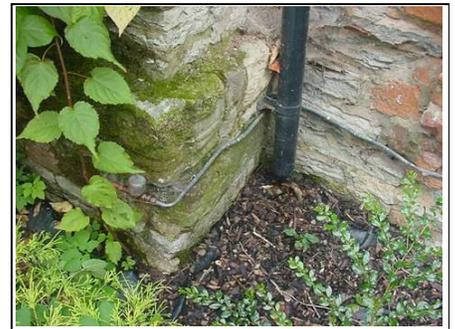
We would also recommend that a review of the guttering and downpipes is made, as we can see several instances where downpipes discharge against the building and/or we believe water surcharges (overflows) when it rains over the gutters and hopper heads. For example, we can see some deterioration to the stonework on the left hand side that we believe is caused by an overflowing hopper head.

Water discharging against the property

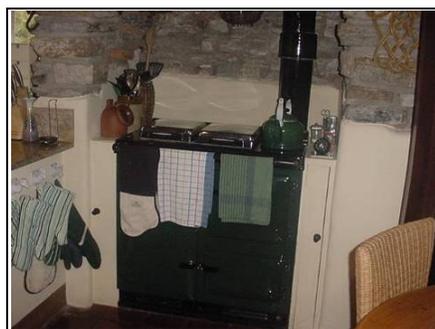
8.3 You currently have an oil fired Rayburn. You may wish to supplement this by a second oil fired boiler. Remember we looked at the property in August, which in theory should be a warm, fairly dry pleasant month. There is still an element of dampness in the property which obviously is far worse in the middle of winter.

Rayburn

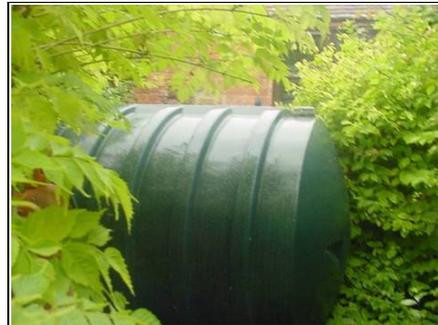
Plastic oil tank

ACTION REQUIRED: Confirm with the owner whether they will leave the oil tank full or not, as winter is on its way.

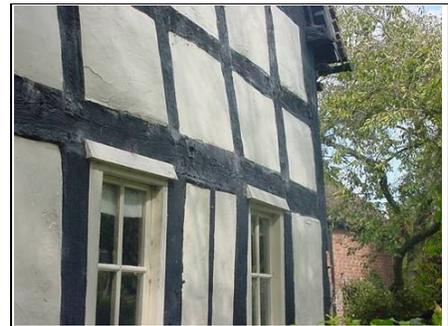
To the right we can see that the wall is bowing in the main building on the right hand wall.

Bowing in right hand gable

ACTION REQUIRED: We recommend the existing owners place insurance claims, advising that a building survey was recently carried out and it identified the items above and insist that monitoring for movement is carried out on the property.

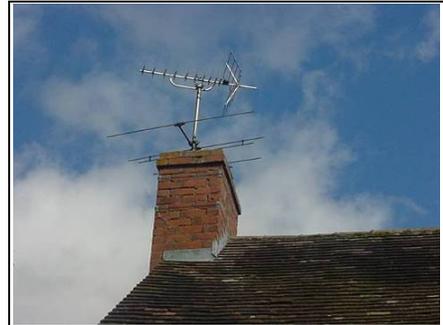
This chimney is brick built with a lead flashing. We are unable to see the top of the chimney known as the flaunchings, we therefore cannot comment on its condition. However we did note cracking and movement in the chimney breast externally. This can also be seen internally.

Front left hand chimney

ACTION REQUIRED: Please see our comments in the Executive Summary with regard to an insurance claim being required due to the movement that is occurring.

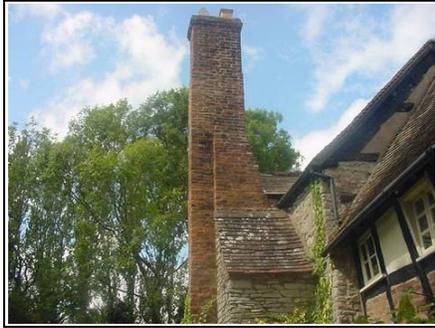
This is a substantial stone and brick chimney. It looks to have been rebuilt and repaired over the years.

Middle chimney

ACTION REQUIRED: It generally needs some ad hoc repointing. It also needs the flashing checked to the rear of it.

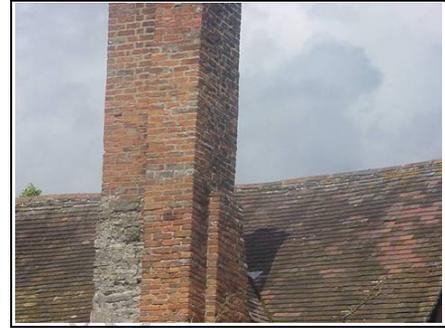
Close up

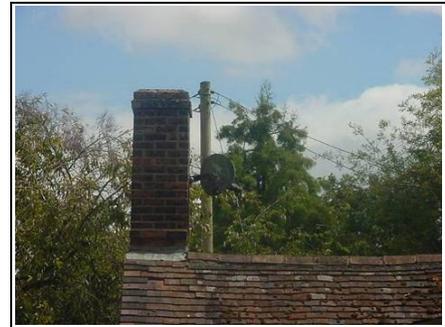
This is located to the rear of the property on the single storey extension which incorporates the cloakroom. It is brick built with no chimney pots and a lead flashing. The flashing was slightly unusual as we would expect it to go higher. We also noticed some undulation in the roof, meaning there may be some movement in this chimney. We were unable to check to see if this chimney was present at lower level.

Rear chimney

ACTION REQUIRED AND ANTICIPATED COST: We would set aside the sum of £1,000 to check if this chimney is present at lower level and/or remove the chimney or add a structural support in.

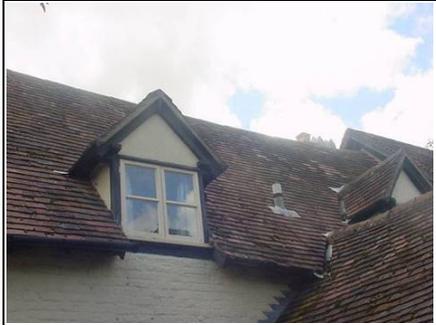
There are two dormer windows situated to the rear of the property. They have rendered fronts and sides with glazed casement windows and a tiled roof and generally look in average condition.

Rear left hand dormer window

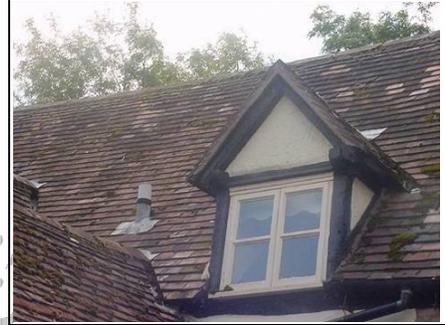
Rear right hand dormer window

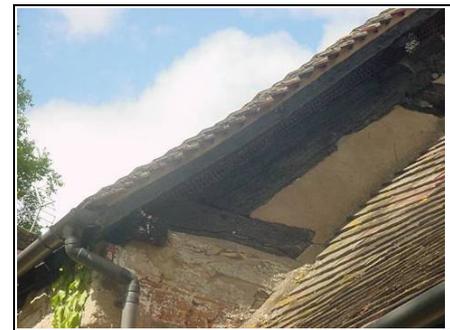
There is an upstand in the roof where there is dampness coming in. You can literally see chicken wire in the gap in the roof. We have spoken elsewhere within this report about adding more loft access, this would then allow you to gain access to this area and to be able view the problem better. Our view was very limited.

Upstand in roof

ACTION REQUIRED: Close gap in upstand.

ANTICIPATED COST: We would set aside the sum of £1,000 to £2,000 for general repairs to close gap in upstand.

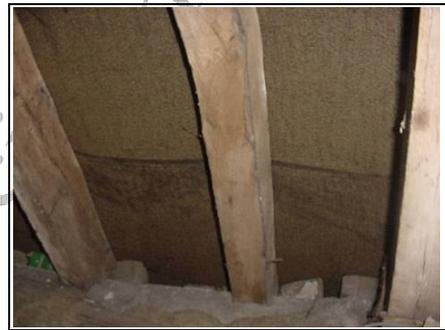
When we inspected the loft space we found a Hessian base Bitumen membrane. This type of membrane has been used since the 1960s. We generally found it to be in average condition, it is damaged in a few places but this is not unusual considering its age.

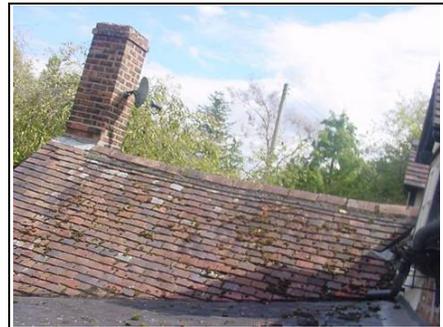
Our comments are very similar to the main roof. There does look to have been some movement around the chimney area. Please note our comments with regard to work needed on this chimney. It does look like there have been repairs around the chimney fairly recently.

Roof over cloakroom

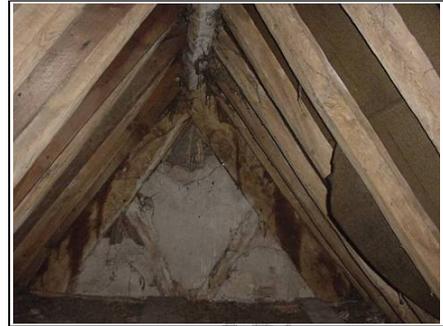
Our examination was limited by the general configuration of the roof, the insulation and the water tank. What we could see was that there was woodworm and some damp/condensation in the roof. The roof is in average to slightly below average condition for its age, type and style. It is, however, feasible that there are problems in the roof that are hidden.

General view

ACTION REQUIRED: The only way to be 100 per cent certain is to have the roof cleared and checked.

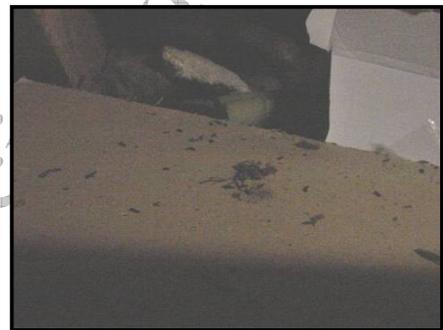
Mouse droppings or possibly carcasses of the woodworm

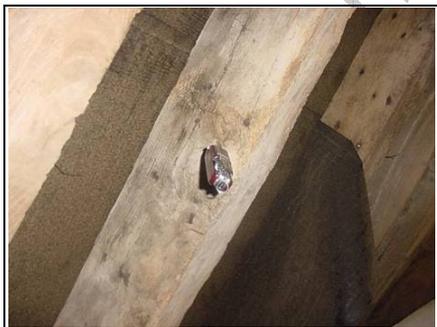
Knife test for softness

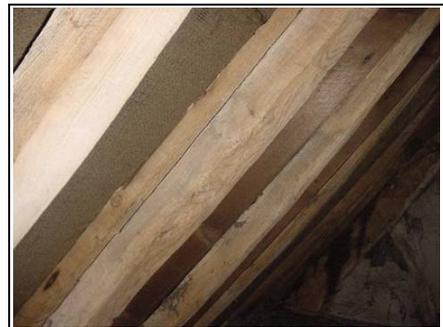
In this instance the original timbers have been replaced and repaired. In some cases additional timbers have been added next to the old.

Some of the timbers have had new timbers put back to back, known as back to backing, to add strength

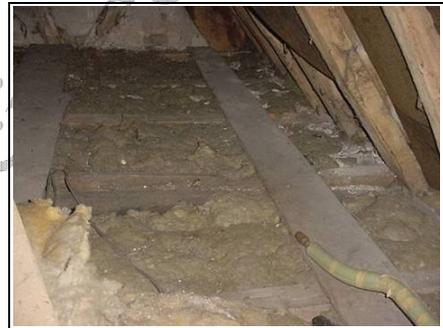
Insulation

We recommend that ventilation is added to the roof. The original natural ventilation has been lost by the re-roofing and adding of a Hessian protective underlayer and then insulation has been added, which contribute towards causing condensation.

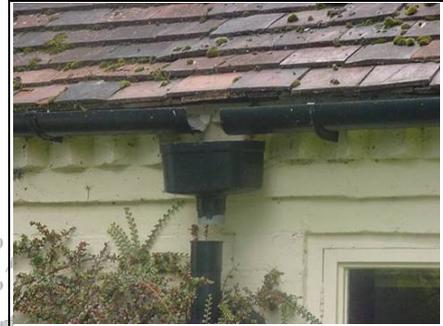
The property has plastic gutters and downpipes. It is so important on a timber frame property and on a stone property such as this that the gutters and downpipes do really take the rainwater away.

Gutters and downpipe
and hopper head

ACTION REQUIRED: Please see our comments in the Executive Summary where we recommend a general overhaul and review of the gutters. We would always recommend that the gutters and downpipes are cleaned out, the joints are checked and the alignment checked to ensure that the gutters fall towards the downpipes.

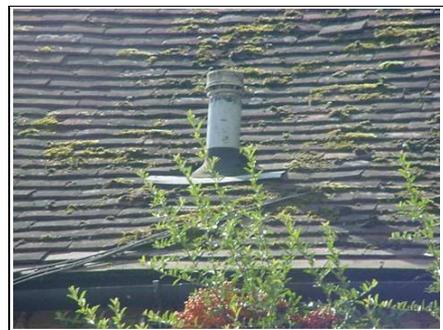
A plastic soil and vent pipe can be seen at roof level. Other than this it is internal.

Plastic soil and vent pipe just
visible to rear of property

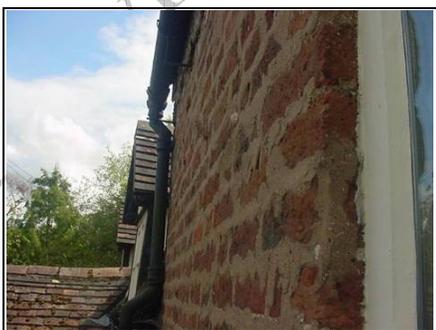
There is some older brickwork to the rear of the property. We can see there was just some render remaining above the top of the older brickwork. Again it appears to be suffering from being poorly pointed.

Old brickwork to rear

ACTION REQUIRED: We recommend repointing.

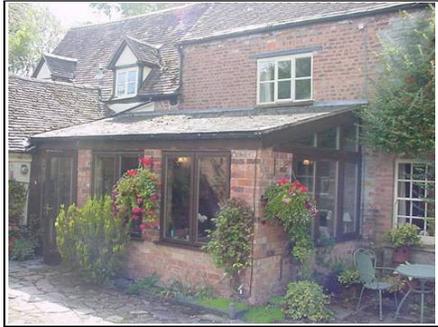
Sun room

The sun room brickwork is in reasonable condition, whilst the brickwork around the cloakroom area is suffering from dampness. This area is very close to the well and this may relate to how water is being brought into the property.

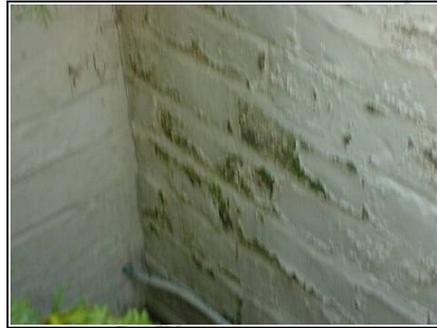
Brickwork around cloakroom

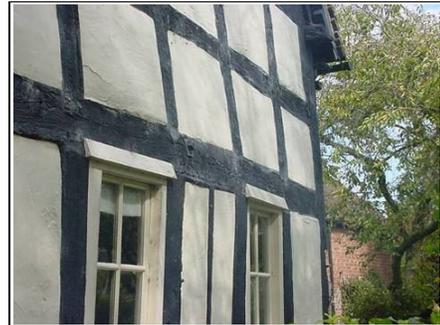
There is bowing to the to right hand gable.

Bowing to right hand gable

ACTION REQUIRED: Please see our comments in Executive Summary.

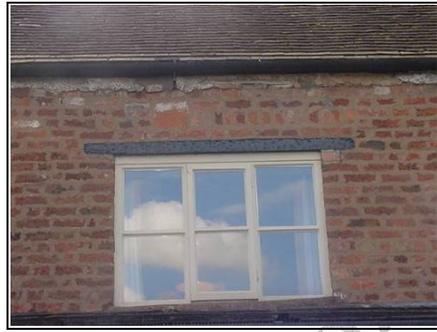
As is common with this age of property there are timber lintels. There is likely to be some deterioration to them, as we find in most timber lintels. We did not see any specific issues.

Timber lintel

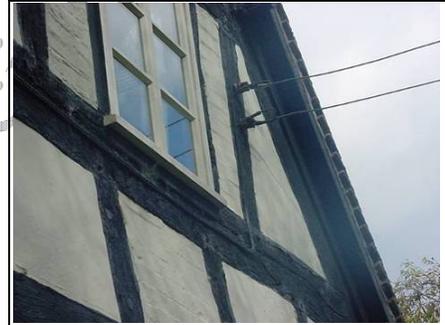
Given the damage we can see from the water discharging down some parts of the walls there is likely to be some deterioration them.

Timber fascias and soffits

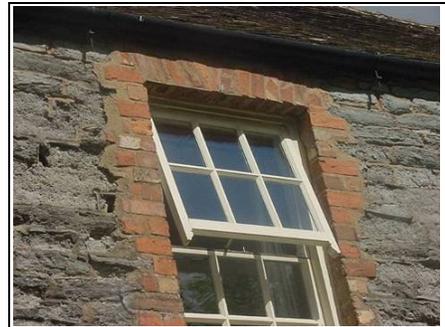
Quite surprisingly the property has modern double glazed sliding sash style windows, (as can be seen in the photo – they did not actually side they opened).

We would refer you to the Appendices where we have put some of the historic window guidance that Tewkesbury Council Conservation Department provide. We do not think they will be very happy with the windows but are unsure of what action, if any, they will take, but it certainly needs to be brought to their attention before your purchase the property to establish the associated risk with it.

Double glazed windows

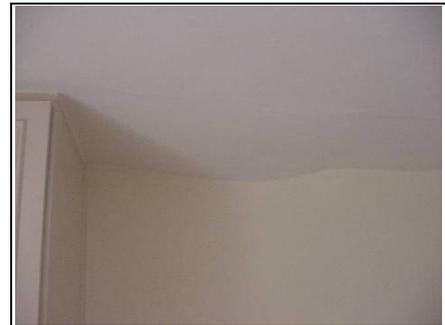
We did not gain access to the roof over the left hand room as we were not certain that the ceiling could hold our body weight. We can however see the undulation in the ceiling and it is also adjacent to the chimney that shows signs of movement on the left hand side and they are likely to be inter-related.

Dip in master bedroom ceiling

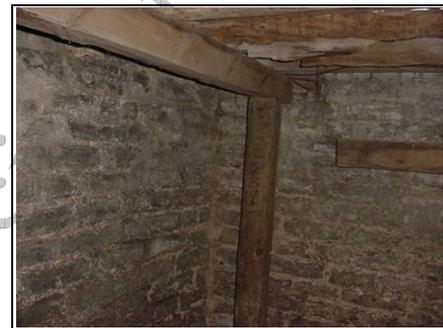
We have assumed that the ground floor construction is tiles on earth. Where it goes over the cellar it is a joist and floorboard construction with embedded timbers. These timbers have been in addition propped in place. However, we have not opened up the floors or lifted the carpets.

Long term additional support in cellar area to ground floor with dining room above

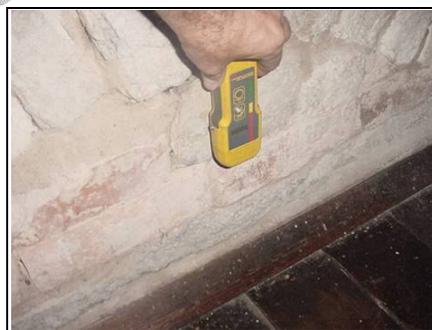
Finding rising damp

A random visual inspection and tests with a moisture meter have been taken to the perimeter walls and some internal walls. We found dampness throughout the property, please see our comments in the Executive Summary.

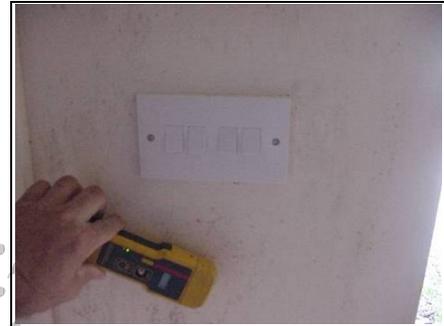
Checking for lateral dampness

Again, we found dampness in various parts throughout the property. Please see our comments in the Executive Summary.

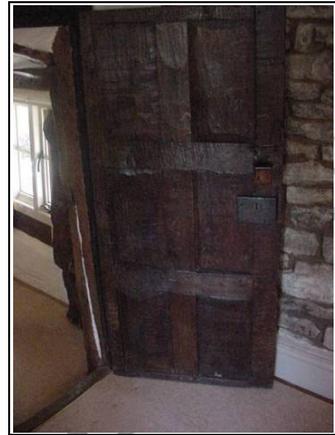
Very old door between walk through middle bedroom and landing area

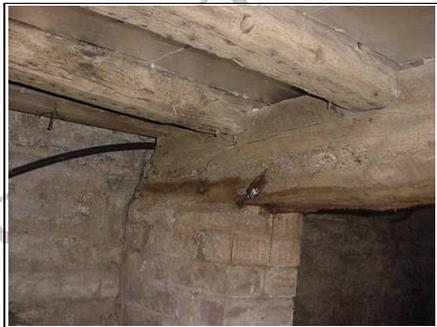
The cellar has been propped up with timbers from many years ago. We found extensive wet rot in the timbers.

Dampness in timber – knife test into damp spine beam

ACTION REQUIRED: We would recommend, particularly given the amount of deflection in the floor of the dining room that new props are added. Probably the best way to do it on old property such as this is to add in new props without removing existing timbers and carry out the general drying out and improvement measures that we have mentioned externally to improve the environment.

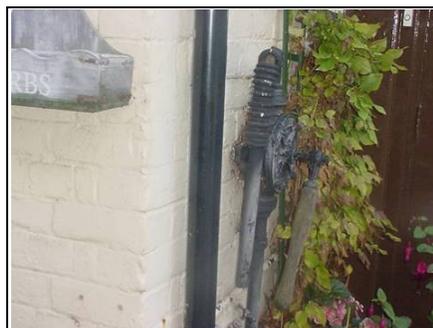
Electric pump from well
(although old pump remains)

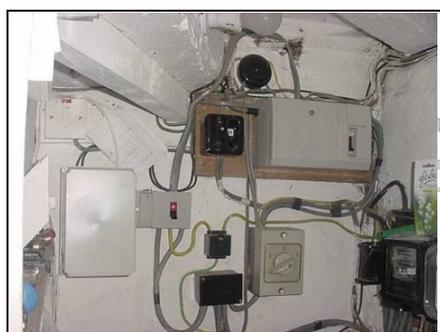
The electrics located underneath the staircase adjacent to the kitchen. The fuse board looked dated.

Electrics and generator switch

ACTION REQUIRED: Ideally replace the fuseboard.

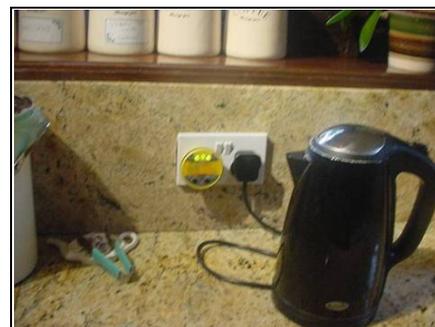
We carried out an earth test in the kitchen area to the socket point that is normally used for the kettle, this proved satisfactory.

Earth test in kitchen

ACTION REQUIRED: As the property is changing occupancy an IEE report should be carried out by a NICEIC registered and approved electrical contractor.

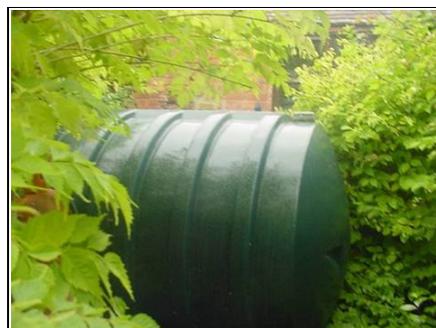
We are advised that the property has oil heating. We were pleased to see that the oil tanks are plastic. These usually replace the older metal tanks that can rust and they typically have a double lining, meaning that if they leak they leak into the outer lining.

Plastic oil tank

All appliances, pipework and flues should be subject to an annual service by a competent OFTEC registered engineer. Unless evidence can be provided to confirm that there has been annual servicing, we would recommend that you commission such a service prior to use to ensure safe and efficient operation.

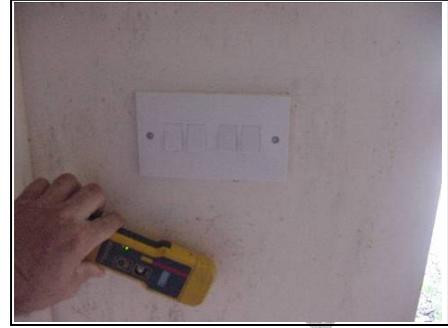
We noticed some dampness visible which we spoke to the owner about. We were advised that during the cold weather when it was recently empty a pipe burst which is why it is newly carpeted in the property.

Finding lateral dampness

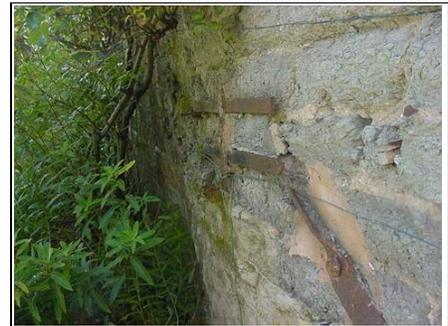
2. The bowing that can be seen to the rear wall. There looked to be signs of old metal braces to the front wall and the general poor condition of the stonework and the lack of even a gutter.

Bracing to wall

ACTION REQUIRED: To the barn major work needs to take place. As recommended in the Executive Summary we would report this to the insurance company. We consider this in very poor condition.
