**RESIDENTIAL BUILDING SURVEY
OF
Richmond TW10**

**FOR
Mr S & Miss D**

INDEPENDENT CHARTERED SURVEYORS

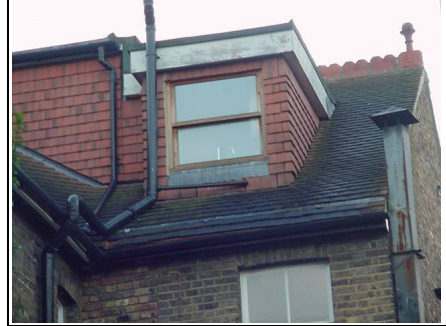
There is one dormer windows to this property, to the rear, of which our view is very limited. We could see the sides are clad in a vertical red tile with a painted fascia board, although the paint is peeling off, and we could just about see the edge of a felt roof. Due to our limited view we have no way of knowing what condition this is in. It forms the roof directly over the kitchen area. There may be access to the roof from adjoining properties (we did try the neighbours to investigate this further, but no-one was in). At the soonest opportunity you need to check the condition of this flat roof and take appropriate action.

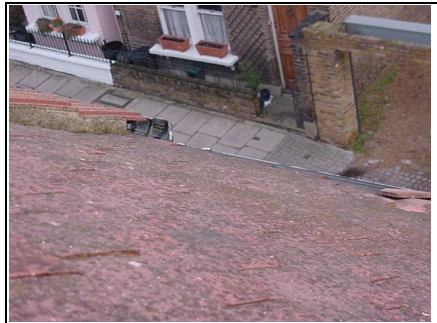
The roof tiles

The main roof is pitched and clad with a small clay tile to the front and some larger concrete tiles to the rear. Both the clay and concrete tiles are likely to be nibbed tiles. Overall we believe the roof to be in average condition, however, its location and our recent windy weather may be the reason for the slipped tiles (that have luckily been caught in the gutter).

Periodic inspections will be needed with this roof. Please see our comments on having a deep flow gutter in the Executive Summary.

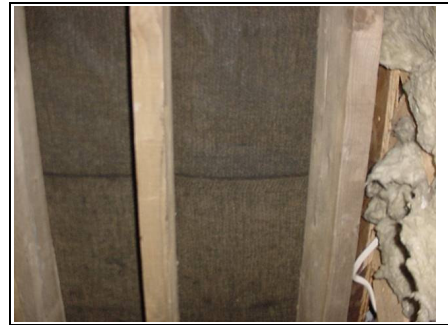
Unfortunately we were only able to see a very small area of the underside of the roof. The small bit that we did see was a Hessian based bitumen, which has been used since the 1960s, and it generally seems to be in an average condition. However, we were surprised to see it rather than the more modern breathable felts that are now used (they have been used for about the past five years) to help reduce the chance of condensation, which can be quite high in a roof such as this.

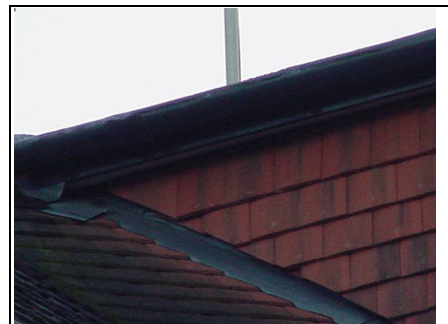
There appear to be two flat roof areas to the main roof; one of them is over the dormer, which, from the edging we could see, looks to be felt and the other is over the rear of your main reception room, which, from the edge that we could see, looks to be lead, although we could not guarantee this. As we

mentioned earlier, you need to take the first opportunity possible to inspect this roof. It may be accessible via the neighbouring properties.

The latest Building Regulations require flat roofs to be ventilated. Building Regulations are not retrospective but the reason for the requirement is to make sure that any moisture that enters the roof construction is dispelled by way of ventilation. We would suggest that if the opportunity arises ventilation should be provided. This will stop the possibility of fungal growth above the ceiling in the flat roof area.

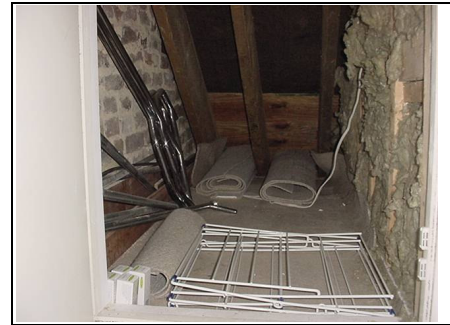
ACTION REQUIRED: We would recommend that you check with your neighbours to see if access is available to the roof. If not, you need to consider putting an access hatch in. The small area of the roof that we were able to access, literally consisted of three common rafters (the ones that form the pitch of the roof), insulation to one side and brickwork to the other. These looked typical of what we normally see, but certainly cannot be relied on as a comment on the condition of the roof as a whole.

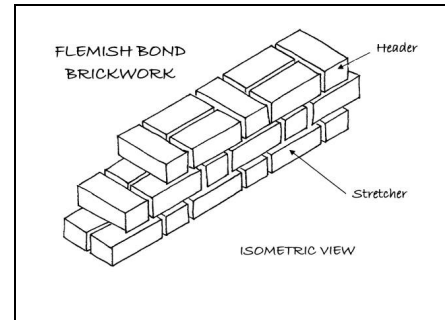
The property is brick built in a Yellow London Stock brick originally in a lime mortar in, what is known as, Flemish Bond brickwork, which has been repointed in a cement mortar.

We are not normally that keen on repointing in a cement mortar, but, as this property has a fairly hard yellow London Stock brick, and it has only just been repointed, we do not recommend removing the cement mortar to replace it with a lime mortar as we would normally.

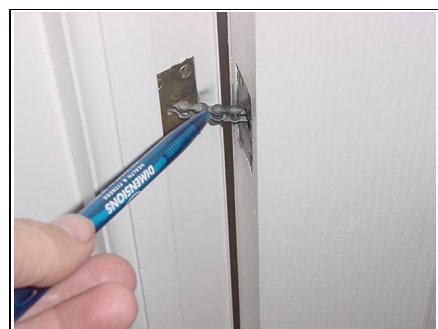
Purco door closer

Within this property there should be fire doors throughout. Fire doors are generally half hour resistant for this type of layout and, in addition, they should have door closers, which in this instance they have Perco (trade name) door closers, these are positioned in the middle of the door.

Please see our comments in the executive summary.

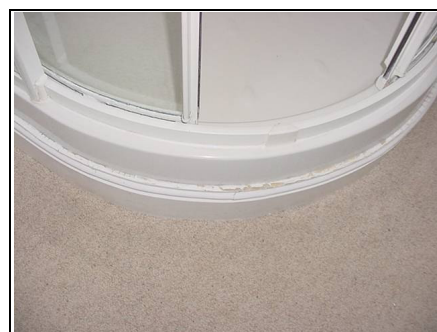
This consists of a WC, a wash hand basin and a shower. We were pleased to see that the shower has a solid base, however, it has been damaged and will require some work.

We would also refer you to our earlier comments with regards to the hairline cracking within the shower unit, which needs sealing.

Finally, although we may have already mentioned it above we would reiterate that it is important to ensure that seals are properly made and maintained at the junctions between wall surfaces and baths and showers etc. We normally recommend that it is one of the first jobs that you carry out as part of your DIY on the property, as water getting behind sanitary fittings can lead to unseen deterioration that can be costly, inconvenient and difficult to repair.
