JOB REFERENCE: xxxxxxxxxxxxxxxx

RESIDENTIAL BUILDING SURVEY

xxxxxxx,
xxxxxxxxxxx,
xxxxxx, Rickmansworth
Hertfordshire
WD3 xxx

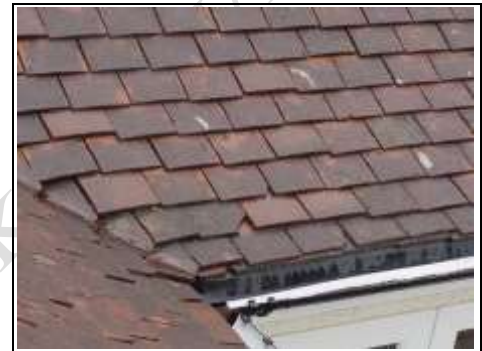
We believe that there has been some movement in this roof and it is suffering from age. We could see that the roof tiles have opened up slightly and also that there are some tiles that are displaced (we appreciate this open joint style is liked by many). In this case, we believe, that there is a problem with the roof as we can see movement in other elements within the structure.

Some roof tiles have opened up and are displaced

As a stitch in time measure we would recommend that you employ a roofing contractor to spend half a day/ a day checking and overhauling the roof and re –positioning any displaced tiles. It is a shame that the roofing work was not carried out when the other work was carried out; please obtain quotations.

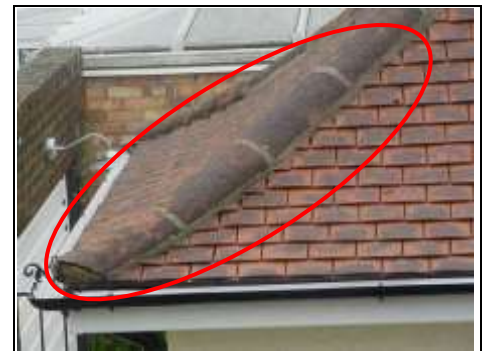
For example: the ridge to the rear right side over the kitchen area has been re-bedded.

Ridge tiles re-bedded

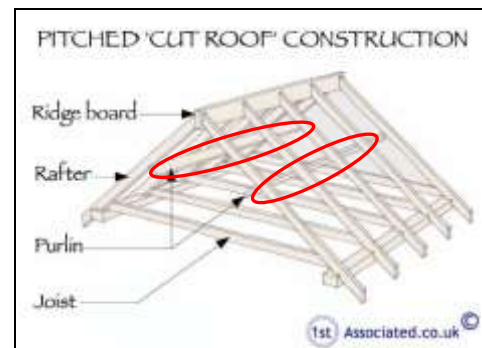
When we investigated within the roof space we could see that some of the purlins had been cut.

Purlins in cut timber roof

If you do wish to proceed with the purchase we believe that you should make an allowance for adding purlins into the roof to bring back the roof integrity.

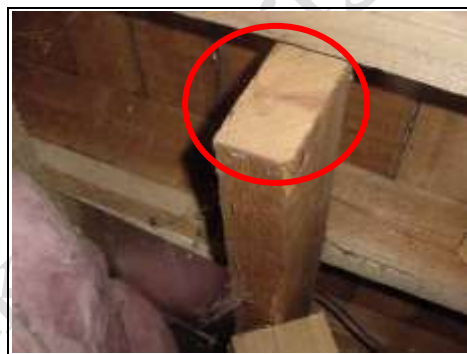
For example: to the rear right hand side a purlin had been cut. We could also see to the front of the property that a purlin had been cut.

This may have been part of the design and alterations to the roof but it is unusual to cut a purlin without offering a replacement purlin that is higher or lower than the cut purlin.

Cut purlin rear right side corner

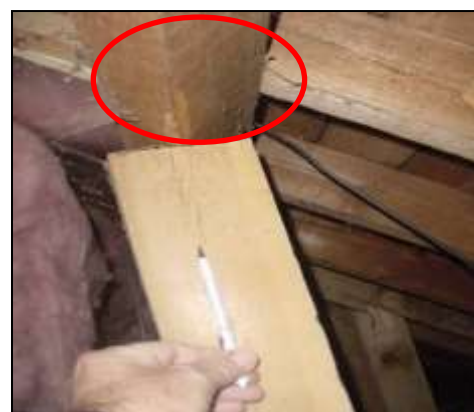
Cut purlin rear with prop identified by the pen

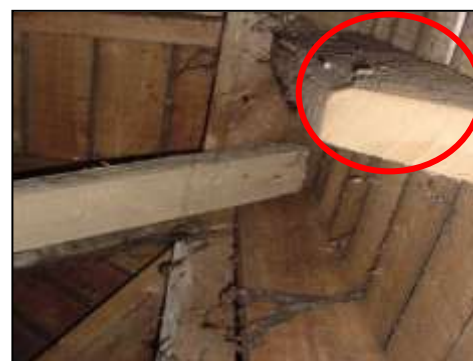
Cut purlin front left side

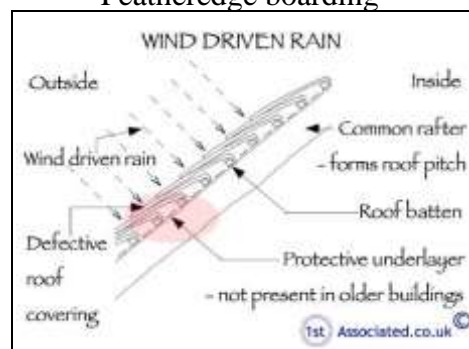
From what we could see some dampness is coming through in these areas. We have found that this is often the case and that wind driven rain can come through this type of older style roof construction.

Wind driven rain. This shows a batten construction rather than feather edge

ACTION REQUIRED: This is very difficult to resolve without re-roofing and adding a protective underlayer.

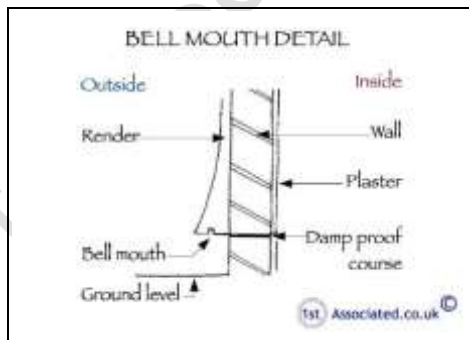
To the rear of the property the bell mouth at the base of the painted render ends very close to the ground level and may be allowing water in via capillary action. Typically a bell mouth should be 150 mm above ground level.

Bell mouth detail left

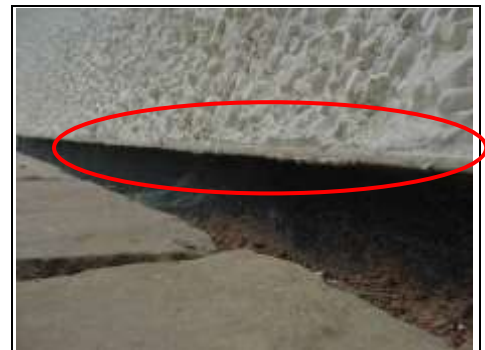
The bell mouth to the render is very close to ground level

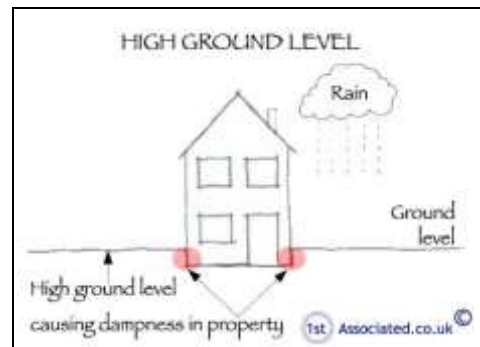
ACTION REQUIRED: We believe that the best way forward is to live in the property to ascertain if the dampness is coming through the walls within habitable areas that will affect you. We do feel that the ground level is high around the property and should be lowered.

High ground level

Allow a sum in your budget and expect a discount on the asking price to resolve dampness problems and redecoration that will follow.

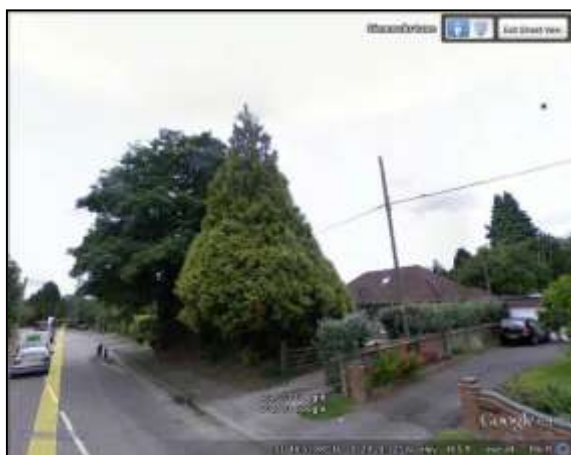
Whilst conifers do not have as large a root ball as many trees do it can often be the way they take water away via their roots that is of help to the lands irrigation system and when removed can cause problems. Other trees, we believe, also appear to have been removed from the images we have from Google Earth.

Front left as it was before trees removed

ACTION REQUIRED: Obtain further information with regard to what trees were removed. The owner advised us that advice was sought from the local council, even though they did not have to, and that they had used a proper tree surgeon to carry out the work (we much prefer an Arboriculturalist).

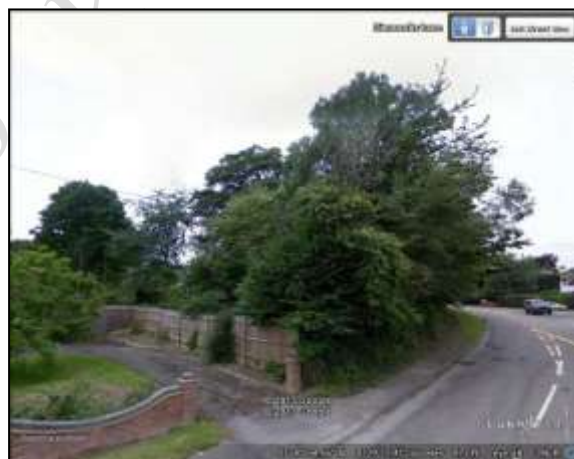
Front right as it was before trees were removed

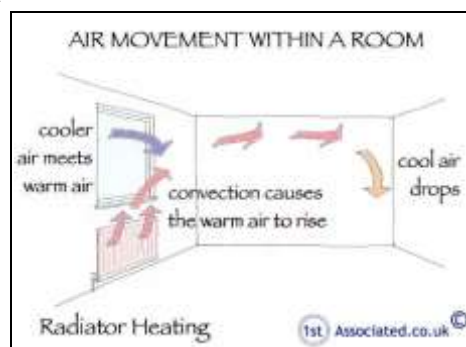
We note that the property has a number of internal radiators, which do not allow the flow of air around the property. We recommend relocation of the internal radiators to a position underneath windows.

Air movement within a room

ACTION REQUIRED: We would recommend the replacement of radiators and movement of internal radiators to position underneath window.

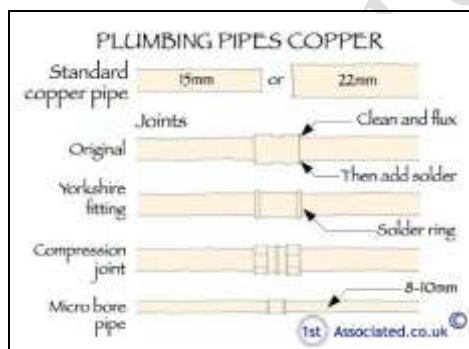
We are not great fans of plastic piping; it takes little skill to install and can literally be thrown in. In this case, for example, in the roof we could see the plastic piping is insulated where it could be seen but if you crawl into the roof, as we did, you can see some piping that is not insulated.

Pipework

we would recommend a full assessment of the plastic piping that has been used in the roof to see if any of it needs to be replaced with copper.

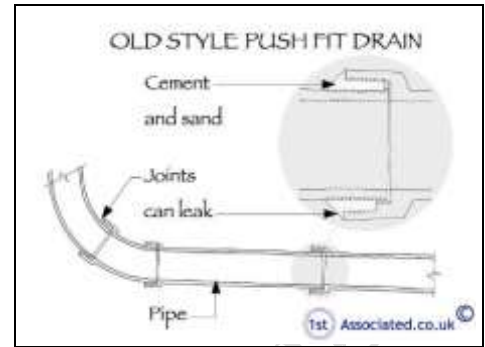
Whilst we have lifted the manholes covers to the rear right side of the property the only true way to find out the condition of the drains is to have a closed circuit TV camera report to establish the condition of the drains. We did note that the manholes are shallow and that the drains may be the older style push fit drains. In this age of property there will often have been leaks over the years.

Push fit drainage

ACTION REQUIRED - SERVICES: We would reiterate that we recommend with regard to all services that you have an independent check by a specialist contractor.

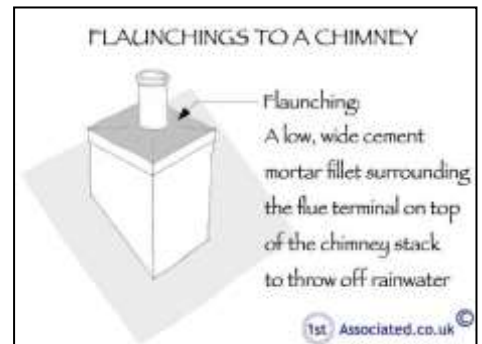
Flaunchings

Unfortunately whilst we cannot see the flaunchings properly there looks to be some moss sitting on the edge of it which does tend to mean that dampness can get in.

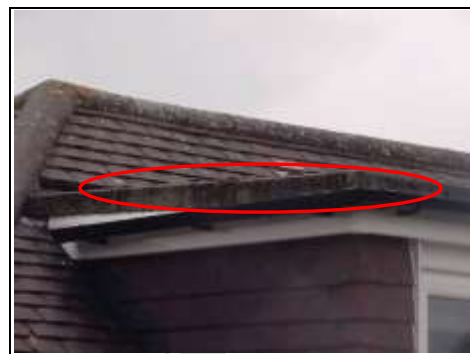
This has a flat roof that we could not see properly and which concerns us as they

usually tend to get forgotten. However there is no sign of water staining internally within the bathroom and the right hand bedroom. The windows are plastic.

Flat roof

ACTION REQUIRED: Set aside a sum of about £1,000 to £2,000 to renew the flat roof in due course unless the existing owners can confirm and show receipts that this has been carried out whilst they have been living at the property.

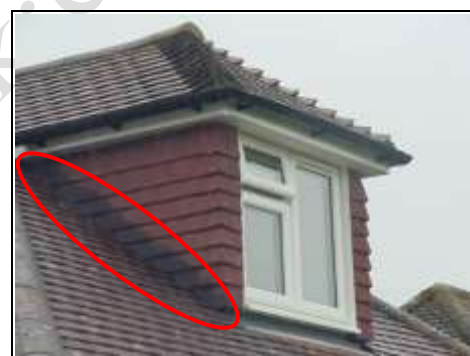
The small dormer has a hipped pitched roof with vertical tiling and plastic windows. We can see some dampness being drawn up underneath the tiles. As the inside of the property is dry-lined we could not identify if dampness is getting in.

Rear small dormer window

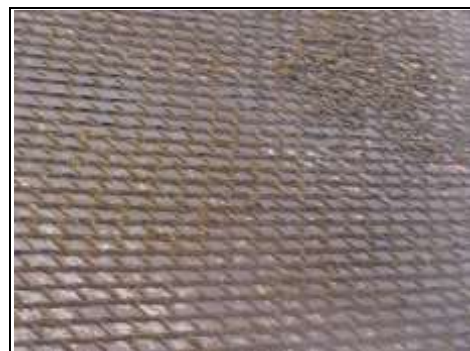
Please be aware that moss can gather on this type of roof and it could look like your neighbours roof.

Nearby roof covered in moss.
We would rather see tiles
laid closer together

ACTION REQUIRED: Please see our comments in the Executive Summary and carry out periodic inspections and maintenance of the roof, as required.

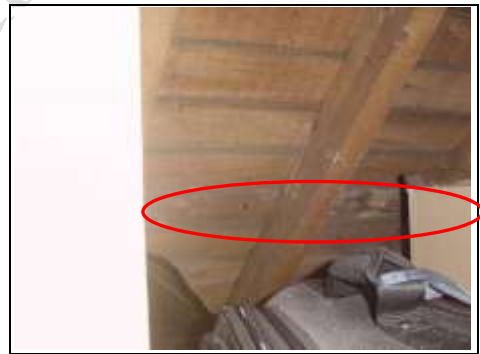
Close boarding with damp coming through

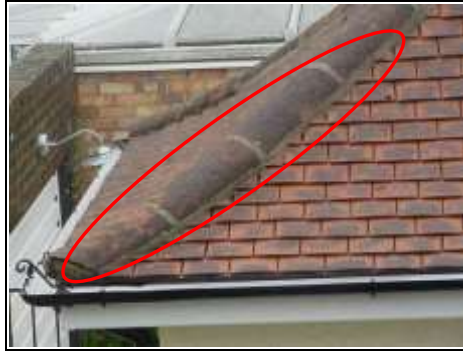
Roof ridge tiles have been re-
mortared

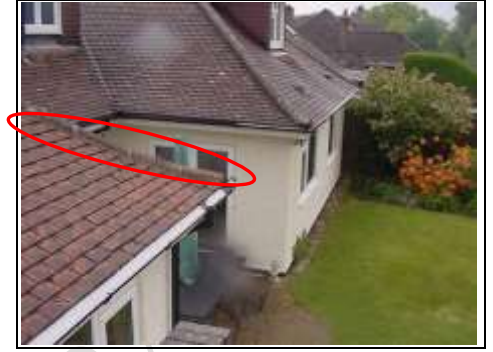
Roof ridge tiles have been re-
mortared

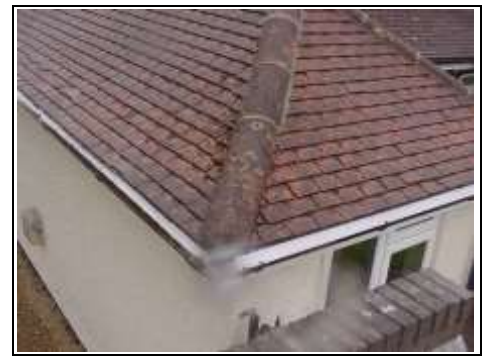
We would comment that the kitchen roof has a very shallow pitch to the base of it and could suffer from wind driven rain problems. Unfortunately we have only had a limited view as we have not been able to gain access into this roof to confirm this

Roof ridge tiles have been
re-mortared

ACTION REQUIRED: Add a loft hatch and we would be more than happy to return to inspect it.

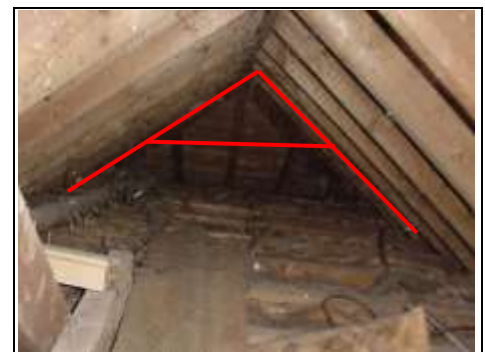
This is what is known as an uncoupled roof and we would suggest that couples are added. If you imagine a capital letter 'A' it is the horizontal part of the 'A' that helps stabilize the roof, however, the whole roof needs to be looked at. Please see our comments within the Executive Summary.

Uncoupled roof over kitchen

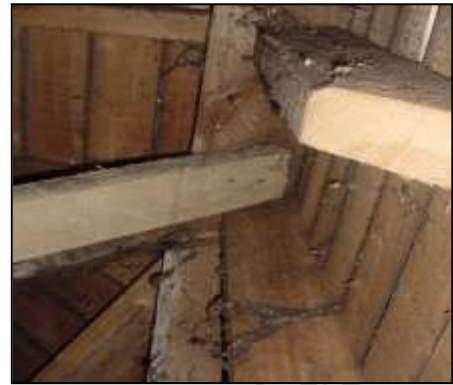
Our examination was limited by the general configuration of the roof, the mass of insulation and stored items. However from what we could see there was what we would term as structurally significant defects to the timber structure in the form of the cut timber purlins.

Cut purlin front left side

ACTION REQUIRED: The only way to be 100 per cent certain is to have the roof cleared and checked.

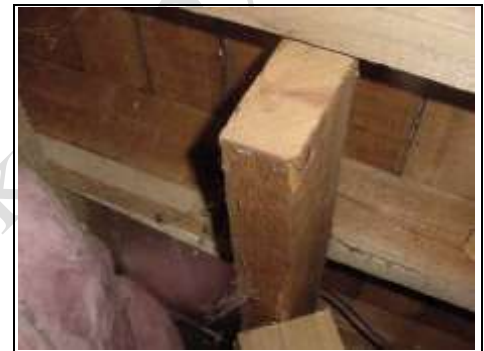
Cut purlin rear right corner

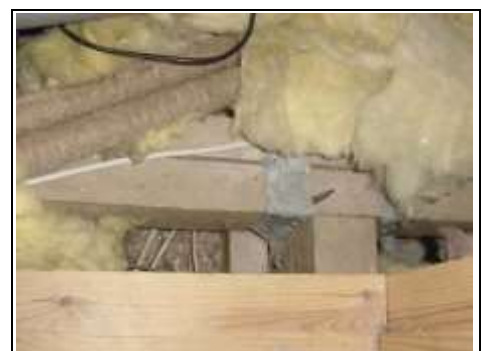
First floor created by adding extra timbers rather than removing and starting again

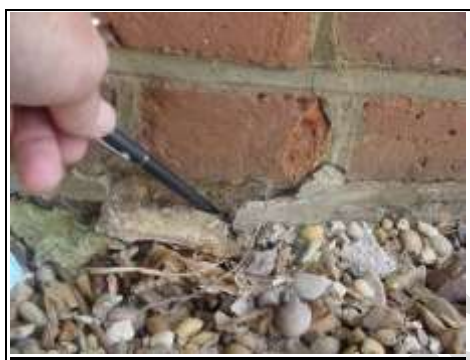
The property has been re-pointed in cement mortar. A solid wall really should have a lime based mortar which allows it to breathe.

Cement mortar is coming away

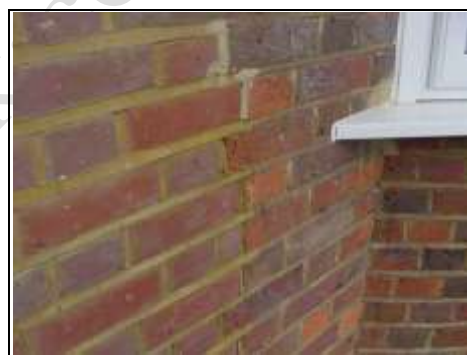
The photo below (right) shows the harder based modern cement mortar to the left hand side and the softer older style cement mortar on the right hand side.

Cement mortar

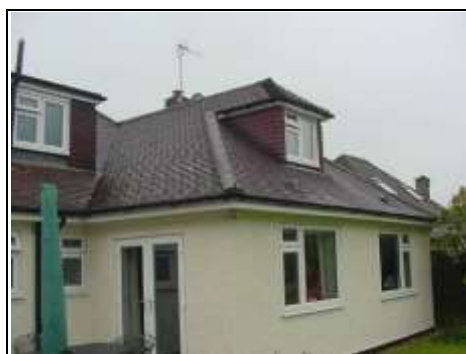
Render to the rear

In this particular case we believe the pebble dash was an original feature of this property although it does look to have been relatively newly redecorated which could be hiding latent defects.

We have carried out a tap test (literally hitting the render with the back of a hammer) testing for blown or hollow render areas. We found it to be in average condition for its age, type and style.

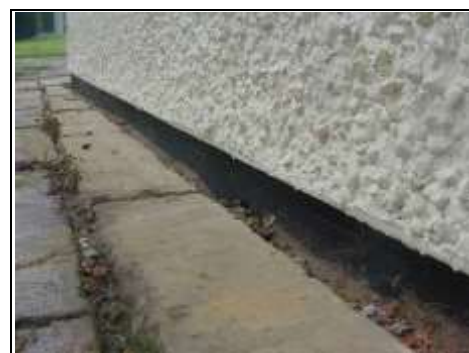
To the base of the render there is a bell mouth detail very close to the ground. We would normally expect to see this 150mm above the ground. We feel it may be bridging the damp proof course and allowing dampness to be drawn up above it as we found dampness within the kitchen area.

Bell mouth very close to the ground

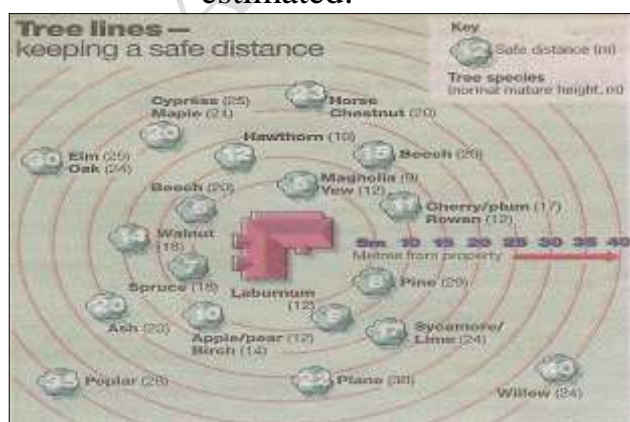
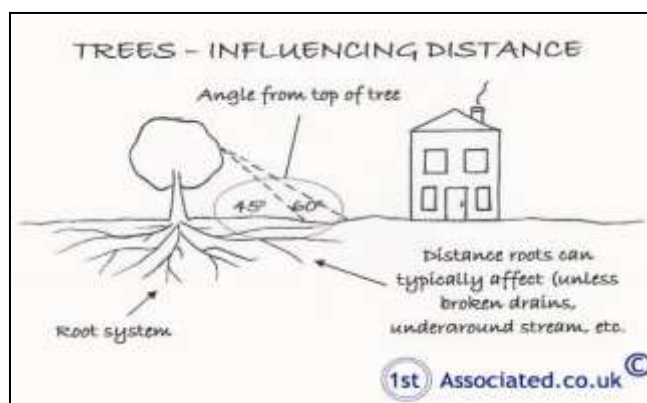
Where a lot of trees have been removed professional advice needed to have been sought (an Arboriculturalist not a tree surgeon). Now the trees have been removed the ground has to cope with a considerable amount of moisture. Also rotting roots in years to come can affect the stability of the ground dependent upon the trees that were there. From looking at the images the trees to the front were of a considerable size.

Numerous trees have been removed from the rear garden

ACTION REQUIRED: We would recommend you obtain more information regarding removal of the trees before you commit to purchasing this property. We spoke briefly to the owner about this but we would comment this was limited advice (he said he was pushed for time) and only related to us that there were trees removed to the rear of the property. The effects of removing trees should not be underestimated.

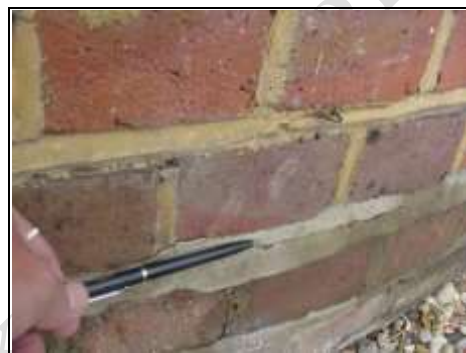
All modern properties should incorporate a damp proof course (DPC) and good building practice dictates that a differential of 150mm (6 inches) should be maintained between the damp proof course and ground levels. In this case, in some areas we can see it and in some areas we can't. There is a line in the brick mortar that probably relates to the damp proof course and we believe that the render is covering up the damp proof course.

Damp proof course

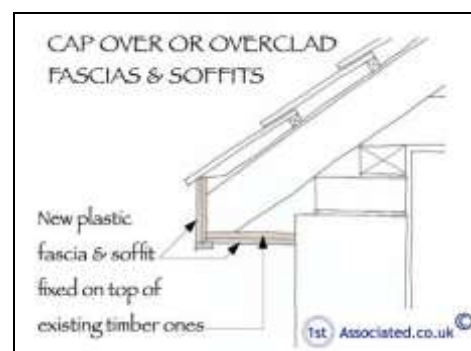
The fascias and soffits are plastic. We believe these are overcladding. Overcladding is generally not considered good practice as the timber fascia and soffit behind is left rotting and the plastic overcladding can accelerate deterioration. Also it is now considered good practice to add vents into the soffits to vent the roof.

Overcladding stick on style rather than pinned on

ACTION REQUIRED: Please see our comments within the Executive Summary.

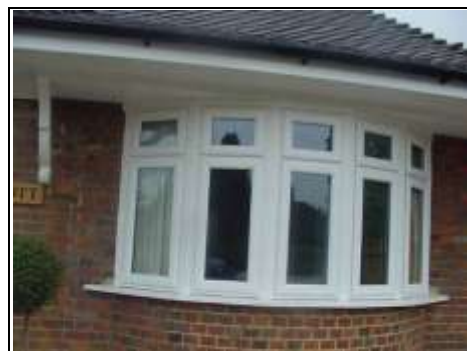
Bay window no trickle vents

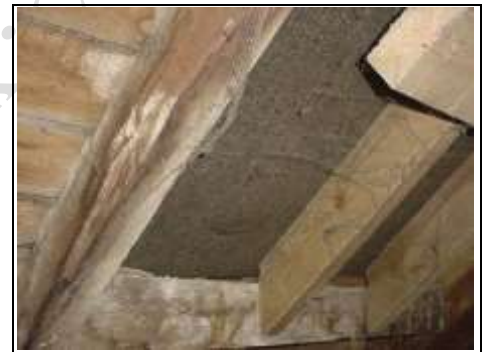
Right chimney removed
letting in rainwater

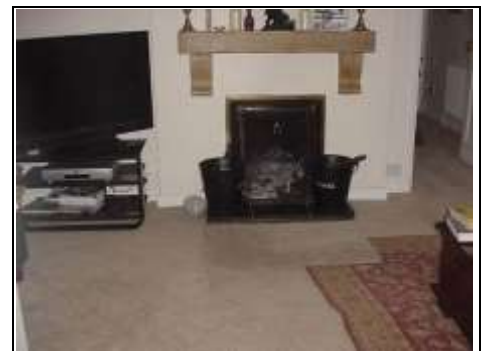
Lounge fireplace may be false

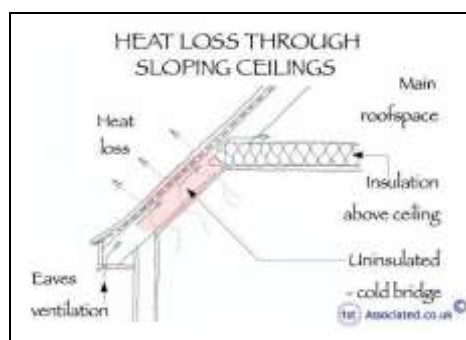
Some roof insulation was present although not too current Building Regulations requirements of 300mm. In this instance there is about 200mm in the areas that we could see. Our concern is that there is no insulation where rooms are formed in the roof and the only way to check would be to open the structure. We did notice vents in the roof that may indicate there is insulation in there.

There may be cold bridging where the vaulted roofs are

ACTION REQUIRED: Your Legal Advisor to check if there are any Building Regulations/Planning drawings with regard to the roof structure.

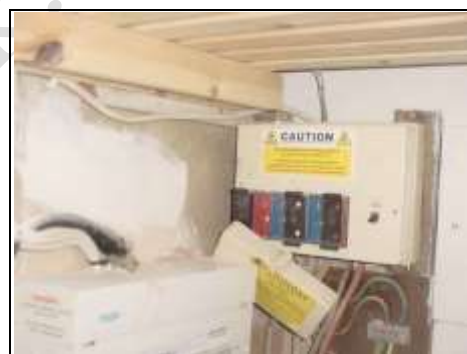
The electric fuses and consumer units were located in the kitchen cupboard. The fuse board looked old circa 1960s and better are now available.

Dated fuse Board

ACTION REQUIRED: Please see our comments within the Executive Summary.

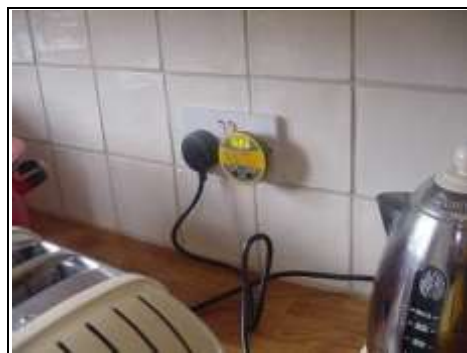
Earth Test

We carried out an earth test in the kitchen area to the socket point that is normally used for the kettle, this proved satisfactory.

ACTION REQUIRED: As the property is changing occupancy an Institute of Electrical Engineers (IEE) test and report should be carried out by a NICEIC registered, or equivalent, approved electrical contractor or similarly approved.

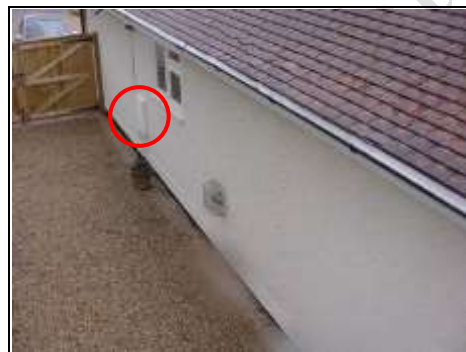
We are advised that the property has mains gas. The consumer unit is located to the right hand side of the property.

ACTION REQUIRED: As a matter of course it is recommended that the entire gas installation is inspected and made good, as necessary, by a Gas Safe registered contractor. Thereafter the installation should be serviced annually.

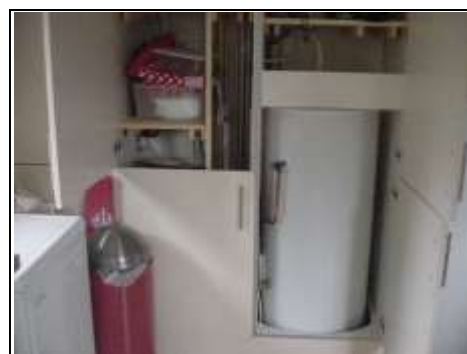
Hot water cylinder

There is a factory insulated hot water cylinder located within the kitchen. This cylinder will therefore have a good thermal efficiency, although not as good as the more modern hot water cylinders.

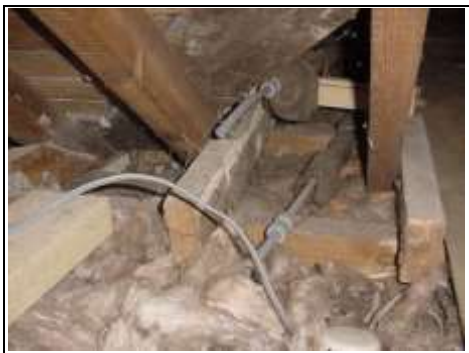
The plumbing, where visible, comprises plastic to copper piping. No significant leakage was noted on the surface, although most of the pipework is concealed in floors, walls and ducts. Please see our comments in the Executive Summary regarding plastic to copper pipework.

Plastic joined to copper pipe

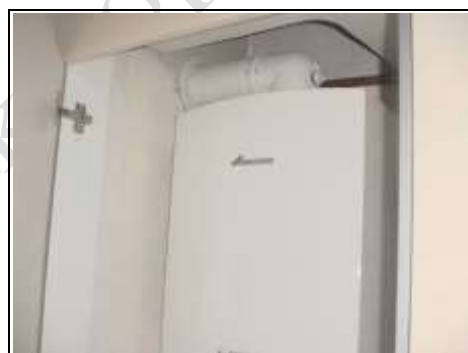
Boiler vented to outside air

Our limited inspection of the hot water and central heating system revealed no evidence to suggest any serious defects but we would nevertheless recommend that the system be tested and overhauled before exchange of contracts and that a regular maintenance contract be placed with an approved heating engineer.

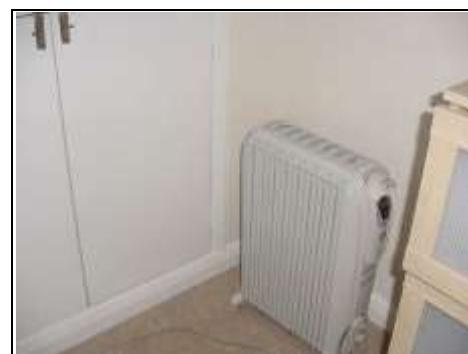
We did note electric oil heaters within the bedrooms which may indicate there isn't any insulation in the roof if these additional heaters are needed.

Electric oil heaters – property may not be as warm as you wish

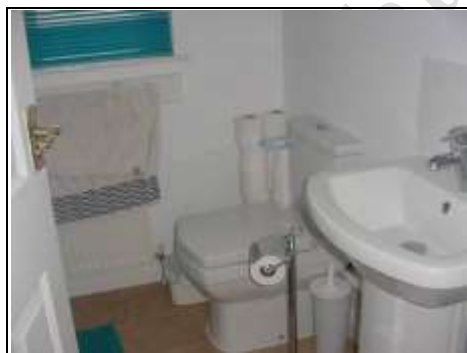
Bathroom

The property has a three piece bathroom suite, consisting of a bath, wash hand basin and WC, which looks in average condition, subject to some day-to-day wear and tear, as one would expect.

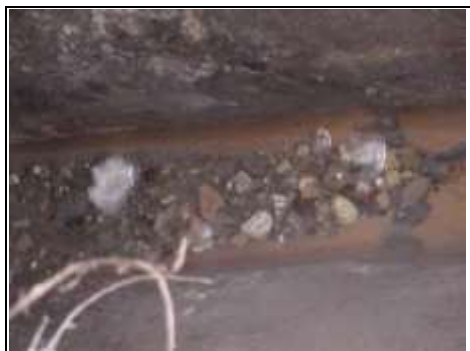
We duly lifted the cover and found there to be some pebbles within it which does indicate to us that there is a very shallow pitch and it is not taking away waste that easily. It also indicates the drainage cover may have been taken off before for rodding etc. which is how some of the pebbles have got in there.

Close up of pebbles in Manhole
One

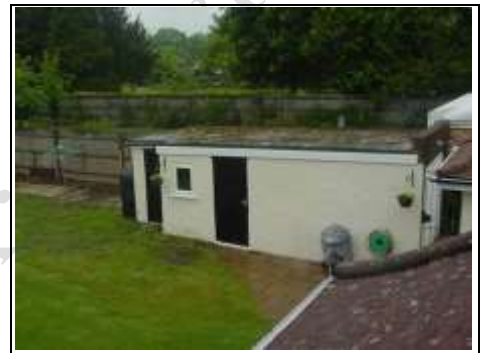
Garage

The property has a detached garage to the left side of the building. We could see dampness getting in via the flat roof which has a Flashband repair which we consider a temporary material.
