RESIDENTIAL BUILDING SURVEY

**A Converted Mid-Terraced Victorian Property,
Shepherds Bush, London, W12**

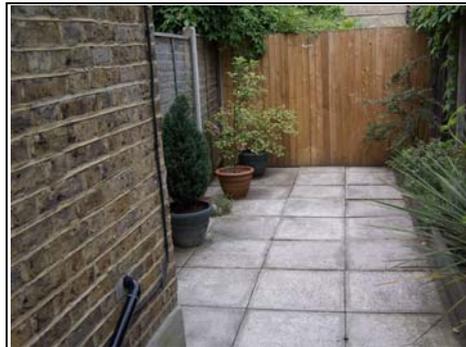
Garden to Rear
(The Estate Agent's details say that
this area is shared).

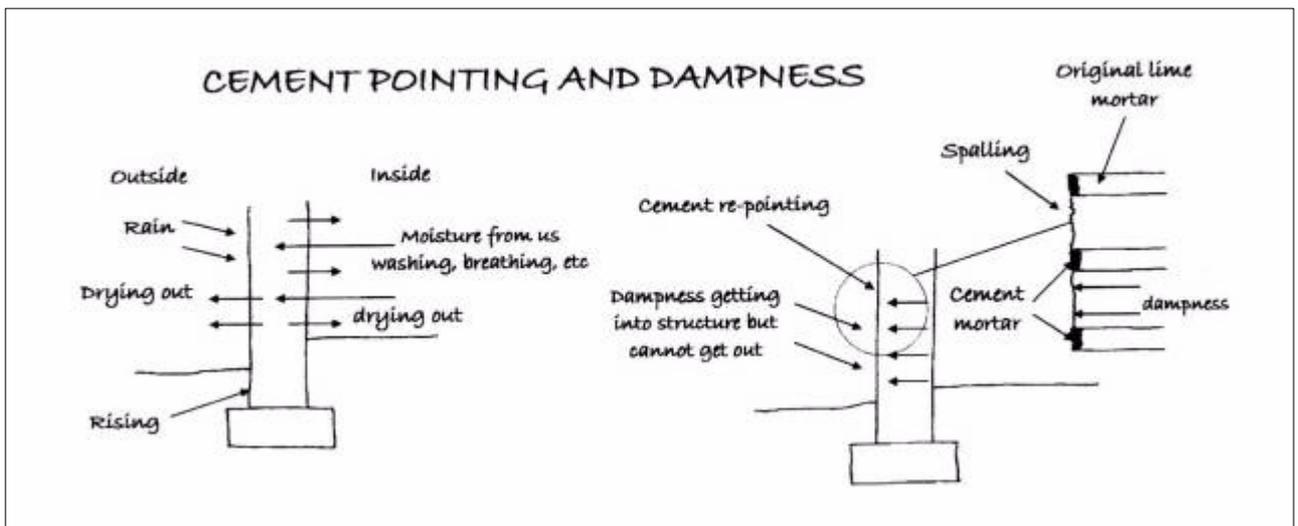
We would draw your attention to the cement mortar re-pointing that has been carried out on the exterior of the property that is not appropriate for this age of construction and can cause damage and deterioration over the long-term. Originally it will have been built with a lime-based mortar and this is what should be used for any re-pointing in the future.

The use of cement mortar causes deterioration to the brickwork and leads to the face of the bricks deteriorating, which in turn leads to dampness. This is a very important point.

Using lime mortar will limit further damage to the brickwork, which is almost impossible to repair successfully. However, we would add that many, if not most, of the properties that we come across are repointed wrongly; it is only in recent years that we have discovered the problems that can occur from it.

ACTION REQUIRED: We suggest that periodically the external walls are rubbed with a stiff brush, or the cement will eventually fall out on its own, and it should be repointed in a lime based mortar.

ANTICIPATED COSTS: This is likely to cost a few hundred pounds every two to three years as you gradually repoint using a lime mortar, where the cement mortar is falling out.

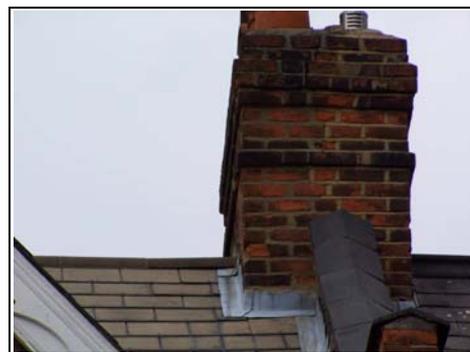
Chimney Two – Located to the Rear Middle of the Property

Unfortunately this chimney was very difficult to see but what we could see of it (one side) was in reasonable condition.

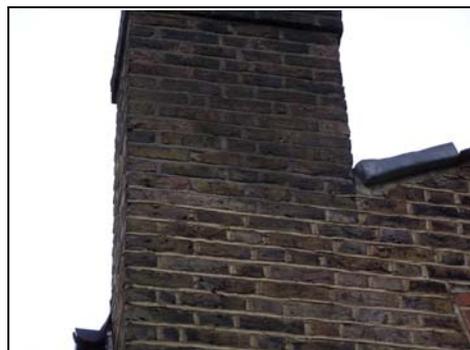
Unfortunately again this chimney was difficult to see; although in this case we could see two sides and both looked in reasonable condition. We could also see to the back of the property that the flashing detail had been amended. If you look closely at this photo you can see the lead work on the right hand side of the chimney, often dampness gets into a property in this area. Usually, luckily for you, it normally only affects the upstairs areas!

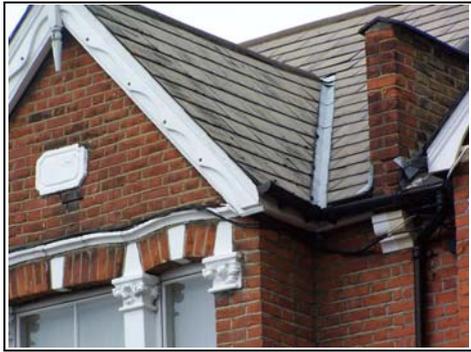
Valley Gutter

Valley gutters are renowned problem areas, unfortunately without being able to get into the roof we cannot comment 100 percent as to whether there is a problem in this instance, although it does not look like there is from the detailing.

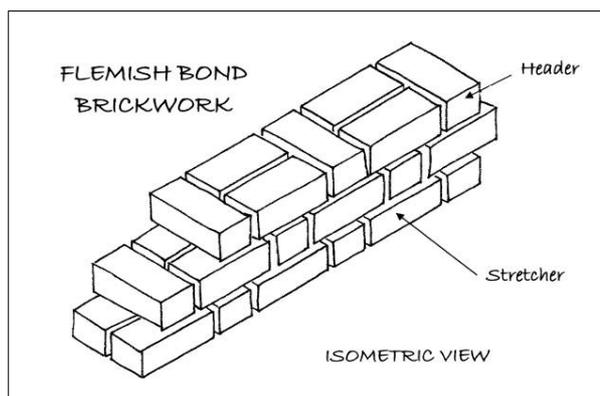
The property is brick built in a Flemish bond construction using a soft red brick to the front and a London stock yellow brick to the rear. Originally the property was pointed in a lime mortar, which has been repointed in a cement mortar. Please see our comments in the Executive Summary. The damage with regard to the pointing will be evident to the softer red brick to the front of the property.

Soft red bricks are also prone to spalling when repointed in a cement mortar. Please see our comments in the Executive Summary.
