# RESIDENTIAL BUILDING SURVEY

**A Converted Mid-Terraced Victorian Property,  
Shepherds Bush, London, W12**

Mr H

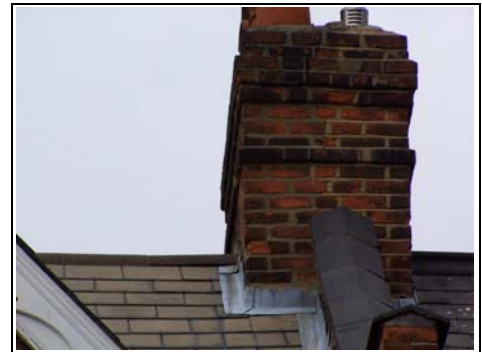
### Chimney One – Located to Front Right Hand Side on the Party Wall

This chimney is brick finished and has a metal flashing, which we believe to be lead. The chimney has numerous chimney pots. The chimney is in average condition and looks to have been repointed fairly recently, albeit that there looks to be some repointing needed near the top. Unfortunately we were unable to see the very top of the chimney known as the flaunchings, we therefore cannot comment upon them.

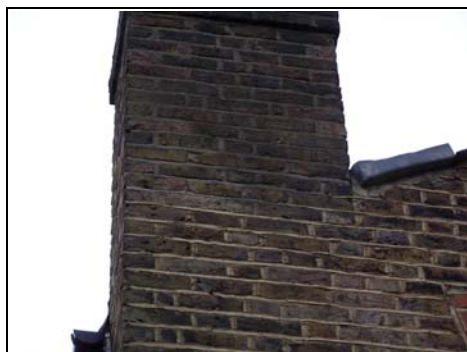
### Chimney Three – Located to the Rear

Unfortunately again this chimney was difficult to see; although in this case we could see two sides and both looked in reasonable condition. We could also see to the back of the property that the flashing detail had been amended. If you look closely at this photo you can see the lead work on the right hand side of the chimney, often dampness gets into a property in this area. Usually, luckily for you, it normally only affects the upstairs areas!

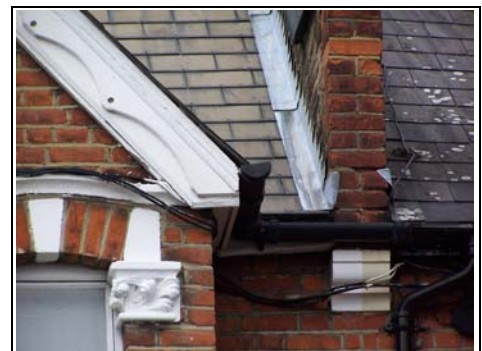
Again this parapet wall is brick finished and we would make similar comments to those made regarding the left hand parapet wall.

To both the left and right hand parapet walls we were pleased to see a metal flashing, which we believe to be lead. We feel this is the best flashing detail that you can have.

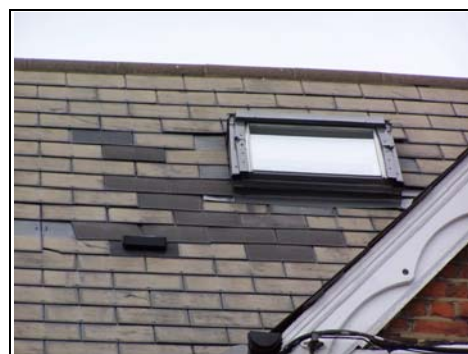
## Roof Windows

The property has modern metal manufactured roof windows. We have checked this the best that we can from ground level as we had no access to the upper apartment. It is difficult to be 100% certain with roof windows, as much is hidden. From what we could see it looked in reasonable condition.

It seems inevitable with roof windows that they will sooner or later leak, but this will be into the top floor apartment.

In the photo above you can also see on the left hand side a vent to the roof. More about this in the Roof Structure Section.

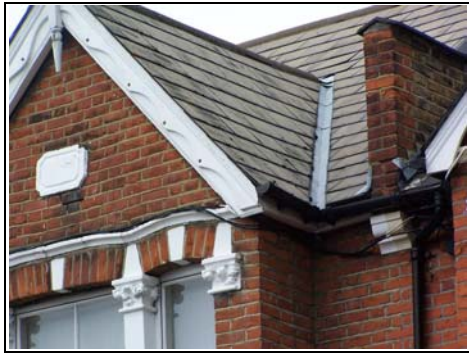
## **Valley Gutter**

Valley gutters are renowned problem areas, unfortunately without being able to get into the roof we cannot comment 100 percent as to whether there is a problem in this instance, although it does not look like there is from the detailing.

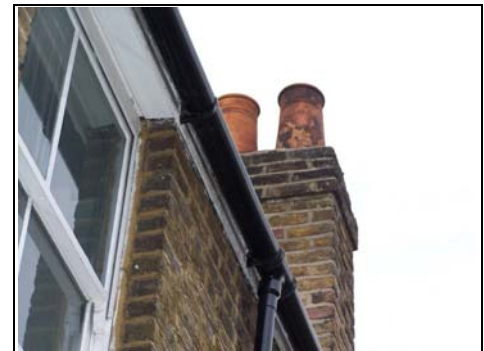
## Fascias and Soffits

Much of the fascia is hidden behind the guttering in this instance and so we cannot see it. However, it is common for this type of detail to have some deterioration to the timber, particularly in this case where we can see the gutters have been replaced.

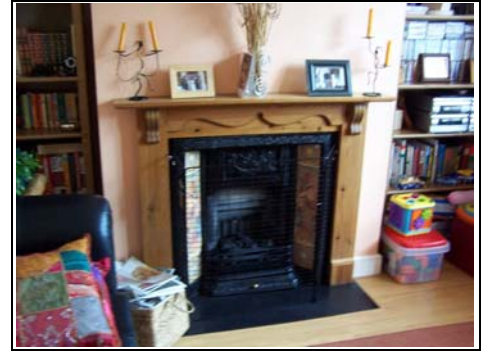
In this case we could see the chimney at the bottom and the top! As you are aware we could not gain access to the first floor apartment. However, from the general straightness of the main chimney we believe that this chimney is likely to be in place all the way up through the structure.

Finally, it is strongly recommended that flues be cleaned and checked for obstruction prior to use to minimise the risk of hazardous fumes entering the building.
