RESIDENTIAL BUILDING SURVEY

**A Modern Detached Property, Somersham,
Cambridgeshire**

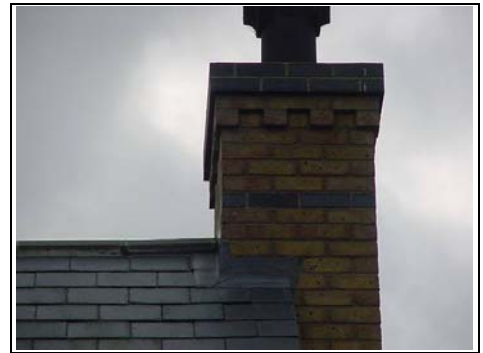
This property has one chimney, which is located on the right hand side. This chimney is brick finished with a lead flashing and one chimney pot. From what we could see it looks to be in good condition. Unfortunately we were unable to see the flashing, we therefore cannot comment upon it.

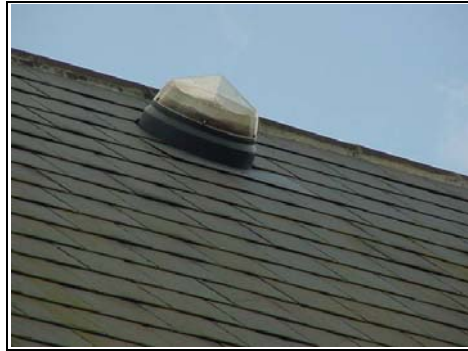
Outside view of the light tunnel

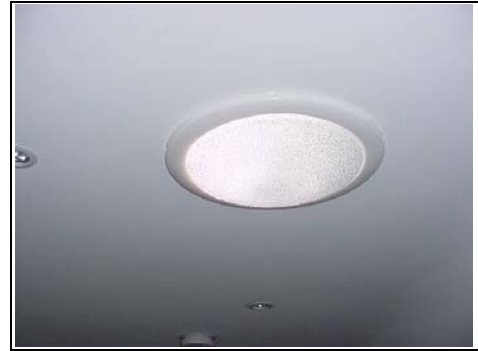
Inside view of the light tunnel

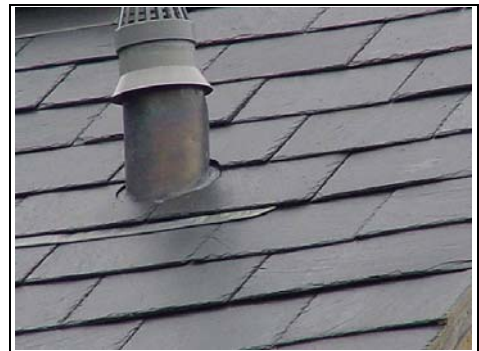
The roof is pitched and clad with manmade slates which should sit very flat and true, as they do in the areas we can see. However, as the manmade slates are thin and light the wind can catch them, so it is important that you check from time to time that the slates are fixed at the perimeter and do sit flat.

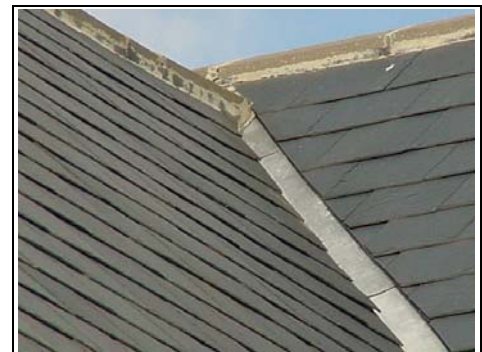
Due to the design of the property there are two valley gutters to the rear and also a slightly awkward roof detail where the lounge lean-to conservatory style building meets the main building.

Problems can occur with the valley getting blocked or what is known as 'surcharging', where the amount of water coming down from the roofs into the valley and then into the gutter at the bottom overflows past the gutters.

Close up of the valley gutter on the left hand side of the property (all directions given as if you face the property from the front).

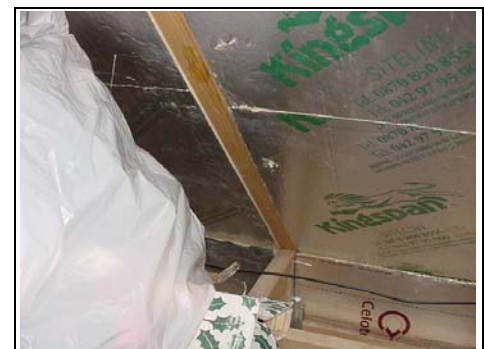
From our very limited view all we could generally see was the back of King Span solid insulation. Unfortunately without opening up the structure we cannot comment further, other than to say in this age of property it would be typical to use a breathable underlayer.

This photo shows the common rafters (the ones that form the pitch of the roof)

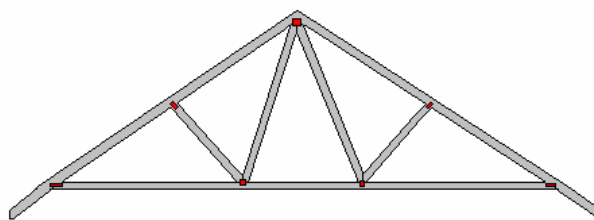
PREFABRICATED ROOF TRUSS

Whilst we could not see the roof structure, given the age, type and style of property, we believe it is likely to be a pre-fabricated 'W' trussed roof rafter. These are made in a factory and transported to site and then lifted into place. Without the manufacturer's calculations and installation details we cannot comment categorically on the roof structure's condition.

ACTION REQUIRED: Your Legal Advisor to request details of the roof structure and these should be forwarded on to us for comment.

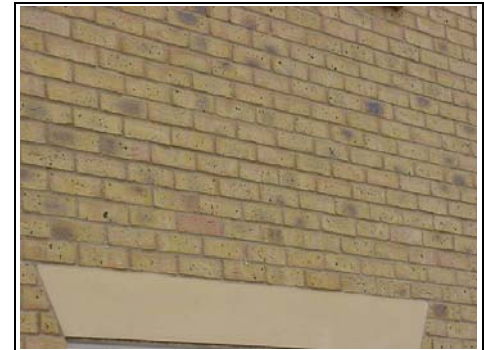
The walls are built in brick and bedded in cement mortar in what is known as stretcher bond brickwork. The brickwork and pointing is in average to above average condition.

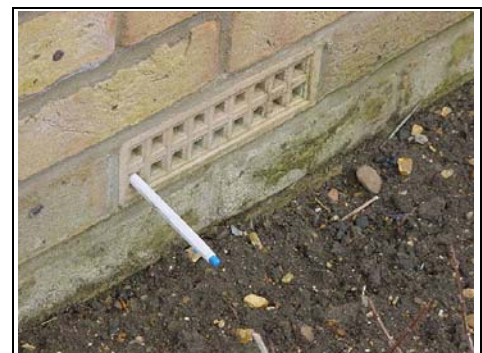
Airbricks are visible to this property, which are usually seen when suspended concrete floors have been used and that would be our thoughts in this case. We were also shown photos of the beam and block flooring.

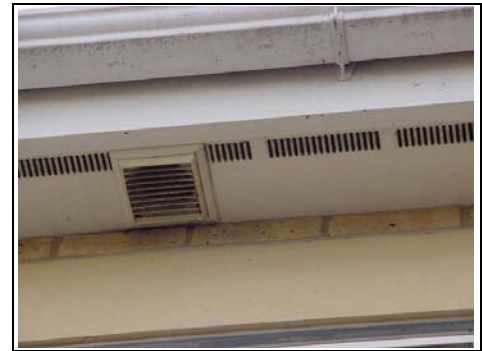
The property has plastic fascias and soffits that are in average condition. We were pleased to see that there is a vent in the soffit that will, providing it is not blocked, allow ventilation to the loft space to help reduce condensation.

Vented fascia and soffit

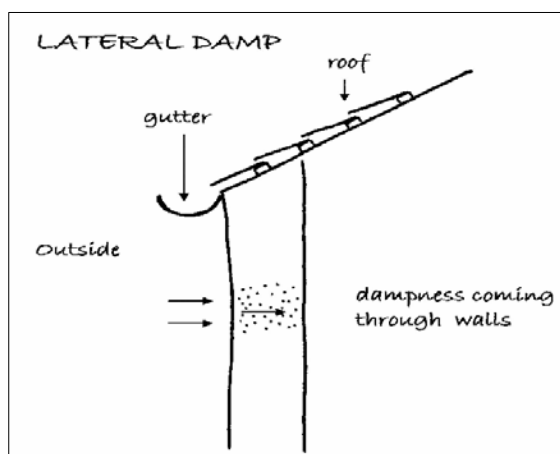
Again, as the property is dry-lined we were unable to carry out damp meter tests. We therefore carried out a visual inspection and did not find any signs of significant dampness coming through.

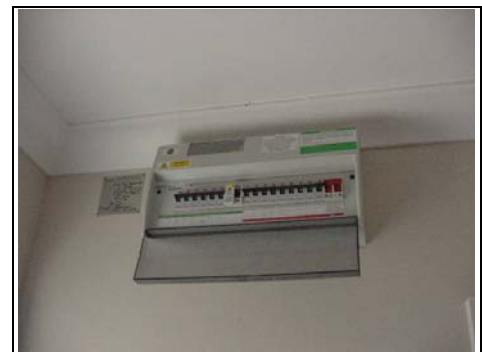
The electric fuses and consumer units were located in the utilities room. We would date the fuse board as being from the 1990s / 2000s and, whilst not the best now available (as improvements are currently being made), it is reasonable.

ACTION REQUIRED: As the property is changing occupancy an IEE report should be carried out by a NICEIC registered and approved electrical contractor.

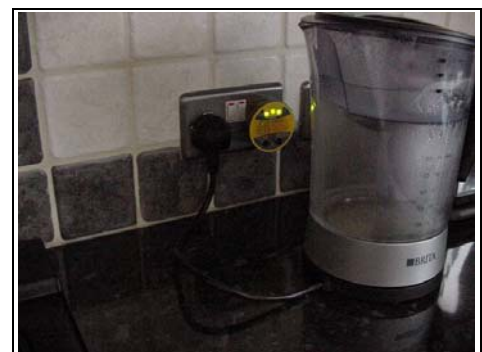
We carried out an earth test in the kitchen area to the socket point that is normally used for the kettle and this proved satisfactory.

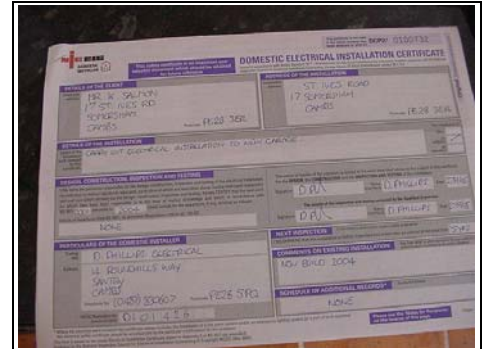
We did see a copy of the Electrical Certificate for the garage only; your Legal Advisor needs to check and confirm that this is genuine and that there is also a certificate for the house as well. For clarity, the document in the photo was signed by D Philips Electrical and the phone number is 01487 830 607.

Copy of the electrical certificate for the Garage

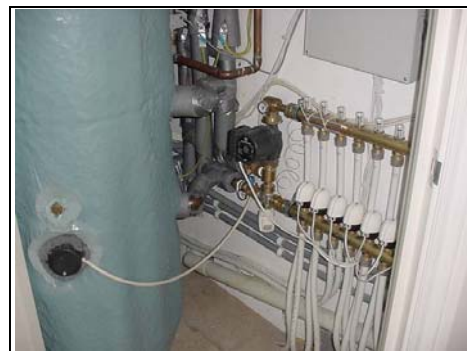
The property has under floor heating throughout, which we do not see very often. There are arguments for and against under floor heating; one of the arguments is that it is the best way to heat – from the ground upwards, others argue that heat coming through a carpet can displace dust and aggravate people that suffer from asthma etc.

Airing cupboard with pipes for the under floor heating.

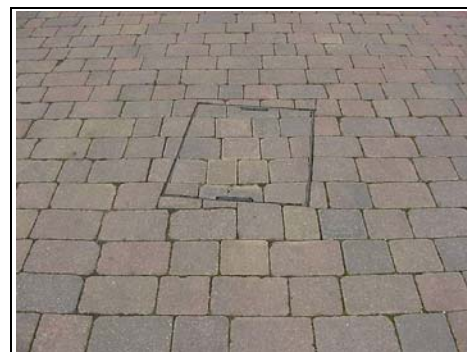
Manhole – In the Driveway to the Front of the Property

We have been unable to lift this manhole cover, which is often the case with this type of inset manhole.

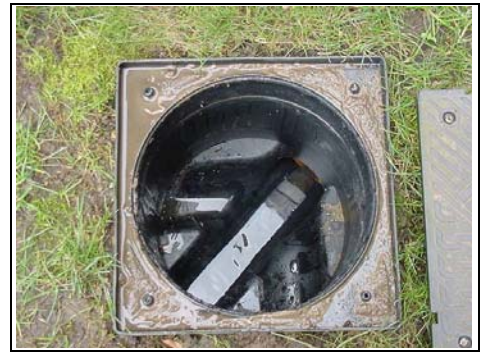
Inspection Chamber – To the Front Right Hand Corner

We duly lifted the inspection chamber cover and found the drain to be free flowing and pre-formed in plastic.

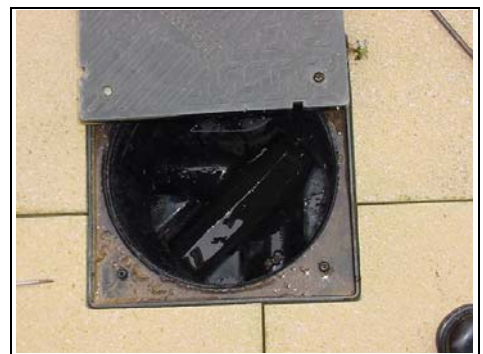
Inspection Chamber – Rear Right Hand Corner

Again, we lifted the cover and found it to be free flowing and pre-formed in plastic.

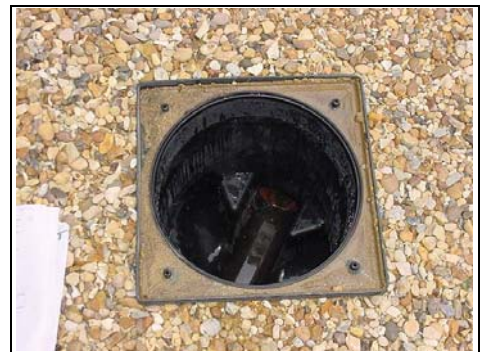
Inspection Chamber – Rear Left Hand Side (in the Driveway)

Again, we lifted the cover and found it to be free flowing and pre-formed in plastic.

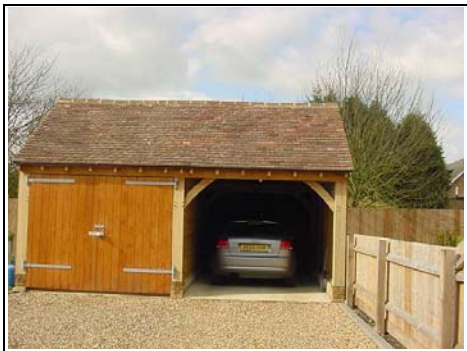
Garage

There is a detached garage area and store to the rear. We spoke to the owner about the garage and asked him if it was a pre-packed kit garage and he confirmed it was.

ACTION REQUIRED: Your Legal Advisor needs to confirm that Planning Permission has been obtained together with Building Regulations and that it is situated on your land (with reference to the land that has been unclaimed to the rear of the property).

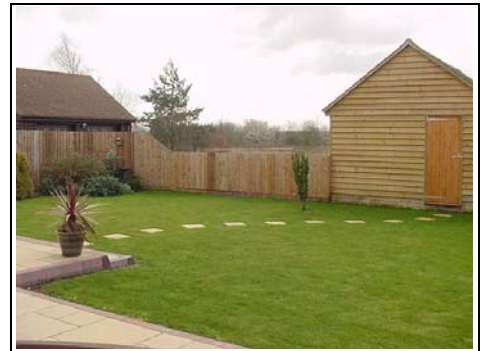
Paddock Area

This is the area that the ownership of is not known. Please see our earlier comments.

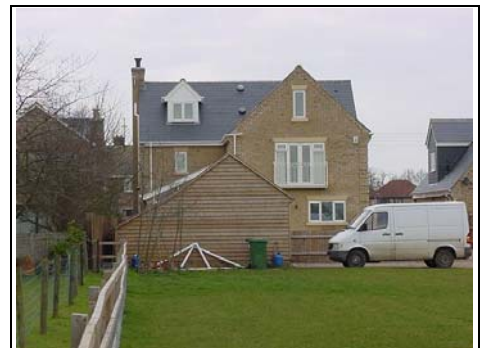
There appears to be a right of way to the rear and side of the property.

ACTION REQUIRED: Your Legal Advisor should make enquiries and advise you further.
