RESIDENTIAL BUILDING SURVEY

Southwark, London

Victorian mid-terraced
property

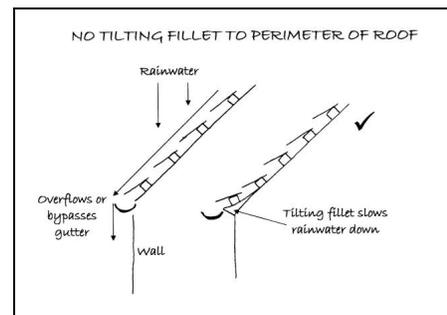
Originally this roof is likely to have been slate covered; it has been replaced with a concrete tile at some point in time (normally the 1970's). We can see that they had difficulty marrying up the thicker concrete tile with the original roof that was made for a slate roof. They look to have missed the tilting fillet at the bottom which may in turn mean that the rainwater misses the gutter.

No tilting fillet

ACTION REQUIRED: Next time it rains you need to stand outside the property and check to see how much rain is actually going into the gutter rather than going down the face of the wall. We can see that the face of the wall is being damaged by rain but this may be due to other factors.

ANTICIPATED COST: We would recommend that you have all the gutters cleaned and any leaking joints checked and sealed. Of course if the rainwater isn't actually being caught by the gutters in the majority of cases you will need to have then realigned as well which will be in the region of a few hundred pounds assuming existing guttering can be re-used; quotations required. Access can be made via long ladders rather than scaffolding.

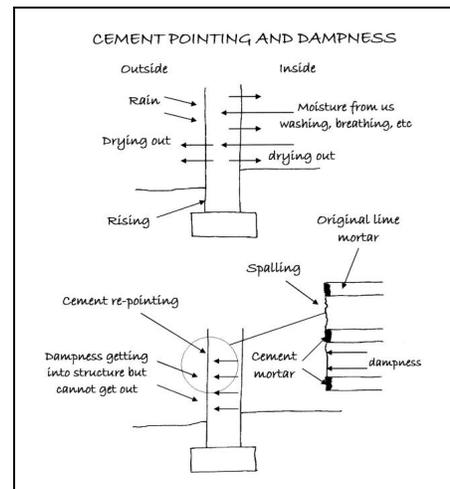
Ad hoc repointing is required to the walls. To the rear the property has been repointed in a cement mortar which in our opinion needs to be removed gradually over the years and replaced with a lime based mortar which will help with the general movement of the characteristics of this building. We would add that cement pointing stops the building from breathing and causes dampness so the gradual removal will generally improve the condition of the property.

ACTION REQUIRED: Generally remove the cement mortar and repoint in a lime mortar, specifically repoint the tuck pointing to the front of the property. We can give you more information on this if you so require.

ANTICIPATED COST: We would recommend that this is carried out over many years where you spend £100 - £200 every year on having the cement mortar removed and repointed; quotations required.

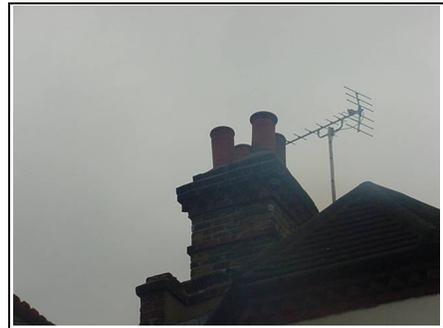
Chimney one

This brick chimney was difficult to view, we are not certain if it has a lead flashing although it seems likely as there is one to the parapet wall. The chimney looks to have been repointed; we can see that it has got aerials attached to it using wires that can cut into it like cheese wire. This chimney is brick finished with four chimney pots, possibly more. From what we could see the chimney looks in average condition. The top of the chimney is known as the flaunchings, we would comment that we were unable to view the flaunching properly; however what we could see appeared to be in average condition.

We would also comment that within the loft space we could see that there was some dampness getting in via the parapet wall and we believe the chimney area.

ACTION REQUIRED: Both the above chimneys need a close up inspection via long ladders by the end of the summer.

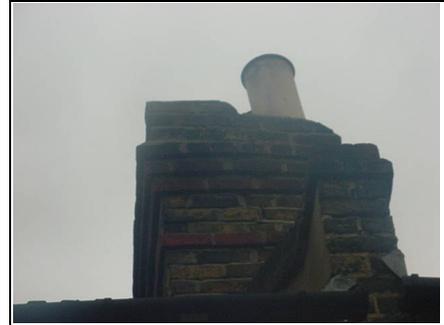
Chimney two to the rear

This chimney was very difficult to view. Again it looks to be brick built and again we would make the comment with regards to dampness coming in via this or the parapet wall.

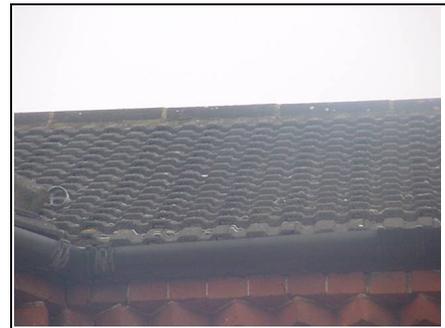
The roof is pitched and clad in a large interlocking concrete tile. From what we could see the concrete tiles are lying level and true and look in reasonable condition considering their age. Sometimes we find that deterioration occurs to the ridges and the perimeter, so you should periodically check these areas.

Concrete tiles to roof

We believe originally the roof was slate, if this is the case and a heavy concrete tile has been added, then we would expect additional roof support, in this case additional props have been added.

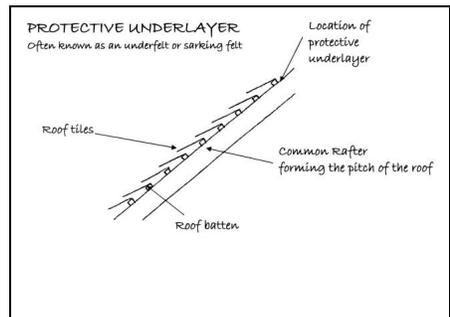
When we inspected the loft space we found a Hessian base Bitumen membrane. This type of membrane has been used since the 1960s. We generally found it to be in average condition, it's damaged in a few more places than we normally find.

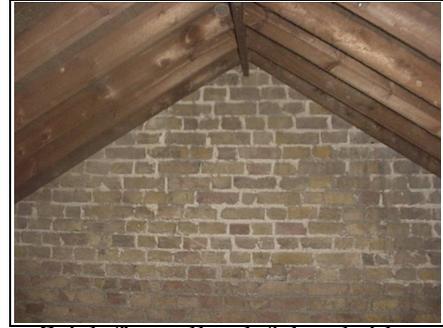
Brick firewall to left hand side

ACTION REQUIRED: Your solicitor to request confirmation of construction of the firewall, otherwise you have to assume it is not and rebuild it.

ANTICIPATED COST: For rebuilding we would allow the sum of £1,500 - £2,000 as it is a very awkward job; quotations required. Please see our comments with regards to party walls.

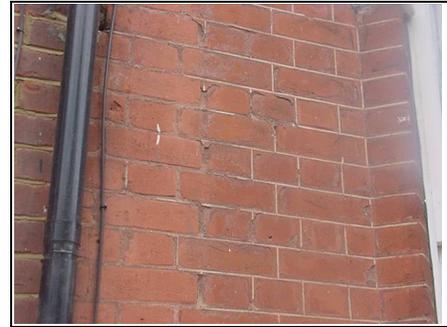
Tuck pointing

The mortar has been finished using a method known as tuck pointing, this method requires a high level of skill, and was used predominately on poorer quality bricks to take the eye away from them and focus on the pointing.

ACTION REQUIRED: Ideally repoint in a like for like style but only a few bricklayers have the skill to carry out this work properly; let them do a section to check they are good enough.

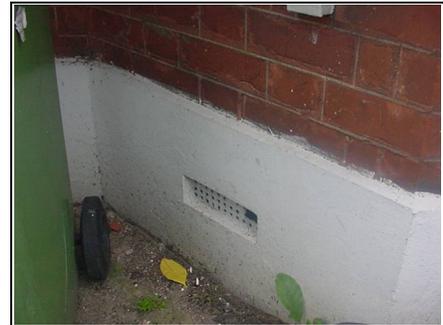
Airbricks are visible to this property, which is usually seen when suspended timber floors have been used and that would be my thoughts in this case. However, without opening up the structure we cannot be certain of the structure or its condition.

Airbrick to front of splayed bay

ACTION REQUIRED: Please see Executive Summary.

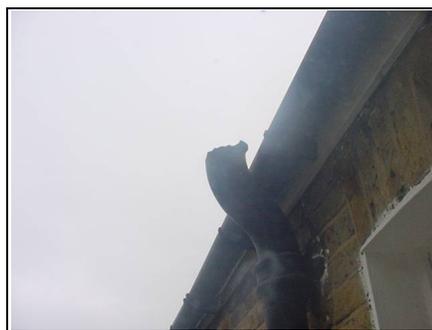
The property looks to have fascia boards only however we cannot see these as they are effectively hidden by the gutter.

Fascia board just visible to the rear of the property (a white board)

ACTION REQUIRED: Bearing in mind our comments with regard to the roof and possibly water discharging down the wall this will dictate the condition of the fascia boards.

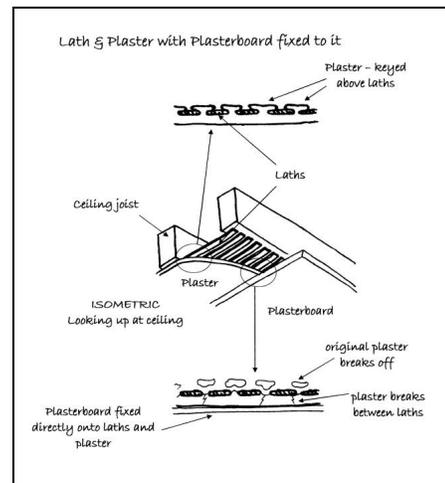
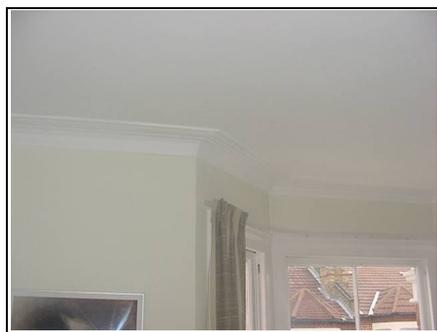
From our visual inspection of the ceilings and our general knowledge of this age and type of construction we believe that the ceilings are originally lath and plaster, but in some areas have had plasterboard tacked over them possibly with replacement plasterboard. This type of work is normally carried out where the ceilings are in poor condition as removing lath and plaster is very messy, time consuming and expensive as it is labour intensive. As you can see in the photo a lot of the plaster has deteriorated.

Checking for leaks to bay window ceiling

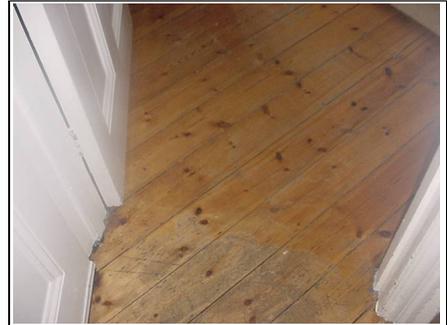
Based on our knowledge of this age of construction we believe that the ground floor construction is predominantly a suspended timber floor. We can see that the floor has been replaced at some time because they have used a thin modern floorboard.

Replacement floorboards on ground floor

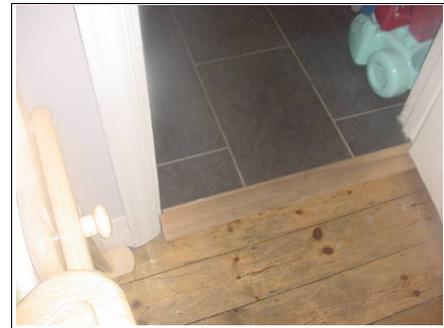
As mentioned previously in the Executive Summary, the remainder of the floor, kitchen onwards, is solid underfoot and assumed to be concrete. There would normally be a step between a timber floor and a concrete floor at the back of this style of property however in this case they are level.

Are tiles on a timber decking or a cement decking – it is difficult to tell

ACTION REQUIRED: We would ideally recommend you take up a section of the floor to check what is happening underneath as this is an unusual floor construction.

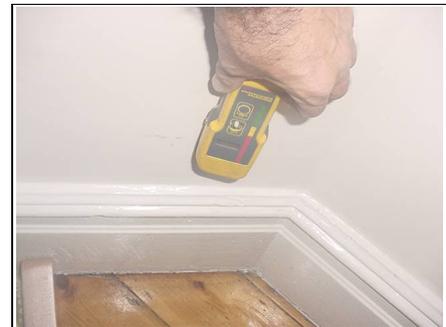
Checking for rising damp

A random visual inspection and tests with a moisture meter have been taken to the perimeter walls and some internal walls. The readings we obtained indicated that there is minor dampness in the property which may have been caused by condensation; it is at low level where rising damp would normally be found.

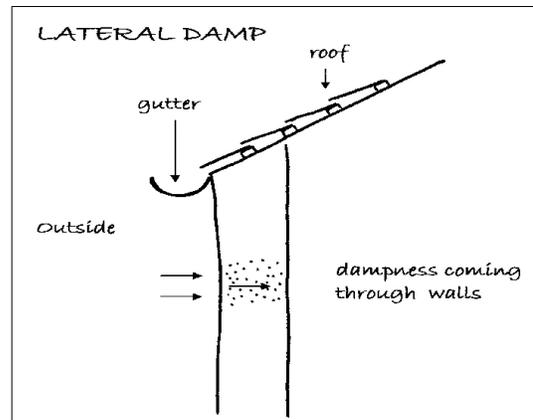
Within the property a visual inspection was carried out and tests were taken with an electronic conductivity meter at selected points to walls. No significant penetrating/lateral dampness was seen or detected considering the properties age, type and style. However within the roof we believe there is some dampness coming in. Please see the adjoining photo.

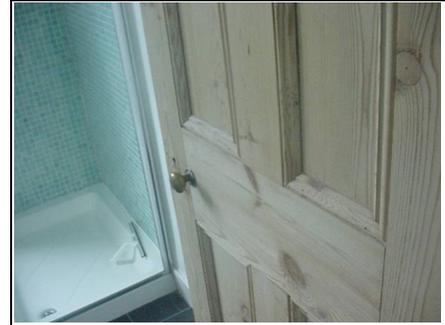
Door

The property has stripped wood panel doors. They are generally in reasonable condition, although they don't fit perfectly.

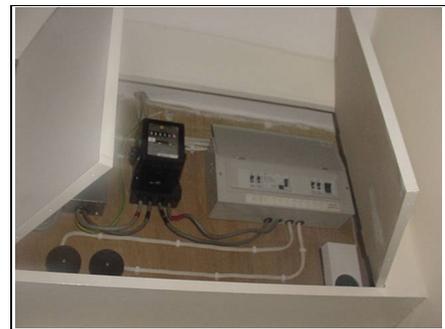
Fuse Board

The electric fuses and consumer units were located under the stairs. We would date the fuse board as being from the 1970's/1980's and, whilst not the best now available, it is average.

ACTION REQUIRED: NICEIC approved contractor to carry out an IEE inspection test and all recommendations to be actioned. A new fuse board is recommended.

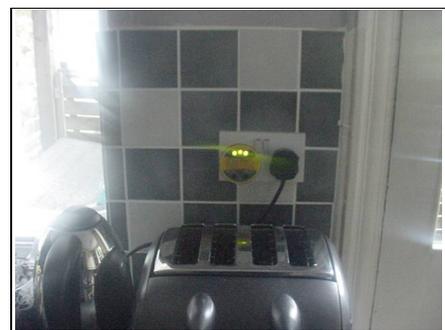
Earth test

We carried out an earth test in the kitchen area to the socket point that is normally used for the kettle, this proved satisfactory.

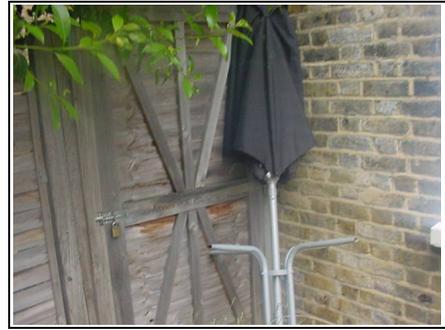
There is a gate to the rear of the property which may be a right of way. Originally in our experience generally these were present to give the coalman a right of way to deliver coal.

Shared access to the garden

ACTION REQUIRED: Your legal advisor needs to check and confirm.

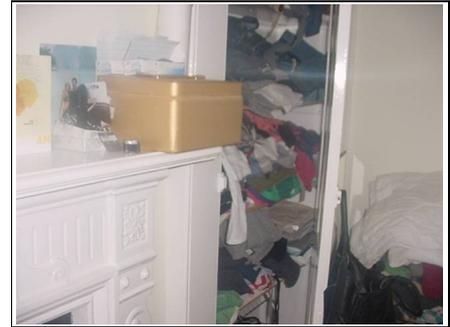
Unfortunately in this instance our inspection has been very limited as we have not opened up any of the floors, we have had a limited view of the roof due to the stored items in it. There were no manholes visible to inspect the drains and we had a limited inspection of cupboards due to amount of stored items.

Inspection limited due to amount of stored items in the cupboards generally
