# RESIDENTIAL BUILDING SURVEY

Southwark,  
SE22

**INDEPENDENT CHARTERED SURVEYORS**

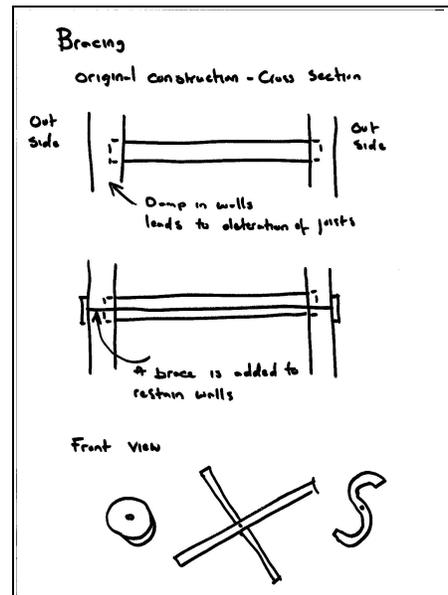
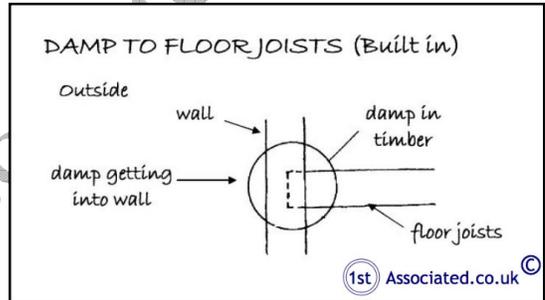
this particular case. We can comment that the brickwork and the proud pointing doesn't look to have had any recent movement.

**ACTION REQUIRED:** As it is always better to be safe than sorry we would recommend opening up the first floor to check the joist ends against the wall and tie them back if necessary.

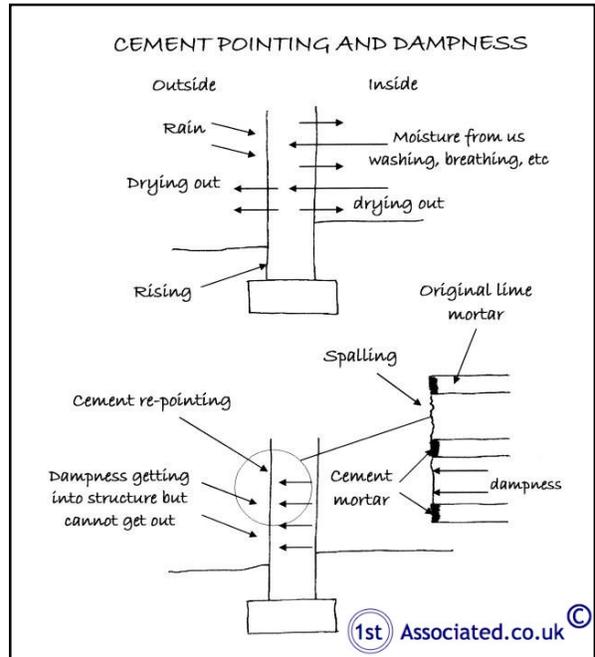
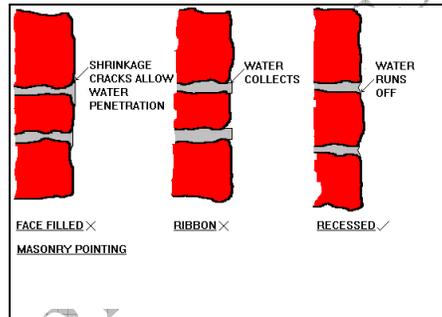
**ANTICIPATED COST:** A few hundred pounds over many, many years; quotations required. We would add that it is almost as if the proud pointing has been carried out to take your eye away from the bowing of the wall.

Proud pointing

**ACTION REQUIRED:** Ideally we would recommend that the cement pointing is removed over many years using a soft brush and repointed in an appropriate lime mortar.

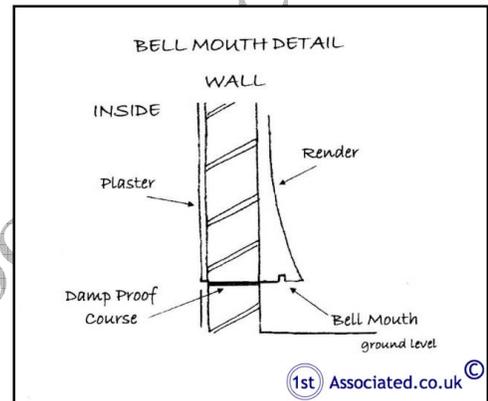
We found rising damp particularly to the reception room and it may well be in the kitchen as well, hidden by the kitchen cabinets.

Base of rendered wall

**ACTION REQUIRED:** The detail to the render should have a bell mouth added to reduce the dampness. You also need to position yourself outside the property next time it rains heavily to see if the rainwater discharges against the property or away. If it discharges against it then you should speak to the Local Authority about altering the pavement.

**ANTICIPATED COST:** In the region of £1,000 - £3,000; quotations required.

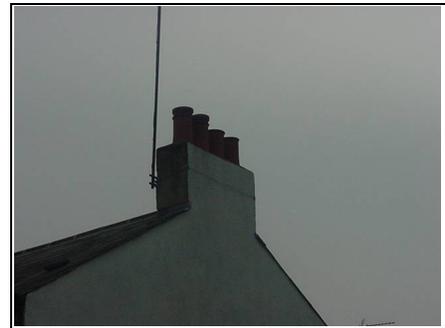
This chimney is brick finished and rendered with four chimney pots and a large aerial (the wire can cut into chimneys like a cheese cutter into cheese). You do need to periodically inspect the chimneys. From what we could see the chimney looks in average condition. Unfortunately we were unable to see the top of the chimney known as the flaunchings, we therefore cannot comment upon them.

Front chimney

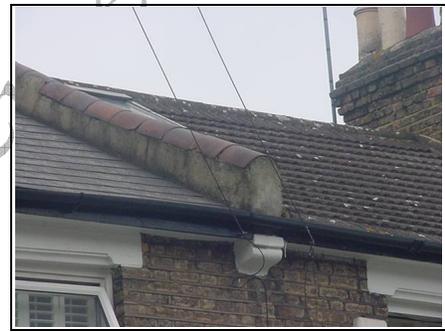
There is a front and rear parapet wall, both are rendered. We were pleased to see a coping stone to the front parapet wall and we would prefer to see one to the rear as we find that without them that water sooner or later gets into the property. Unfortunately we were not able to view the rear roof.

Parapet wall to right hand side

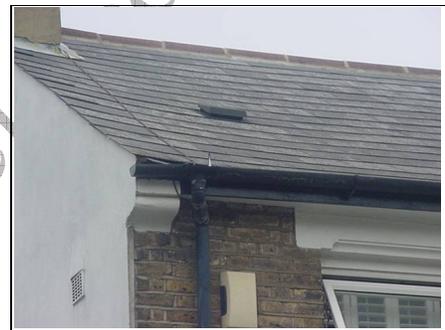
The roof is pitched and clad in a man made slate. From what we could see the slates are lying level and true and look in reasonable condition considering their age. Sometimes we find with man made slates that they can be lifted very easily by the wind particularly at the perimeters and the ridges, so you should periodically check these areas.

Main roof

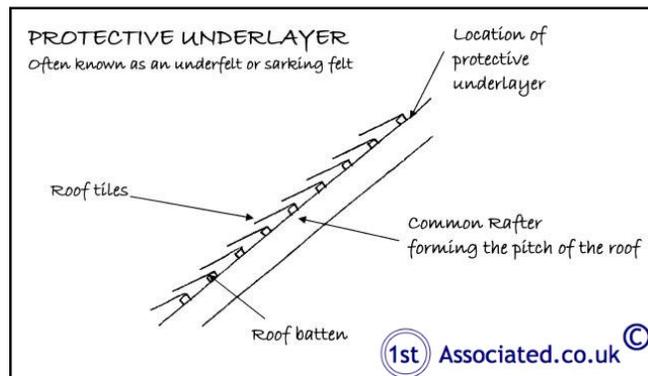
When we inspected the loft space we found a Hessian base Bitumen membrane. This type of membrane has been used since the 1940s. We generally found it to be in average condition, it's damaged in a few more places than we normally find.

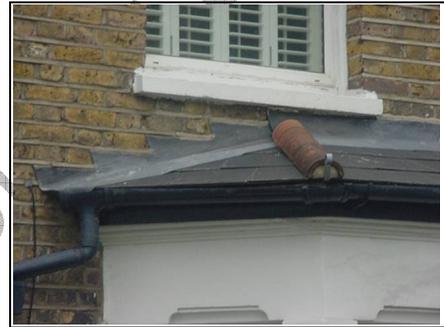
The flat roof has a slate finish with a lead flashing. From our limited view it looked to be in reasonable condition.

Bay window roof

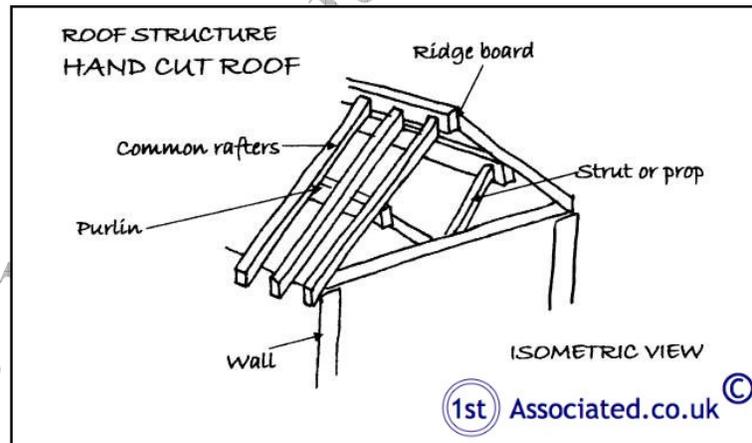
This type of roof structure has, what is known as, a cut timber roof, which is a roof that is purpose made and hand built on site. It is in below average condition because the purlin timbers are smaller than we would normally expect.

Where we could see, we found the supporting purlin timbers to be thinner than we would expect although they are supported with struts and it could be argued they have survived the test of time but do need to be checked from time to time. Our examination is usually limited by the general configuration of the roof, the insulation and stored items.

**ACTION REQUIRED:** If you decide not to carry out your loft conversion then we would recommend additional strengthening work is carried out in the roof.

**ACTION REQUIRED:** Please see our comments in the Executive Summary.

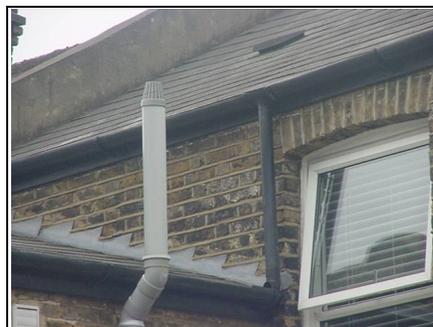
We could see a plastic soil and vent pipe. Generally the waste pipes and soil stack appear to be satisfactory where a surface inspection is possible, although for the most part they run in ducts and cannot be inspected.

Soil and vent pipe

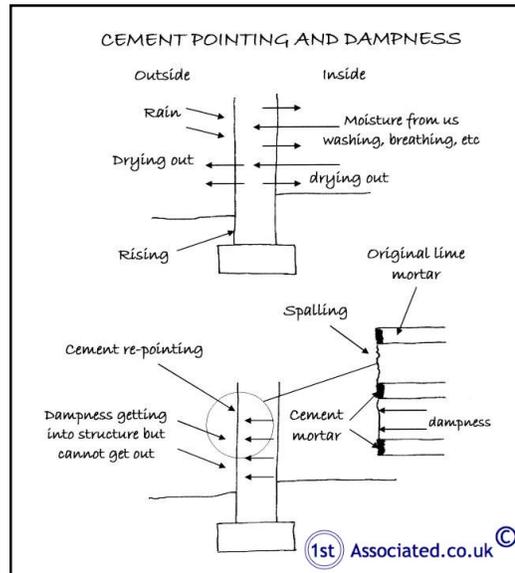
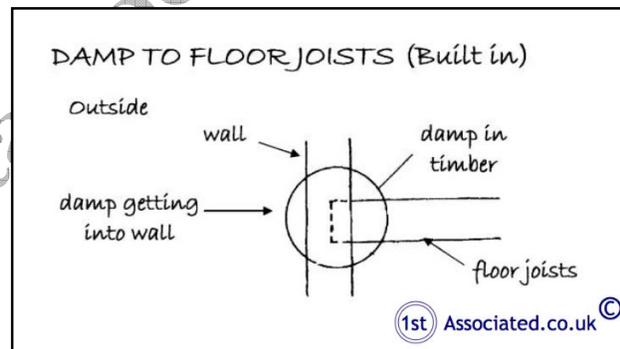
We can see that the left hand side wall is bowing which is probably due to joist ends rotting. Many properties of this age have been tied back. Whilst from looking at the brickwork and pointing there doesn't look to be recent movement we would recommend that you open up the first floor to check the joist ends and tie back if needed.

**ACTION REQUIRED:** Please see our comments in the Executive Summary.

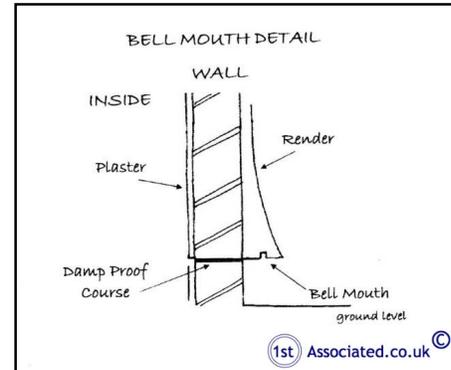
A good indication of the quality of rendering, we have found over the years, is by the quality of detailing above the windows and to the base of the property. The detailing on this property has been carried out to a poor standard. Good detailing would have had drips to appropriate areas and a bell mouth to the base of the property.

Side render that needs bell mouth

**ACTION REQUIRED:** Form a bell-mouth to the base of the render.

**ANTICIPATED COST:** In the region of £1,000 - £3,000; quotations required

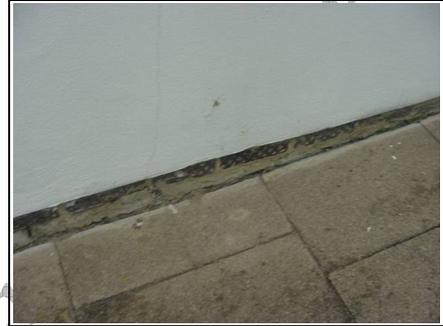
All modern properties should incorporate a damp proof course (DPC) and good building practice dictates that a differential of 150mm (6 inches) should be maintained between the damp proof course and ground levels. In this case, the damp proof course wasn't visible due to the render to the side of the property, and to the brickwork it was difficult to see due to the proud pointing. Your attention is drawn to the section of the report specifically dealing with dampness.

Difficult to see DPC due to render

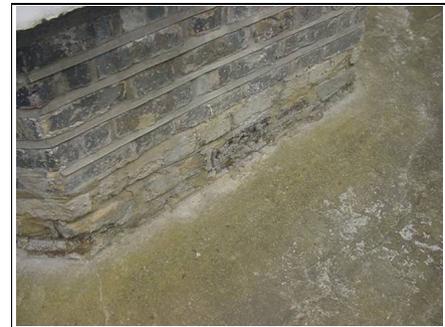
Again, difficult to see due to the brickwork

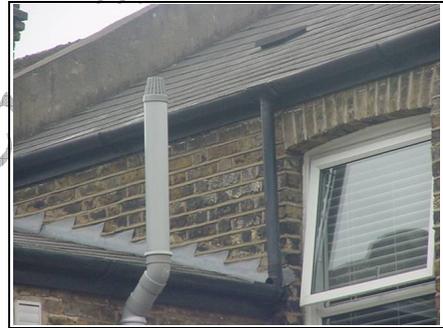
The property has painted timber fascias. They are difficult to view as they are hidden by the guttering, what we could see we would term as being in average condition.

Fascias and soffits

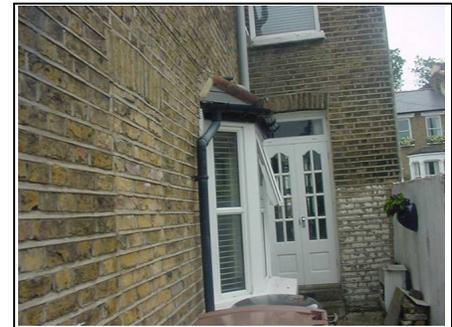
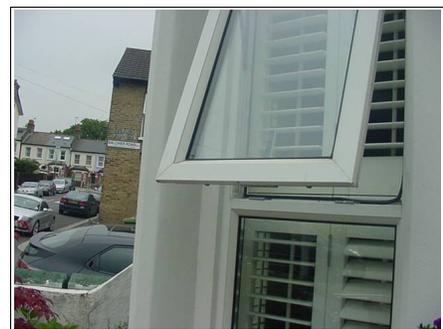
Windows

The property has plastic, double glazed windows, which generally look to be of an average quality for the year made. We did not see any trickle vents indicating the windows are pre 1990s. There are timber doors.

We would draw your attention to the fact that sealed double glazed units can fail, particularly as a result of poor workmanship during installation. Failure of the seal leads to condensation between the two panes of glass and simply replacing the affected units may not provide a satisfactory long-term solution. In this case they are in average condition.

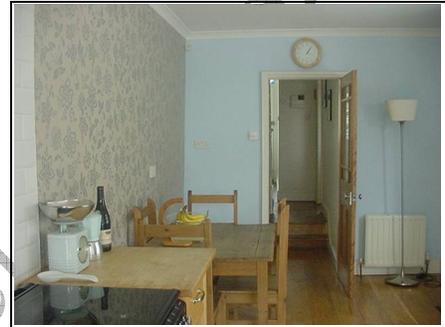
The rear chimney breast has been removed as this would be visible from within the kitchen. In theory this should have had Building Regulations Approval although we generally find that they were often removed without approval. In this instance we were unable to see how it is supported which is not ideal however it has stood the test of time and there is no obvious visual deterioration to the ceiling area.

Area of kitchen where chimney would have once been

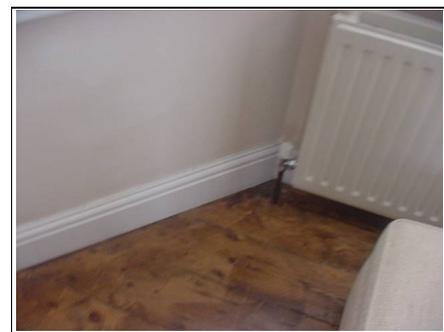
Flooring in lounge

**ACTION REQUIRED:** We would recommend that the floor is opened up and viewed before you commit to purchase this property.

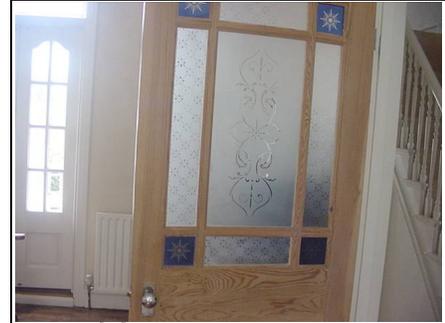
The property has stripped wood panel doors. They are generally in above average condition. We were advised by the owner during our question and answer session that they were a new addition to the property.

New internal doors throughout the property in an older style

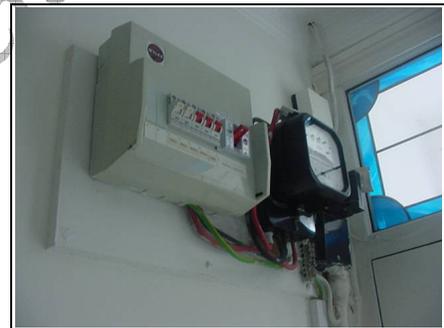
Fuse board

The electric fuses and consumer units were located near the front door. We would date the fuse board as being from the 1990s and, whilst not the best now available, it is reasonable.

**ACTION REQUIRED:** If there is no record of an electrical test having been undertaken within the last five years, it is recommended that the installation be tested by a competent electrician (NICEIC registered) and all recommendations implemented. Thereafter, the installation should be re-tested every five years.

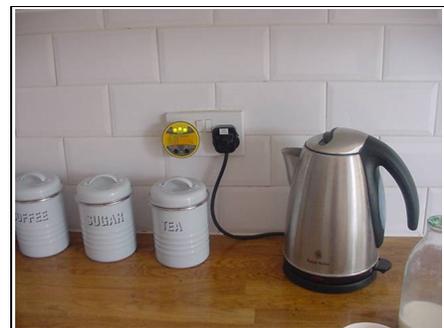
Earth test

We carried out an earth test in the kitchen area to the socket point that is normally used for the kettle and this proved satisfactory.

Neither of these indicators can give certainty as to the condition of the rest of the wiring

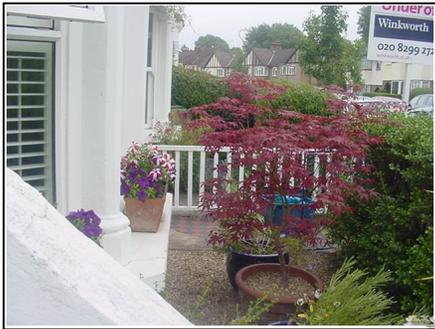
Well presented small front garden – typical of this era of property

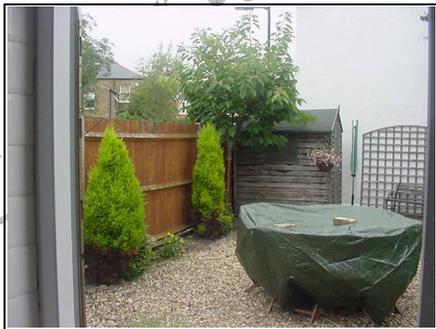
As is often the case with corner plots the garden is affected. In this case it is limited in size and is what we would term a low maintenance garden.
