RESIDENTIAL BUILDING SURVEY

A 1960's Detached Property, St Albans, Hertfordshire, AL3

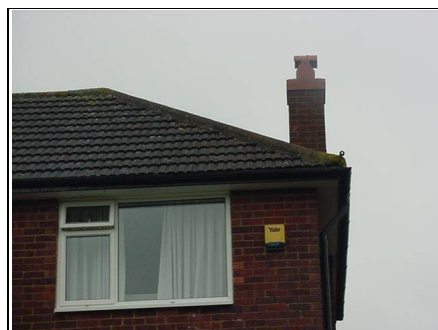
Chimney One – Located at Front Right Hand Side of the Property

This chimney is brick finished with one chimney pot with lead flashings. It is tall and thin. From what we could see the chimney looks in average condition; although some repairs have taken place to the brickwork in the form of a cement mortar patch; this may have been to repair where an area has been removed or similar.

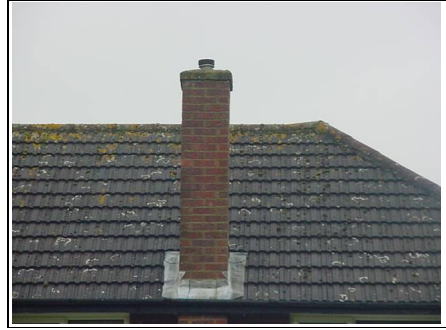
Chimney Two – Located at the rear of the Property

We would comment in a similar manner to the previous chimney. This has a single flue at the top, which we believe is the flue from the boiler in the kitchen.

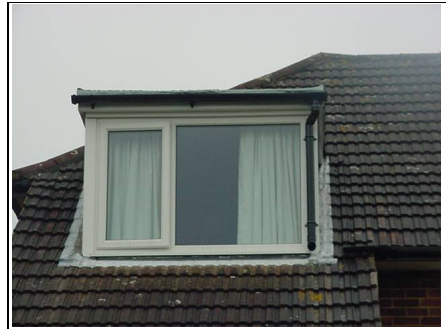
The roof over the entrance porch we could see had moss sitting on it indicating that it is flat rather than having a fall of approximately twelve degrees. Water sitting on a roof will reduce its life span. We anticipate that the flat roof over the porch roof will have five more years of life particularly the flashing detail that is in felt which you can see is starting to crack; this may even go sooner.

There is one dormer window to this property. The roof is clad with felt, but our view was limited, the cheeks/sides are in timber, we are not certain of the type. Generally as viewed from ground level it looked in reasonable condition.

ACTION REQUIRED: Budget to replace within the next five years. We recommend using a high performance felt and you must ensure there are 'falls' on these roofs. A good way to do this is to add an insulation cut to fall and then finish with a high performance felt.

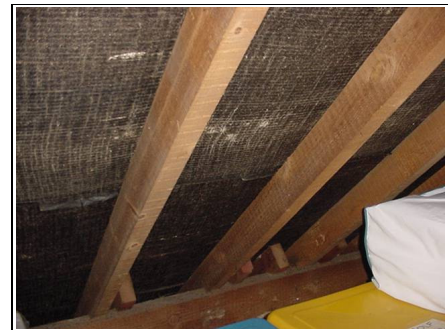
When we inspected the loft space we found a Hessian based bitumen membrane. This type of membrane has been used since the 1960s. We generally found it to be in average condition, although it is damaged in a few places but this is not unusual considering its age.

This photo shows the common rafters (the ones that form the pitch of the roof) and the dark area between is the underlayer.

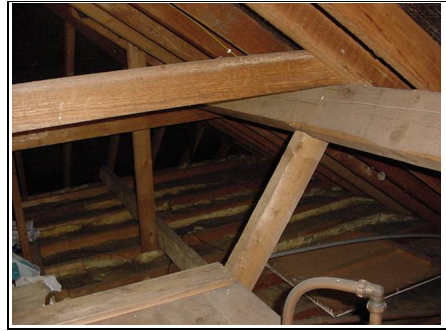
Roof Timbers

We found the roof timbers generally in average condition considering their age. We have inspected the roof structure for:

Our examination was limited by the general configuration of the roof, the insulation and stored items. As mentioned what we could see was generally found to be in average condition considering its age. It is, however, feasible that there are problems in the roof that are hidden.

ACTION REQUIRED: The only way to be 100 per cent certain is to have the roof cleared and checked.

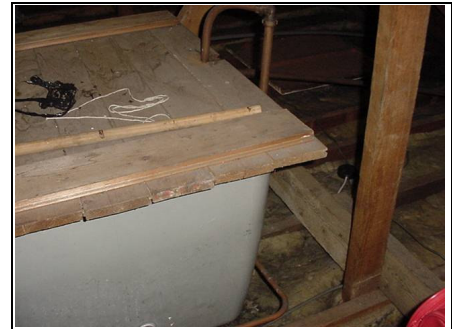
Water Tanks

The water tank is plastic, possibly fibre glass, with a timber lid. We would always recommend that water tanks be drained down and cleared of any debris etc. (we have seen dead birds and other unmentionable things in these tanks). As you are cleaning your teeth with this water it is best that it is as clean as possible!

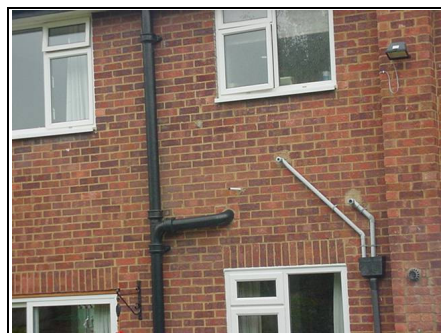
Soil and Vent Pipe

The soil and vent pipes are cast iron; they appear to be satisfactory where a surface inspection is possible, although cast iron of this age will need regular maintenance such as repair and painting and can rust and crack.

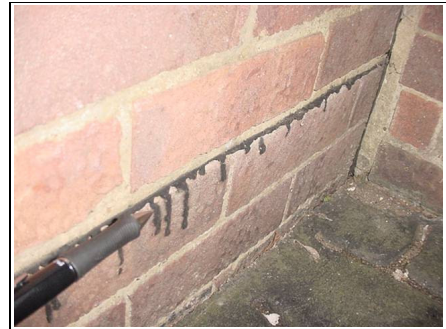
We noted that the damp proof course to the rear of the property was slightly low on the rear left hand side (it should have two courses of brickwork between the ground level and the damp proof course and it only had one). This was causing some spalling to the brickwork.

All modern properties should incorporate a damp proof course (DPC) and good building practice dictates that a differential of 150mm (6 inches) should be maintained between the damp proof course and ground levels. In this case, we could see a bitumen damp proof course. It is slightly low to the rear particularly on the rear left hand side of the property with the bricks starting to deteriorate. Your attention is drawn to the section of the report specifically dealing with dampness.

Bitumen damp proof course

ACTION REQUIRED: We recommend that you have a look the next time there is a heavy downpour of rain just to see how the rainwater passes from the rear of the property to the front to see if there is any obvious signs where it can/is causing damage and deterioration and then take appropriate action.

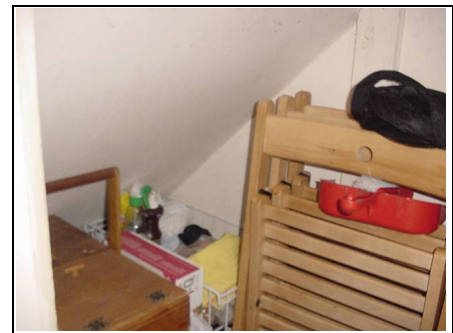
Staircase

We were unable to examine the underside of the stair timbers due to it being lined, which precluded our inspection, so we cannot comment further upon the stair structure. We can, however, say that the lining gives a resistance to the spread of fire if such circumstances were to occur.

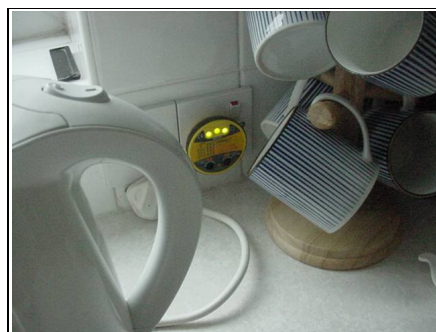
We carried out an earth test in the kitchen area to the socket point that is normally used for the kettle, this proved satisfactory.

Neither of these indicators can give certainty as to the condition of the rest of the wiring.

ACTION REQUIRED: As the property is changing occupancy an IEE report should be carried out by a NICEIC registered and approved electrical contractor.

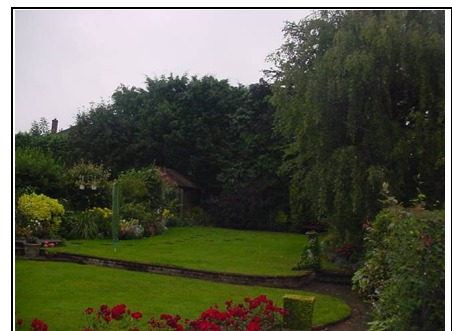
Rear Garden

You have a mature garden with larger trees. All trees will need regular maintenance.
