RESIDENTIAL BUILDING SURVEY

Great Ashby, Stevenage, SG1

GEM Associates Limited
INDEPENDENT CHARTERED SURVEYORS

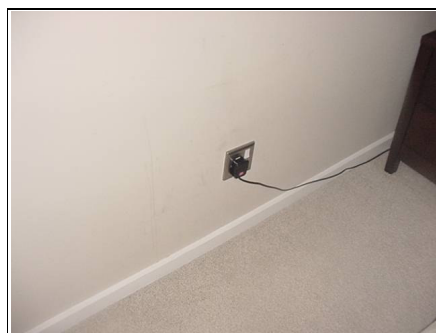
We were surprised that there were single socket points in some areas. Normally in a modern property double socket points are the norm.

ACTION REQUIRED: As the property is changing occupancy the Institute of Electrical Engineers (IEE) recommend an NICEIC (or equivalent) registered and approved electrical contractor carry out an inspection, test and report.

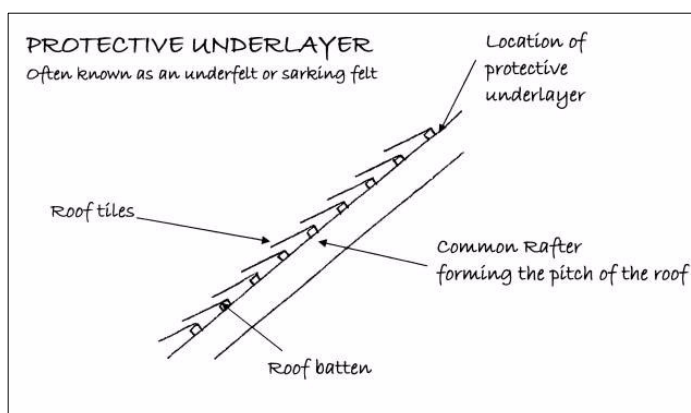
When we inspected the loft space we found a Hessian base Bitumen membrane. This type of membrane has been used since the 1960s. We generally found it to be in average condition, it is damaged in a few more places than we normally find.

We were slightly puzzled about the dark areas of insulation that we noted. It is as if it parts of the felt are deteriorating and falling onto the insulation. This may be being caused by condensation. It is very difficult to know without analysing what is on the insulation as we haven't come across this previously.

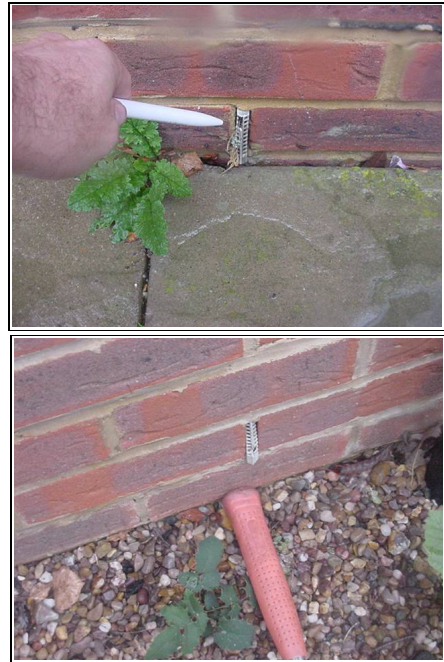
Trickle vent

It was noted that there are trickle vents in the structure. This means that within the cavity there is cavity trays transferring moisture from the inner wall to the outer wall. This is a good modern practice provided it is carried out correctly.

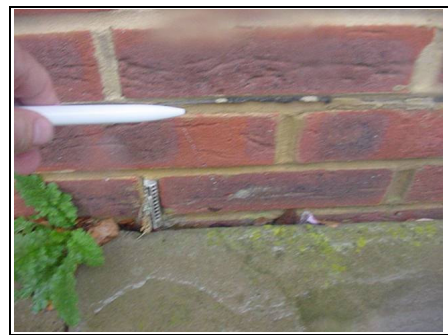
Damp proof course

All modern properties should incorporate a damp proof course (DPC) and good building practice dictates that a differential of 150mm (6 inches) should be maintained between the damp proof course and ground levels. In this case the damp proof is visible. We were not able to use our damp meters due to the property being dry-lined however visually we didn't find any signs of dampness.

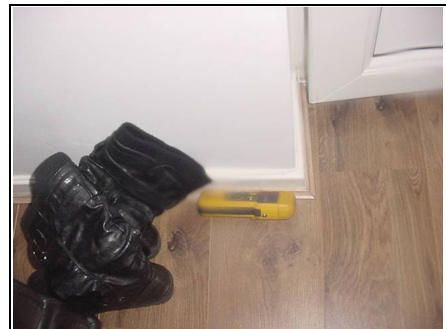
Damp meter test

We believe the property is dry-lined and therefore we were not able to use a damp meter which sends an electric current into the surface and then looks at resistance so we carried out a visual inspection.

ACTION REQUIRED: The only way to be 100% certain is to open up the structure which we wouldn't recommend based upon what we have seen.

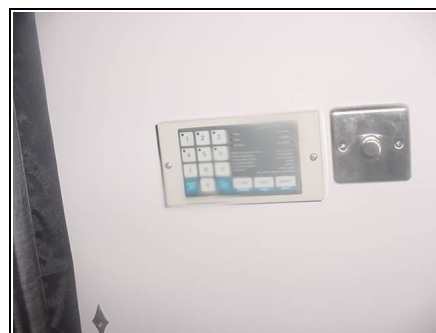
Security alarm

A security system was noted but we are advised not used. It is a personal decision as to whether you feel one is necessary. We are not experts in this field and therefore cannot comment further. We suggest you contact a member of NACOSS (National Approval Council for Security Services), obtainable

through directory enquiries, or your local Police Force for advice on a security system.

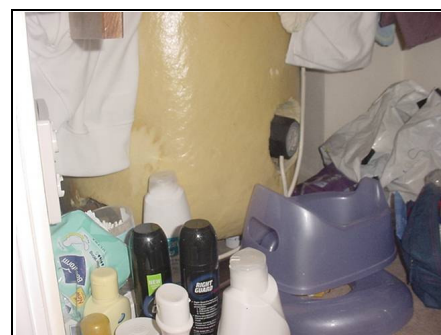
Hot water cylinder

The hot water cylinder is relatively new as it is factory lagged and located in the bathroom cupboard.

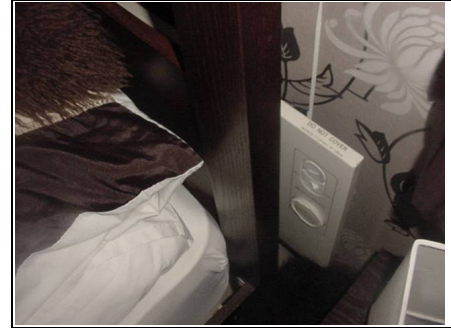
Electric radiators

The property has modern electric radiators, the property was warm during the time of our inspection so we assume they had been working that night.
