RESIDENTIAL BUILDING SURVEY

Hertfordshire

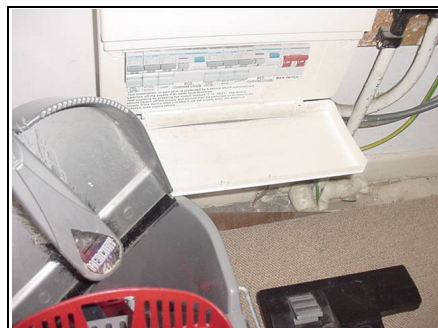
Electrics

Much of the electrics look to be original, albeit that some of the power points have been changed to double sockets and the fuse board looks to be relatively new. We would still nevertheless recommend that the single socket points are upgraded to double socket points.

ACTION REQUIRED: Ideally we would upgrade the fuse board to the latest available and also upgrade single to double socket points.

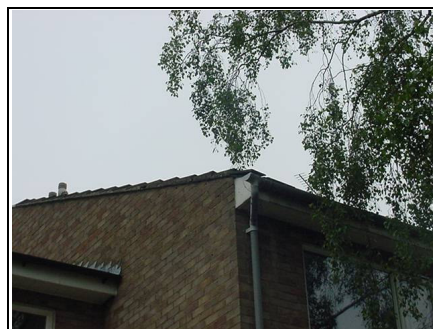
The roof is pitched and clad in a concrete tile. From what we could see the concrete tiles are lying level and true and look in reasonable condition with the exception of near the rear right hand corner (all directions given as you face the property) where we think there may be some displaced tiles. There are also likely to be a lot of leaves lying on the roof.

ACTION REQUIRED: Please see our comments in the Executive Summary with regards to the verge needing repointing.

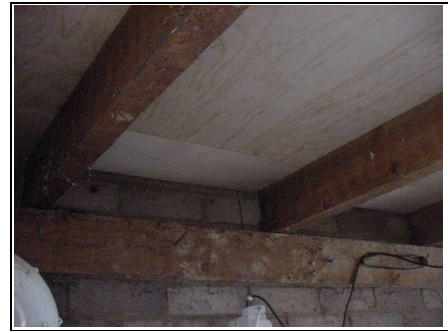
Underside of garage roof

Please see the comments in the Executive Summary.

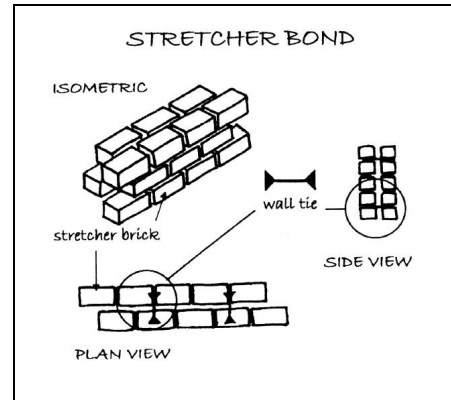
At around the time when this building was constructed construction was changing; insulation was starting to be used however from the age of the property we would recommend more insulation is added.

ACTION REQUIRED: Add insulation to cavities. As discussed there are various grants available and you mention that you may be able to get even bigger grants!

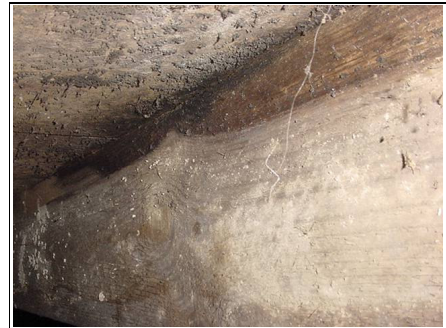
Under bathroom floor

You have had a tiled floor put on top of the suspended timber floor. In our experience these two never work well together even where there is an expansion joint which we couldn't see. A suspended timber floor moves differently to a harder tiled floor, we normally find that tiles end up cracking at the joints and allowing water to leak thorough which inevitably gets spilled in a bathroom.

ACTION REQUIRED: We believe that the floor is probably saveable but you will only know this when you take up all the tiles. It then may dry on its own however you do have to consider that you may have to put new flooring down using a WBP quality floor covering. We would then also recommend vinyl flooring in this situation with all the seals being sealed and forming a skirting of approximately 150mm to make sure any spills of water don't get behind it.

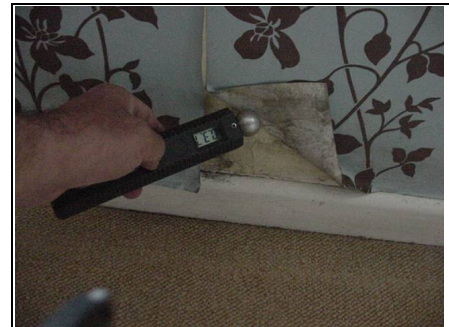
The readings we obtained indicated that there is minor dampness in the property mainly due to the sloping site and the damp proof course being a bit low in some areas. We feel that most people would be able to live with this however we haven't see the property when it rains!

Checking for dampness with an electronic conductivity meter

ACTION REQUIRED: We would recommend adding a French drain. Please do stand outside the property the next time it rains heavily.

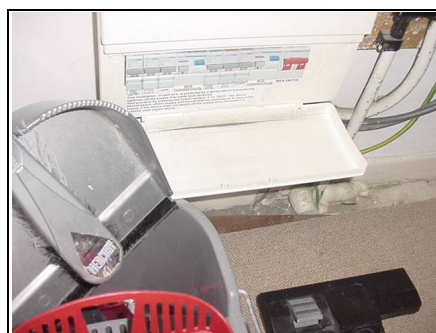
Fuse Board

The electric fuses and consumer units were located in a cupboard off the hallway. We would date the fuse board as being from the 2000s and, whilst not the best now available, it is reasonable.

ACTION REQUIRED: Ideally update the fuse board to the best available. Remember that you will have some dated wiring in this age of property.

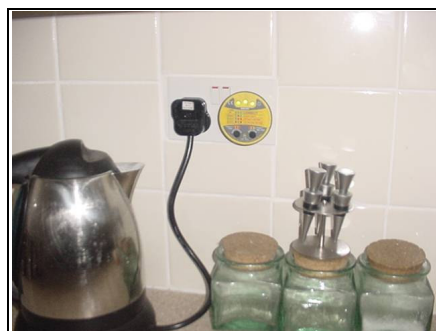
Earth test

We carried out an earth test in the kitchen area to the socket point that is normally used for the kettle and this proved satisfactory.

ACTION REQUIRED: If there is no record of an electrical test having been undertaken within the last five years, it is recommended that the installation be tested by a competent electrician (NICEIC registered) and all recommendations implemented.

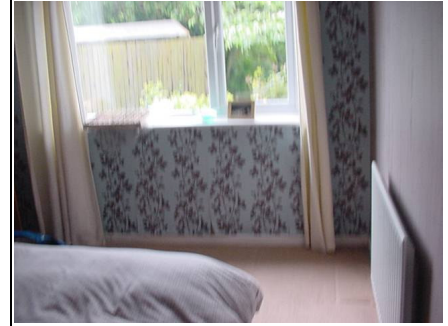
We noted that there are a fair number of internal radiators. The radiators would normally be positioned under the window, which helps circulation of the warm air. These radiators may not warm the property to the heat that you desire.

Internal radiators are generally used by plumbers to reduce costs (less pipe work) and save time (less pipe work). Sometimes dampness (what's known as cold bridging) occurs; we have personally had this problem and ended up moving the radiators to the traditional location under the window.

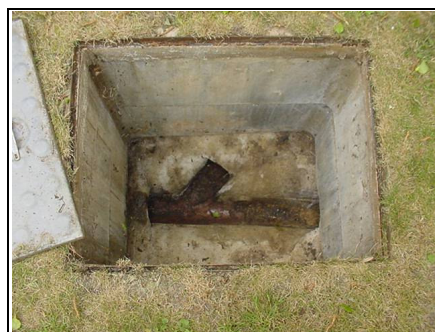
We duly lifted the manhole/ inspection chamber cover and found the drain to be clear, we noted it was finished in concrete.

Manhole which is located to the rear of the right hand next door neighbours garden
