# RESIDENTIAL BUILDING SURVEY

**Studham,  
Near Dunstable,  
Bedfordshire LU6**

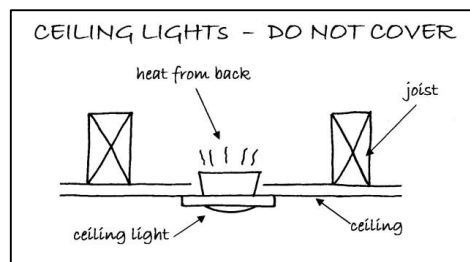
The electrics are dated. We recommend an Institute of Electrical Engineers test and report on the property and we believe that a new fuseboard will be required. The property may also benefit from some additional socket points.

We would also get the electrician to specifically check the lights in the roof as they do not have any covers on them.

**ACTION REQUIRED:** As the fuseboard is old we would recommend a check to the Institute of Electrical Engineers (IEE) standards by an NICEIC registered and approved electrical contractor.

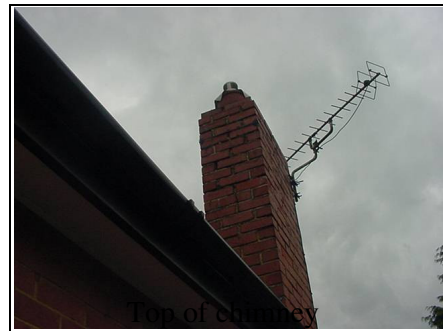
This chimney is brick finished and is in a poor condition. Please see our comments about the repairs in the Executive Summary.

Unfortunately we were unable to see the top of the chimney known as the flaunchings and we therefore cannot comment upon them.

**ACTION REQUIRED:** Please see Executive Summary.

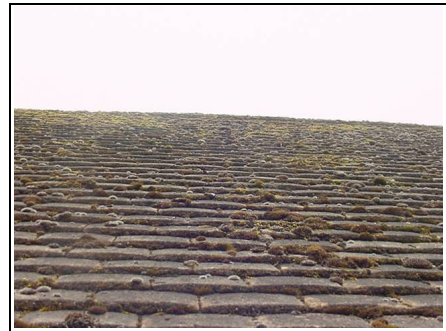
The main roof is pitched and clad in a small nibbed concrete tile. From what we could see the concrete tiles are lying level and true and look in reasonable condition.

Nibbed concrete tile

As is often the case with older concrete tiles there is a covering of moss. Ideally this should be removed with a soft brush as it can cause damage to the concrete tile surface and also block the gutters up.

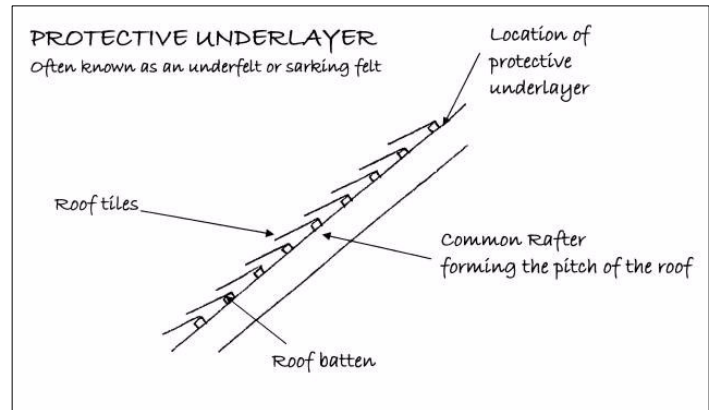
In the main roof we found a Hessian base Bitumen membrane. This type of membrane has been used since the 1960s. We generally found it to be in average condition, although it is damaged in a few places but this is not unusual considering its age.

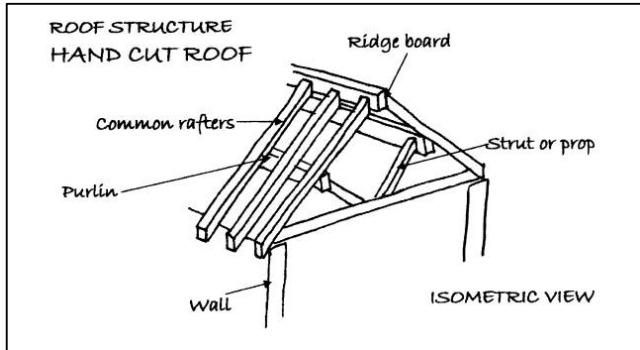
This type of roof is purpose made and hand built on site and is known as a cut roof. Without the original design details we cannot categorically confirm that there are no defects, however it is in line with what we typically see. We can see some minor movement in the roof however the roof is hipped and we would expect some movement.

The sketch above shows a typical example of the central section of the roof. It should be noted there has been movement to the purlins.

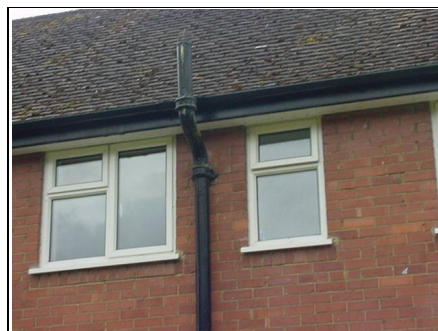
The soil and vent pipes are cast iron. They appear to be satisfactory where a surface inspection is possible. We cannot see the back that well or high up.

Cast iron will need regular maintenance such as repair to any rusting or cracks and painting.

Cast iron soil and vent pipe

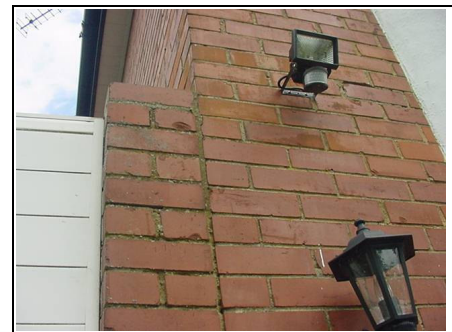
Tying in of the garage to the front of property

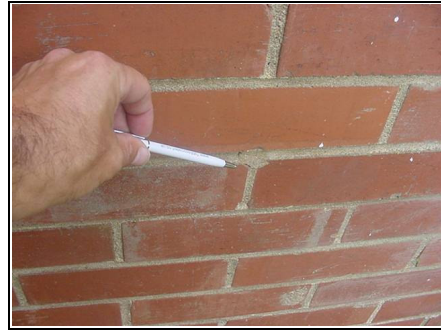
We find that old cavity insulation compresses the only way to check is to thermal image the property.

Insulation added

**ACTION REQUIRED:** Please see our comments in the Executive Summary.

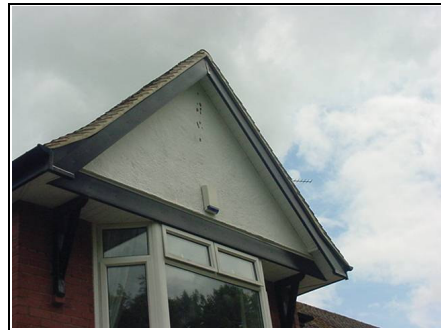
There is an area of render at high level to the front of the property. It is in reasonable condition and is marked at the very top.

Render at high level

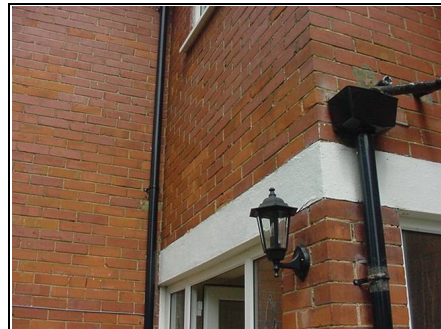
However, we noted concrete lintels which can cause cold bridging (please see the article in the Appendices of this report) and we can see the double glazed plastic windows do not have trickle vents and this can add to problems. In addition to this, there is no extract fan in the bathroom. All of these mean that an occupied property could suffer from condensation, depending upon how you use the property.

Concrete lintel

**ACTION REQUIRED:** You need to add an extract fan to the bathroom and ensure the property is well vented. If problems occur then we would recommend adding trickle vents to the windows.

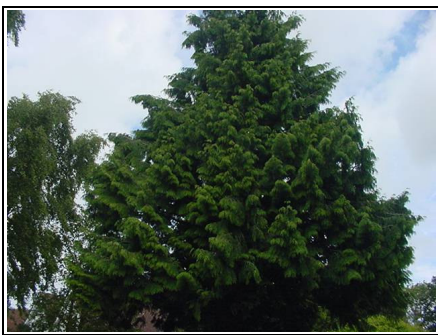
There are various trees surrounding the property, for example a large tree to the front of the property, which is causing some damage to the front wall. There are large trees to the rear of the property and also several trees that have been removed.

Tree to front

**ACTION REQUIRED:** We recommend you instruct an arboriculturist to comment (not a tree surgeon). Please see our comments within the Executive Summary.

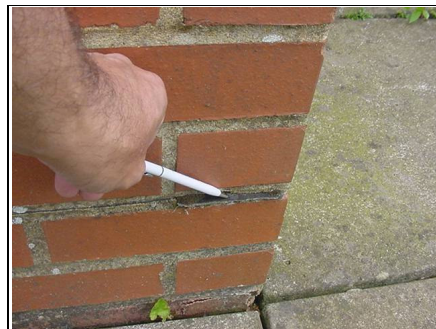
All modern properties should incorporate a damp proof course (DPC) and good building practice dictates that a differential of 150mm (6 inches) should be maintained between the damp proof course and ground levels. In this case, we could see a DPC to the property in a number of places. Your attention is drawn to the section of the report specifically dealing with dampness.

Damp proof course

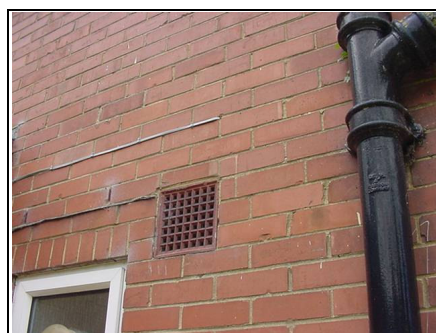
High level air bricks were introduced originally to help manage condensation in this age of property. You need to ensure that they are open for them to be able to help with condensation problems.

High level air brick

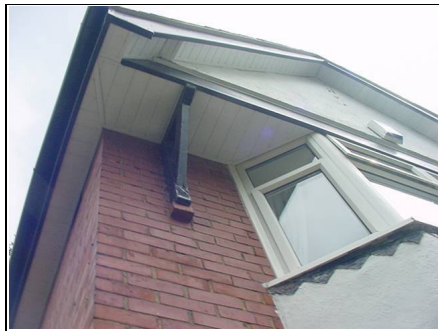
The fascias and soffits have been overclad. This can lead to problems in future years with the degrading of the timber cladding behind. We normally find that the timber cladding was already in a poor state which is why the overcladding has been used. Unfortunately further problems are caused by overcladding.

We noted that the property has plastic fascias and soffits, we think that these over clad the original timber fascias and soffits.

This is a poor system used to look as if the fascias and soffits have been replaced / repaired. The plastic is usually stuck on and, as there is no ventilation in this area, rot can occur.

Plastic fascia and soffit

**ACTION REQUIRED:** Remove overcladding, checking the condition of the fascia and repair as necessary. Then either replace with a solid plastic fascia and soffit or with a repaired or new timber fascia and soffit. We also recommend adding vents for the roof.

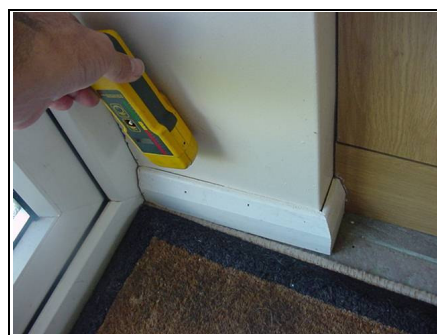
No evidence of any significant rising dampness was detected in the random areas checked. It is not usual in a property of this type and age to have minor damp/condensation.

Checking for rising damp

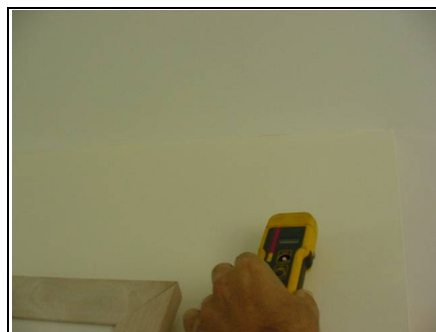
A visual inspection was carried and tests were taken with a electronic conductivity meter at selected points to walls. No significant penetrating/lateral dampness was seen or detected considering the properties age type and style.

Checking for lateral dampness

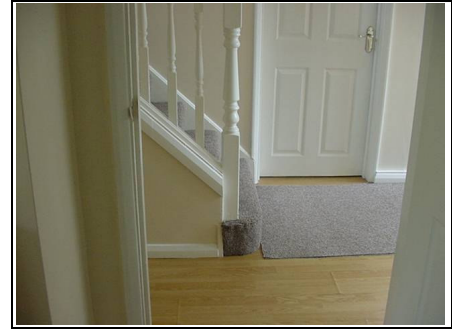
The property has hollow core doors (sometimes referred to as egg box doors, as this is what the internal of them looks like when they are opened up), which have a pressed and painted finish.

Painted hollow core door

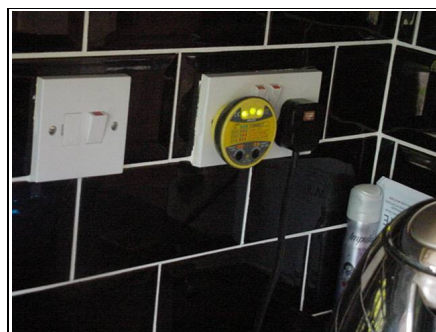
We carried out an earth test in the kitchen area to the socket point that is normally used for the kettle and this proved satisfactory.

Earth test

**ACTION REQUIRED:** We recommend an NICEIC approved contractor carry out an IEE inspection test and all recommendations to be actioned.

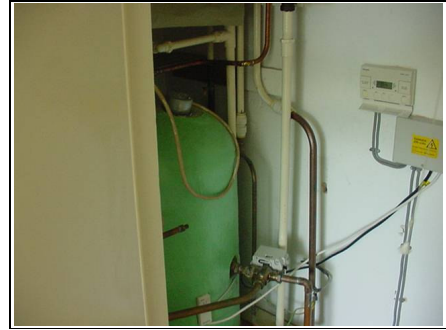
The hot water cylinder is relatively new (in this case we mean in the past 30 years) as it is factory lagged and located in the cupboard in the front left hand bedroom (all directions given as you face the property).

Hot water cylinder

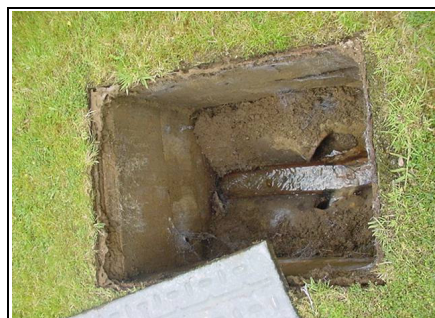
Manhole to front near hedge

We duly lifted the manhole/ inspection chamber cover and found the drain to be free flowing, we noted it was finished in concrete.

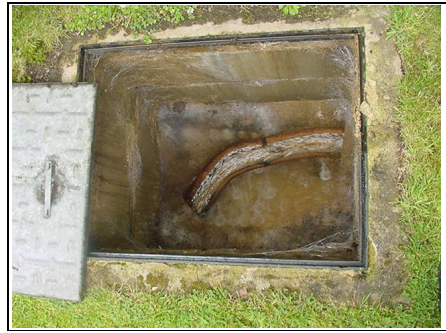
Manhole centre of front lawn

This manhole was lifted and found to be free flow and built as previously described.

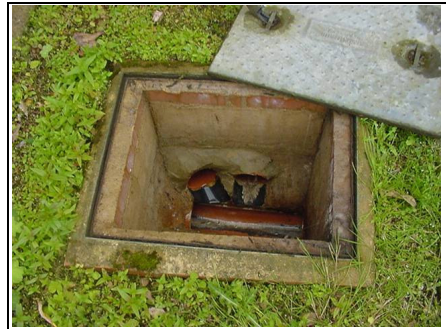
Rear manhole next to extension

We duly lifted the manhole/ inspection chamber cover and found the drain to be free flowing, we noted it was finished in concrete.

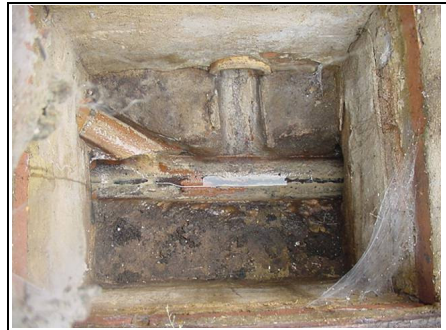
Rear manhole centre of rear garden

We duly lifted the manhole/ inspection chamber cover and found the drain to be free flowing.

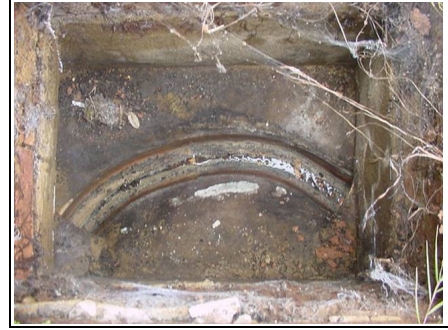
Rear manhole near garage

We duly lifted the manhole/ inspection chamber cover and found the drain to be free flowing, we noted it was finished in brick.

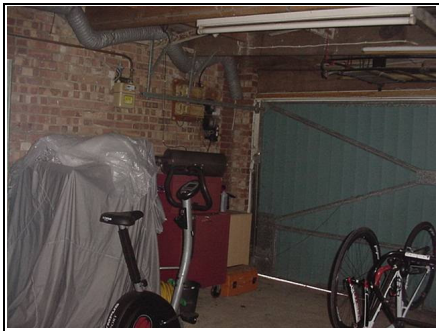
Inside garage

With regard to the garage roof please see our comments in the Executive Summary and also our comments in the Walls Section of the report.

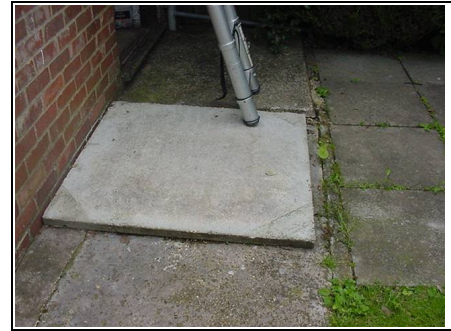
Unfortunately in this instance our inspection has been very limited due to not having the benefit of opening up the floors and some of the storage cupboards were full of stored items. Also we could not lift the concrete slab to the rear of the property!

We did not pick up things  
such as this large slab

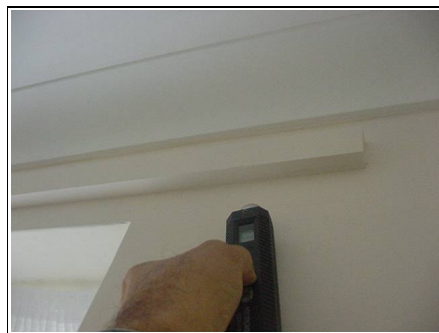
Dampness and condensation around  
the concrete window lintel
