RESIDENTIAL BUILDING SURVEY
OF
Sudbury, Suffolk CO10

FOR
Dr S

Prepared by:
INDEPENDENT CHARTERED SURVEYORS

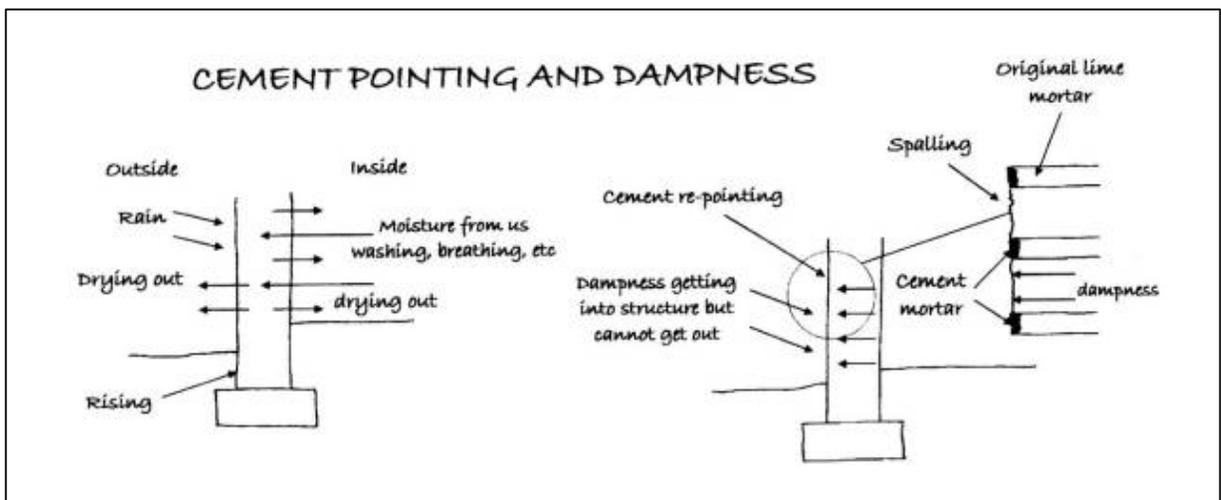
The property has a large red brick (a soft brick) chimney, which is in need of repointing and general work. The repointing should be carried out in a lime mortar to minimise further deterioration in the chimney. There appears to be some cement mortar from past "repairs". Unfortunately, it has caused accelerated deterioration to the brickwork. There is also a cement flashing rather than a lead flashing. If these items are left dampness will start to come into the property.

Close up, where a lead flashing is needed

ACTION REQUIRED: Repair and repoint the chimney appropriately and add a lead flashing.

ANTICIPATED COST: As this is high level work, it is likely to need scaffolding (savings may be made if you buy a tower scaffold). We would anticipate costs in the region of £1,000 to £2,000 Quotations will be required.

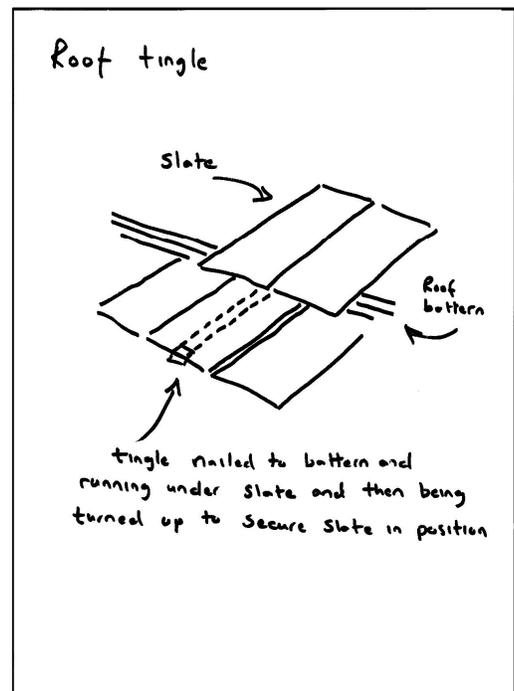
You have an older style slate roof, which does not have an underfelt. This indicates that it was carried out 40 plus years ago, or it was carried out more recently and not to current standards! The lead tingles would indicate that the nail fixings are rusting and failing, as tingles are commonly used where this problem occurs. It is known, in a worst case scenario, as nail sickness.

The property may have nail sickness. However, the roof does look very flat and true.

ACTION REQUIRED: We feel that ongoing maintenance will be required. We normally consider it a rule of thumb that if there are more than a dozen tingles (near each other) you need to look at re-roofing the property. In some areas you are getting close, for example directly above the rear right hand side (all directions given as you face the property dormer roof).

ANTICIPATED COST: We would recommend setting aside a budget to buy slates to match the ones on the roof so that the repairs can be carried out immediately. Remember, there is nothing underneath the slates other than your roof insulation, some plasterboard and your bedrooms.

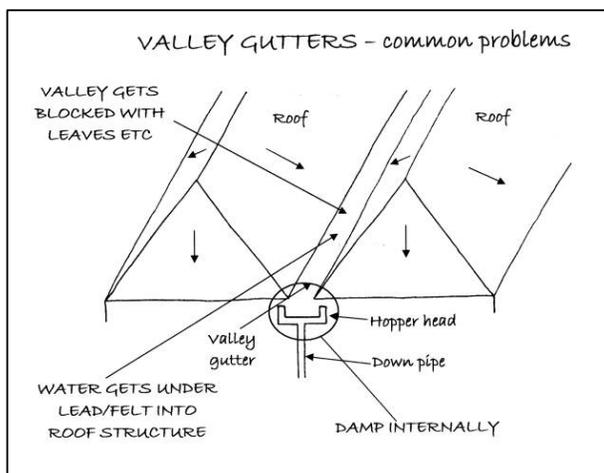
The front valley gutter is leaking. This looks to have been a problem for some time, as the lead valley has then been tarred. There are no obvious signs of splits in the leads, but these are often difficult to see when they have been tarred. Therefore, there may be defects in the lead, or alternatively, the leaves may have collected in the gutter and the valley gutter and built up and allowed water to pass around the valley gutter and into the roof.

Dampness from valley gutter

ACTION REQUIRED: We would recommend for this winter that a bitumen coating is added and redecoration takes place within the room. The warm interior of the property is likely to draw out more moisture during the winter months, if this is not significant then the problem has been resolved. It is a matter of clearing the gutter and keeping them clear more regularly.

If dampness does come in we would recommend the entirety of the valley gutter is removed and replaced with a lead valley gutter.

ANTICIPATED COST: In the region of £1,500 to £2,500, again because there is likely to be access scaffolding costs. Please obtain quotations.

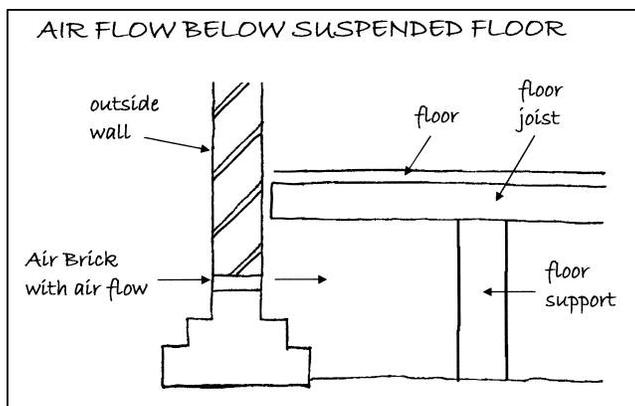
To the front of the kitchen the floor is a suspended timber floor. This requires an air flow underneath to help prevent wet rot. In this case rising damp was found in the wall, which in turn will cause dampness to the wooden floor beneath.

Checking for rising damp, Kitchen right hand internal wall

ACTION REQUIRED: It is very difficult to sort this problem out without major work. We recommend, as a helpful preventative measure, that additional air bricks are added externally and also internally a running vent is added.

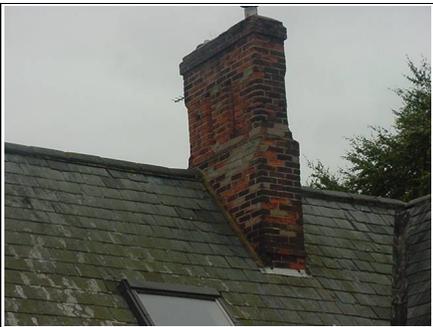
This substantial chimney is brick built with a cement flashing/partly lead, and one flue. From what we could see the chimney needs repointing and the flashing needs checking/replacing. We were unable to see the very top of the chimney know as the flaunchings, we therefore cannot comment upon it.

General view of chimney

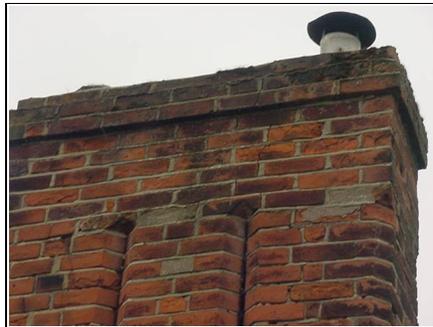
Close up of chimney.

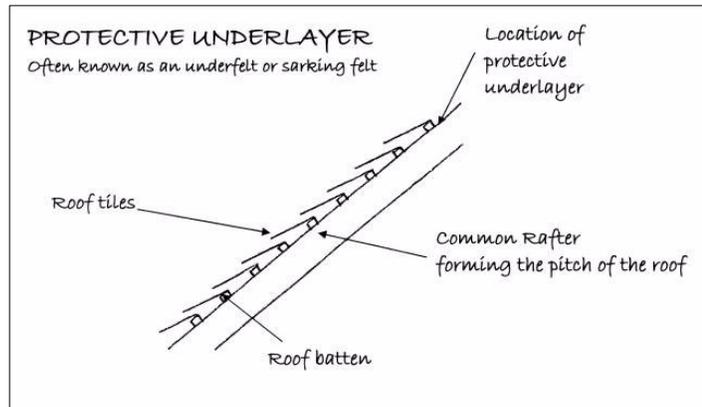
The roof does not have a protective underlayer. We could see the backs of the slates and daylight in some areas, when we were in the roof/attic space.

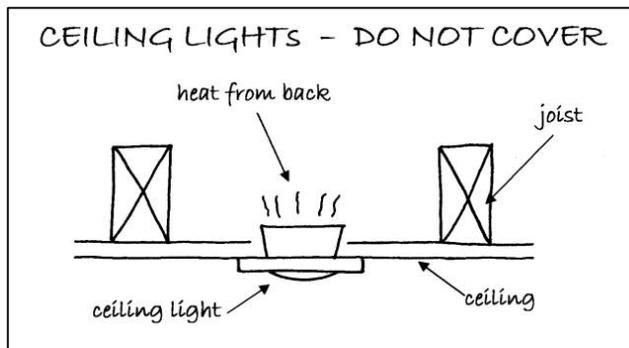
It looks like you have some classic 1970's lights. These were known for giving heat off the back and, in some cases, causing problems. We are aware of a fire that was once caused, whilst we were carrying out a survey on a pub, due to these lights. Whilst we are not suggesting that there is anything like that degree of problem, it is very much worth an electrician checking and replacing them for a newer light that does not give off as much heat.

1970's ceiling lights

ACTION REQUIRED: Replace old lighting fittings.

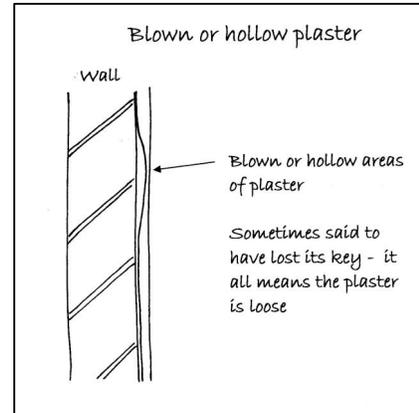
These are likely to be lath and plaster with a skim coat of gypsum plaster. We noticed an above average level of blown levels of plaster.

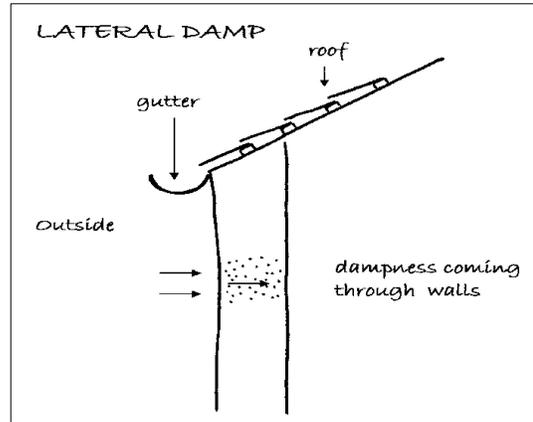
Tests were taken with a moisture meter at random points to internal walls, floors and other surfaces. Our readings were in line with what we would expect for this age of property, i.e. minor dampness. No evidence of any significant lateral dampness was detected, however, if the hairline cracking to the render is not dealt with then you will have lateral dampness and also if the gutters overflow there is likely to be some lateral dampness.

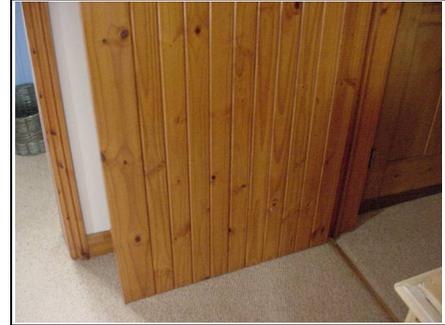
You have modern(ish) internal doors, which are to personal taste.

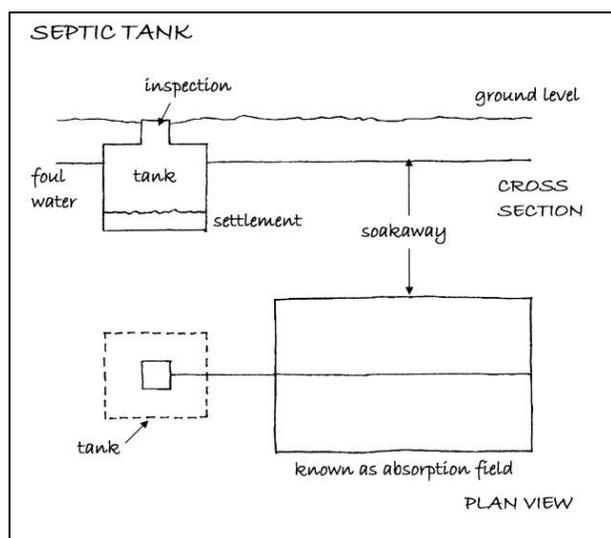
Septic tank

The cesspool was full at the time of our inspection and we have been unable to determine the size, construction or condition of the chamber: obviously the size of the chamber will determine the frequency of the required pumping out, which is, nowadays, a relatively costly operation. In some cases, cesspools have been provided with overflows, or some similar arrangement, designed to reduce the frequency of emptying.

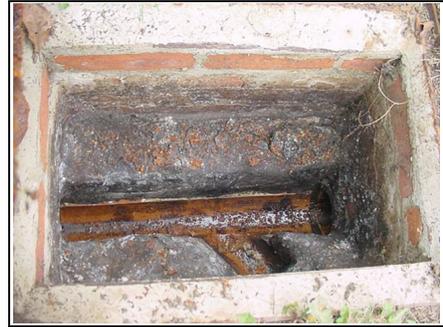
Manhole

We duly lifted the cover and found it to be free flowing at the time of our inspection.

From what we could see it is brick built.

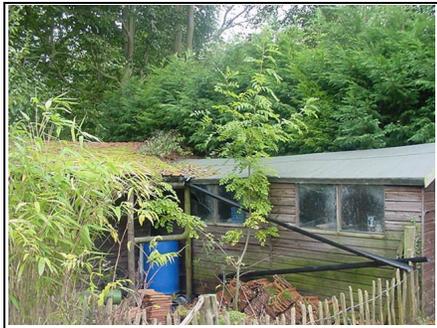
Sheds

As we discussed, the outbuildings are a useful space.
