RESIDENTIAL BUILDING SURVEY
OF
Swindon, SN2

FOR
Ms R

INDEPENDENT CHARTERED SURVEYORS

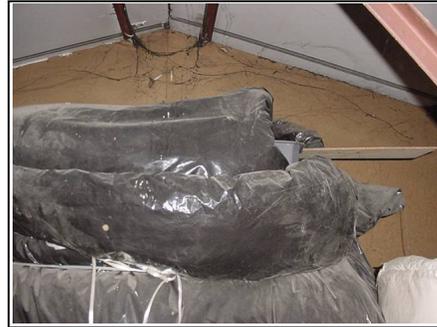
There is a modern water tank in the roof which we assume has been replaced in the last ten to twenty years. We were also pleased to see that it was insulated.

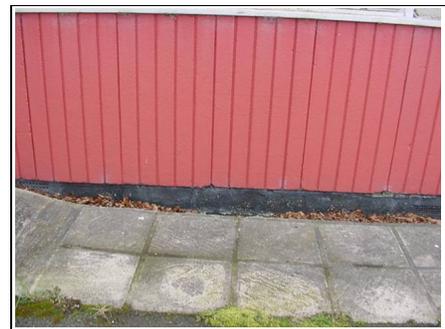
The type of cladding used is normally reinforced concrete. Without opening it up we cannot confirm this.

The high level panels from discussion with the local authority could either be concrete panels as mentioned or metal panels.

Concrete Panels to Wall

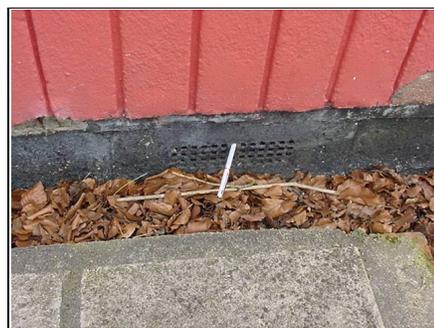
Airbricks are visible to this property, which is usually seen when suspended floors (although unfortunately we do not know what the floor structure is) have been used and that would be my thoughts in this case. However, without opening up the structure we cannot be certain of the structure or its condition.

ACTION REQUIRED: Please see our comments in the Executive Summary
