RESIDENTIAL BUILDING SURVEY

Tewkesbury,
Gloucestershire GL20

Mr & Mrs H

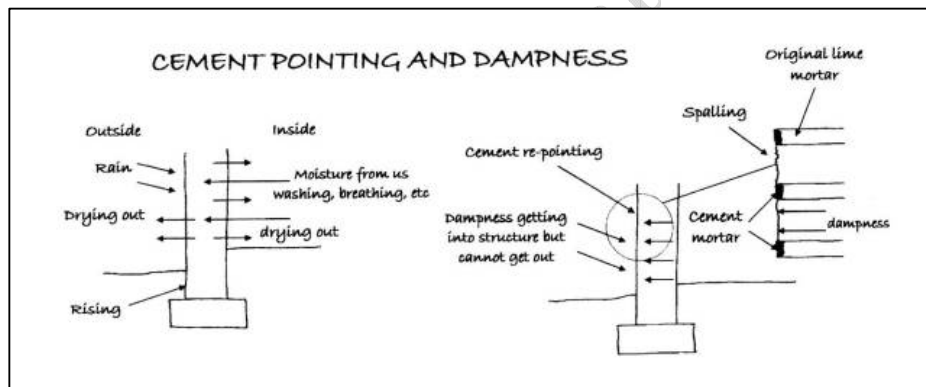
We can see that the face of the stonework is deteriorating. This we feel is due to the pointing being a cement mortar rather than a lime mortar and gutters leaking.

As we discussed with you, a lime mortar allows the property to breathe and gives a gortex type breathable structure, whereas a cement mortar has more of a raincoat type affect, causing the rain to deteriorate the stonework.

Deteriorating stonework

ACTION REQUIRED: Repoint all areas with a lime mortar rather than cement mortar.

ANTICIPATED COST: This is labour intensive work and likely to require scaffolding. You may be best off buying your own tower scaffolding. Costs in the region of £20,000 to £30,000. Care will have to be taken as this is a Listed building, as well as consultation with the Conservation Officer. Please obtain quotations.

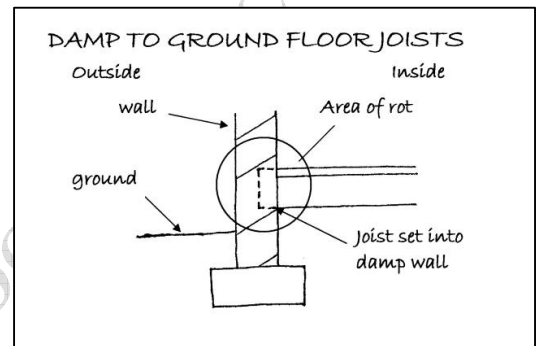
Part of the property has a timber frame structure which we feel is in need of repair, for example to the cellar area and the dining room above and the middle bedroom, all of which show wet rot defects and woodworm defects. It is also likely to be due in part to the embedded timbers, as shown in the sketch.

Timber frame structure

We believe we could see some active woodworm to the gable end, although this is very difficult to comment on as it was at high level.

As the building is Listed the work will have to be carried out with the Conservation Officer's approval. We feel there is a lot of cement mortar that can be removed from the property with effect that there will always be some wet rot and woodworm discovered in the timber frame structure as the repointing is carried out which will need repair.

ACTION REQUIRED: General repairs and repointing in a lime mortar and timber repairs as necessary.

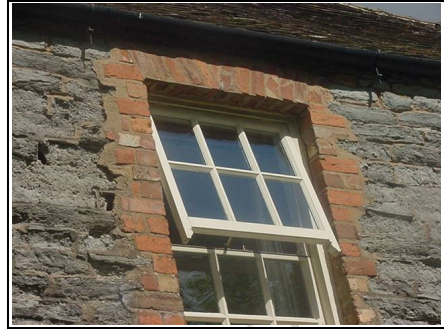
There are relatively new double glazed windows in the building. Double glazing generally requires consent, particularly in a Listed building. We discussed this with the owner who did not think (did not know if) they had Conservation Approval / Listed Building Consent, which normally means they do not have. He advised that the windows followed the pattern of the original windows. You can see, for example, the sliding sash opposite has a modern opening casement style.

Double glazed windows
- sliding sash look with a modern sash style

ACTION REQUIRED: We feel it is best you discuss the double glazed windows with the Conservation officers as soon as possible and voice concerns that they are double glazed. In many cases Listed Building Officers will not require you to do anything, however this is down to the Listed Building Officer in question.

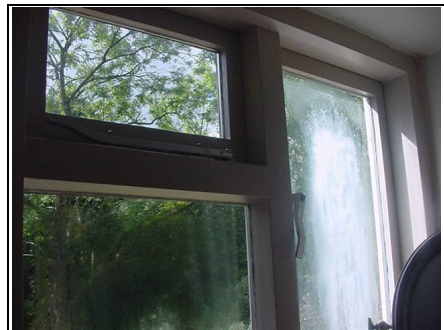
On a technical point of view some of the double glazed units are missing up. This is often due to movement in the structure which double glazing cannot accommodate.

ACTION REQUIRED: You will have to replace the double glazed units

ANTICIPATED COST: Set aside the sum of £10,000 for dealing with the worst case scenario with the Conservation Officer. They may have photographic records of how the windows were and wish you to replace them as this standard. This would be a liability in the tens of thousands.

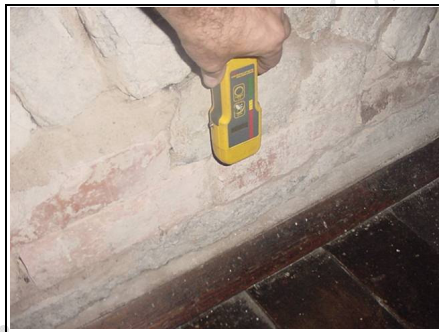
We are finding high levels of dampness. Whilst this is partly to do with the cement mortar it is also in part to do with the high ground levels around the property which we recommend are lowered and ideally a French drain is added (subject to Conservations Officer's approval), discharging into the septic tank.

Finding rising damp

ANTICIPATED COST: Set aside the sum of £10,000 to £20,000 for general making watertight repairs; please obtain quotations.

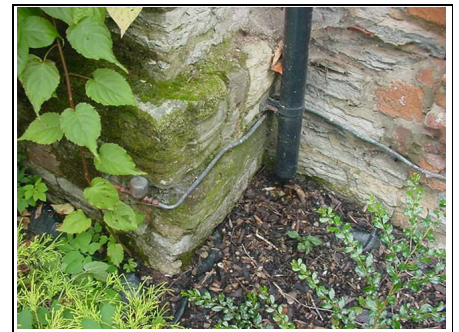
Water discharging against the property

ACTION REQUIRED: In all properties it is very important to ensure that dampness does not get into them. In this case you have dampness coming in at high level via the gutters and downpipes and in some areas the roof detailing with cement flashing. In other areas you have rising damp due to the ground level being too high and downpipes discharging against the property.

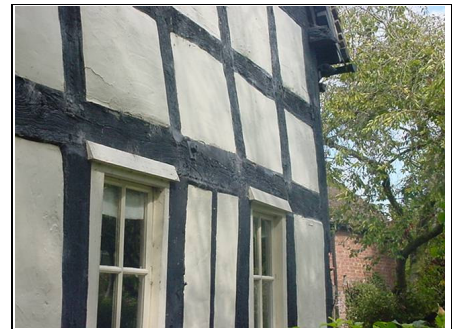
10.2 Right hand wall

To the right we can see that the wall is bowing in the main building on the right hand wall.

Bowing in right hand gable

ACTION REQUIRED: We recommend the existing owners place insurance claims, advising that a building survey was recently carried out and it identified the items above and insist that monitoring for movement is carried out on the property.

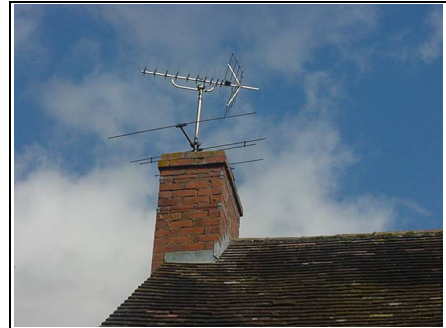
Front left hand chimney

This chimney is brick built with a lead flashing. We are unable to see the top of the chimney known as the flaunchings, we therefore cannot comment on its condition. However we did note cracking and movement in the chimney breast externally. This can also be seen internally.

ACTION REQUIRED: Please see our comments in the Executive Summary with regard to an insurance claim being required due to the movement that is occurring.

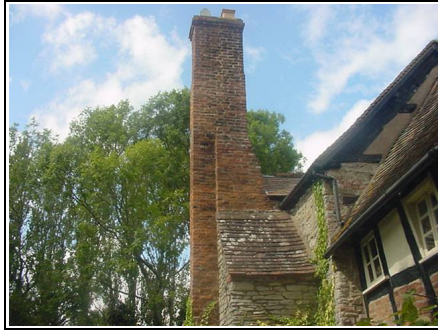
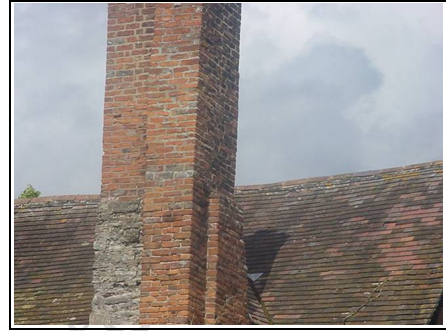
Middle chimney

This is a substantial stone and brick chimney. It looks to have been rebuilt and repaired over the years.

ACTION REQUIRED: It generally needs some ad hoc repointing. It also needs the flashing checked to the rear of it.

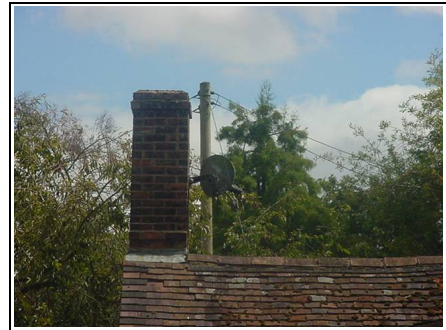
Rear chimney

This is located to the rear of the property on the single storey extension which incorporates the cloakroom. It is brick built with no chimney pots and a lead flashing. The flashing was slightly unusual as we would expect it to go higher. We also noticed some undulation in the roof, meaning there may be some movement in this chimney. We were unable to check to see if this chimney was present at lower level.

ACTION REQUIRED AND ANTICIPATED COST: We would set aside the sum of £1,000 to check if this chimney is present at lower level and/or remove the chimney or add a structural support in.

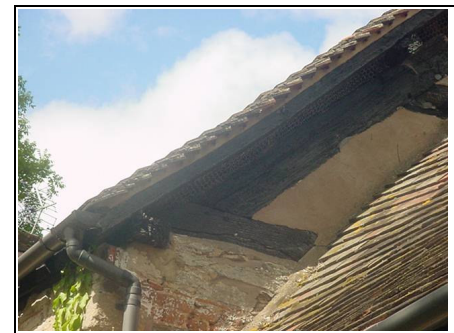
Upstand in roof

There is an upstand in the roof where there is dampness coming in. You can literally see chicken wire in the gap in the roof. We have spoken elsewhere within this report about adding more loft access, this would then allow you to gain access to this area and to be able view the problem better. Our view was very limited.

ACTION REQUIRED: Close gap in upstand.

ANTICIPATED COST: We would set aside the sum of £1,000 to £2,000 for general repairs to close gap in upstand.

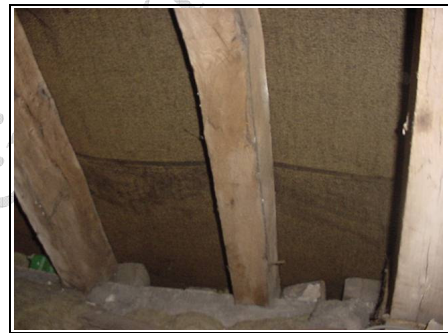
When we inspected the loft space we found a Hessian base Bitumen membrane. This type of membrane has been used since the 1960s. We generally found it to be in average condition, it is damaged in a few places but this is not unusual considering its age.

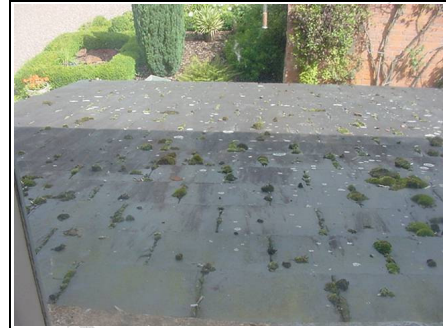
Roof over sun lounge

This is a relatively shallow pitched with has moss sitting on it, which we often find is the case with a shallow pitched roof.

ACTION REQUIRED: Clear moss, making sure you do not damage the roof.

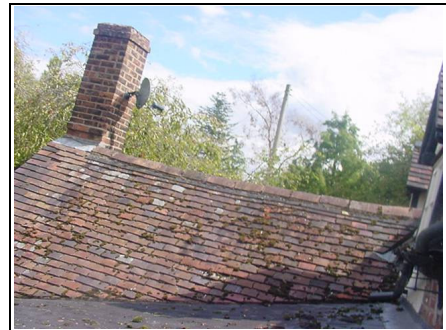
Roof over cloakroom

Our comments are very similar to the main roof. There does look to have been some movement around the chimney area. Please note our comments with regard to work needed on this chimney. It does look like there have been repairs around the chimney fairly recently.

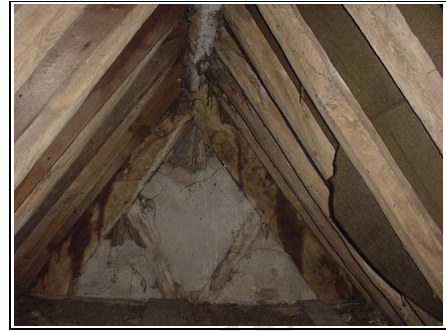
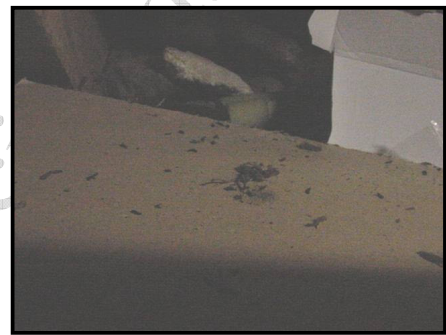
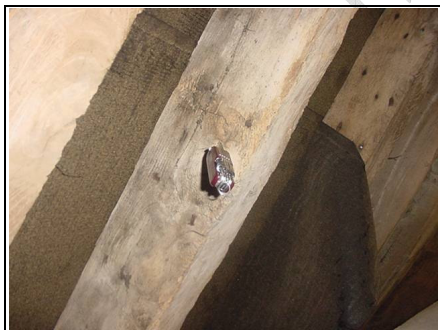
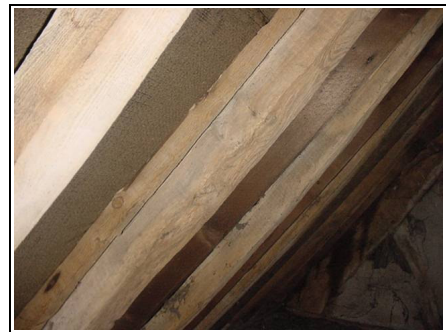
Our examination was limited by the general configuration of the roof, the insulation and the water tank. What we could see was that there was woodworm and some damp/condensation in the roof. The roof is in average to slightly below average condition for its age, type and style. It is, however, feasible that there are problems in the roof that are hidden.

Mouse droppings or possibly carcasses of the woodworm

Knife test for softness

Some of the timbers have had new timbers put back to back, known as back to backing, to add strength

ACTION REQUIRED: The only way to be 100 per cent certain is to have the roof cleared and checked.

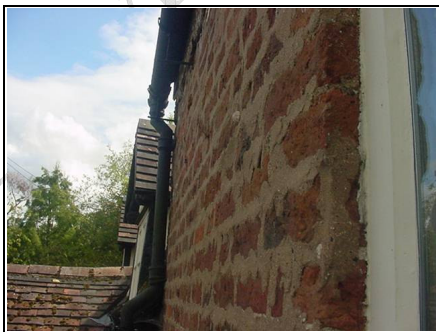
Old brickwork to rear

There is some older brickwork to the rear of the property. We can see there was just some render remaining above the top of the older brickwork. Again it appears to be suffering from being poorly pointed.

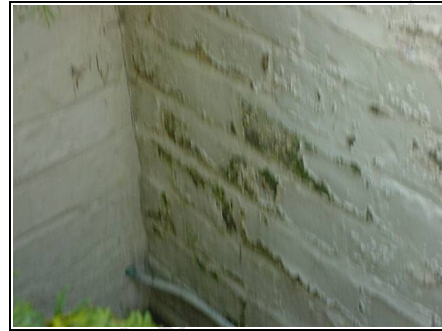
Brickwork around cloakroom

The sun room brickwork is in reasonable condition, whilst the brickwork around the cloakroom area is suffering from dampness. This area is very close to the well and this may relate to how water is being brought into the property.

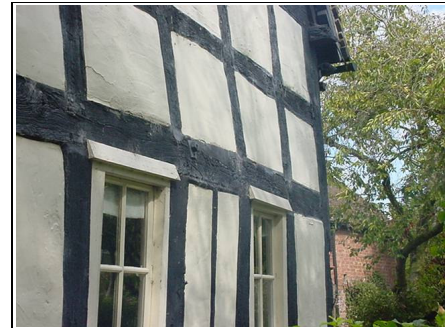
There is bowing to the to right hand gable.

Bowing to right hand gable

ACTION REQUIRED: Please see our comments in Executive Summary.

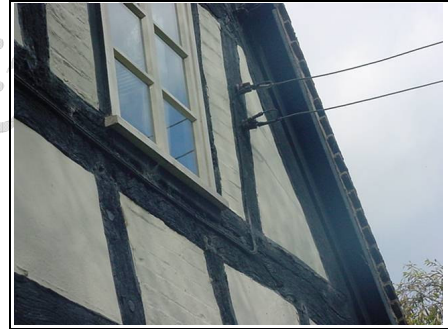
Timber fascias and soffits

Given the damage we can see from the water discharging down some parts of the walls there is likely to be some deterioration them.

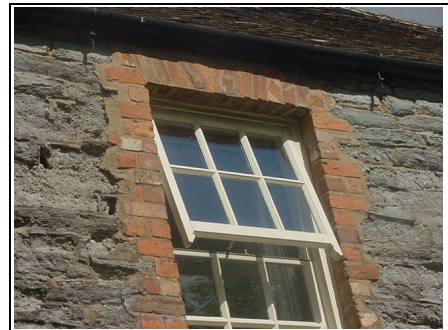
Double glazed windows

Quite surprisingly the property has modern double glazed sliding sash style windows, (as can be seen in the photo – they did not actually side they opened).

We would refer you to the Appendices where we have put some of the historic window guidance that Tewkesbury Council Conservation Department provide. We do not think they will be very happy with the windows but are unsure of what action, if any, they will take, but it certainly needs to be brought to their attention before your purchase the property to establish the associated risk with it.

If you do look to develop the property then they may have requirements of bringing this back to a more appropriate style.

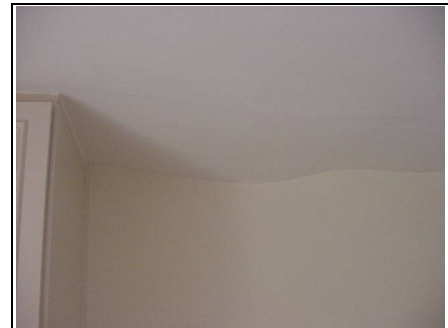
2. The general undulation in the ceiling we feel is due to a defective lath and plaster ceiling which has lost its key and is the reason why we did not walk in the main ceilings. It could also relate to movement on the gable end, which we talk about in the Ugly Section of this report.

We did not gain access to the roof over the left hand room as we were not certain that the ceiling could hold our body weight. We can however see the undulation in the ceiling and it is also adjacent to the chimney that shows signs of movement on the left hand side and they are likely to be inter-related.

Dip in master bedroom ceiling

ACTION REQUIRED: We feel that some opening up of the ceilings will be necessary to check the condition. To this end we would recommend additional loft hatch openings are added to the roof. This will also benefit any future inspection. We would also recommend the roof is lit throughout (and a good fire alarm system is also added in the roof).

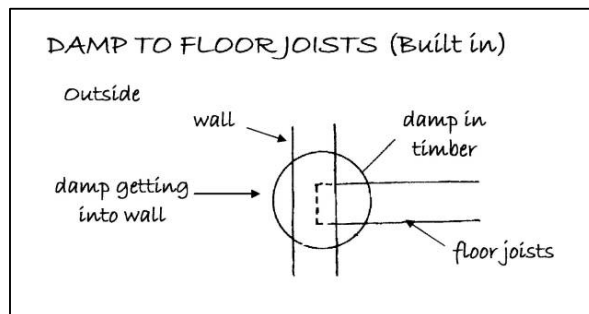
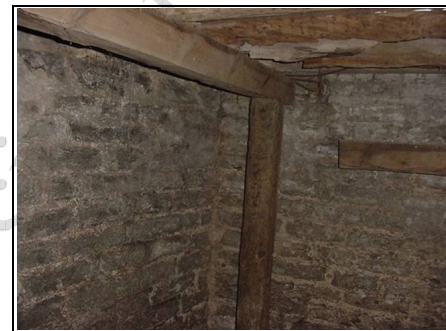
We have assumed that the ground floor construction is tiles on earth. Where it goes over the cellar it is a joist and floorboard construction with embedded timbers. These timbers have been in addition propped in place. However, we have not opened up the floors or lifted the carpets.

Long term additional support in cellar area to ground floor with dining room above

ACTION REQUIRED: We would recommend, particularly given the amount of deflection in the floor of the dining room that new props are added. Probably the best way to do it on old property such as this is to add in new props without removing existing timbers and carry out the general drying out and improvement measures that we have mentioned externally to improve the environment.

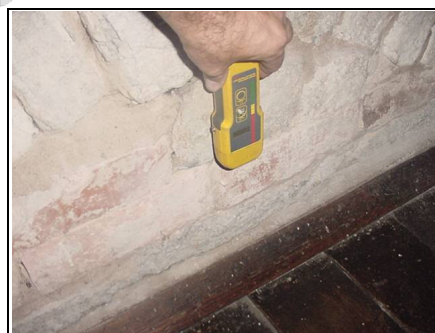
A random visual inspection and tests with a moisture meter have been taken to the perimeter walls and some internal walls. We found dampness throughout the property, please see our comments in the Executive Summary.

Finding rising damp

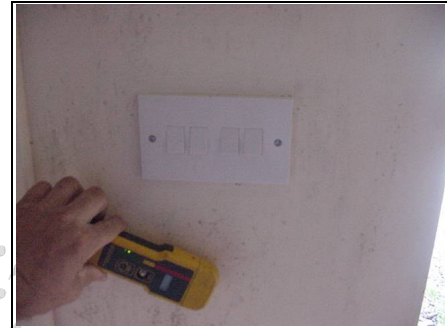
Again, we found dampness in various parts throughout the property. Please see our comments in the Executive Summary.

Checking for lateral dampness

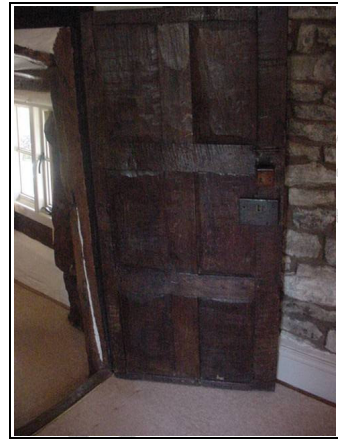
Very old door between walk through middle bedroom and landing area

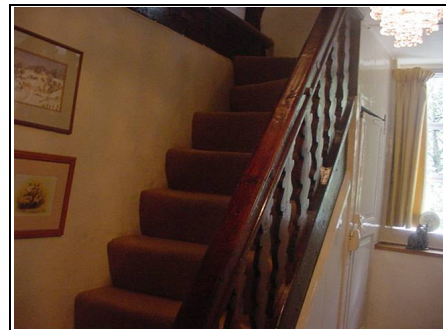
Stairs adjacent to kitchen

There are two staircases; both are straight runs and both are fairly old. The staircase near the kitchen we are advised is of special interest. This is often noted in the Listed Building Reference. Unfortunately we have been unable to find this so we cannot comment further.

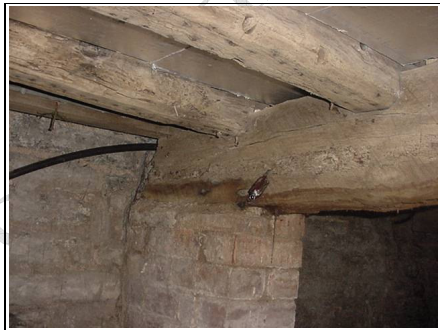
The cellar has been propped up with timbers from many years ago. We found extensive wet rot in the timbers.

Dampness in timber – knife test into damp spine beam

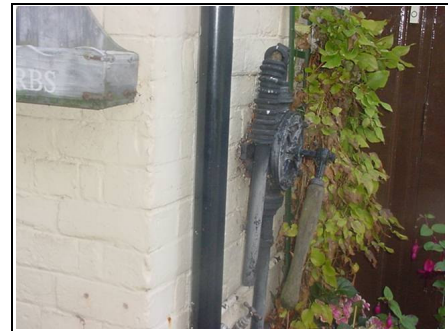
Any good old property, particularly of this age, will have its own well. We are advised that the building had almost been built over the top of it. We have not physically seen the well and we would refer to our comments with regard to the dampness in the painted wall nearby.

Electric pump from well
(although old pump remains)

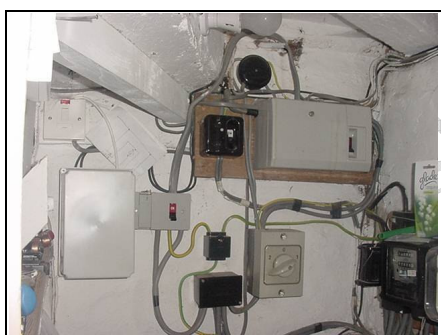
The electrics located underneath the staircase adjacent to the kitchen. The fuse board looked dated.

Electrics and generator switch

ACTION REQUIRED: Ideally replace the fuseboard.

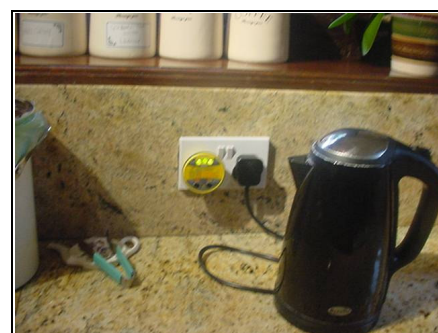
We carried out an earth test in the kitchen area to the socket point that is normally used for the kettle, this proved satisfactory.

Earth test in kitchen

ACTION REQUIRED: As the property is changing occupancy an IEE report should be carried out by a NICEIC registered and approved electrical contractor.

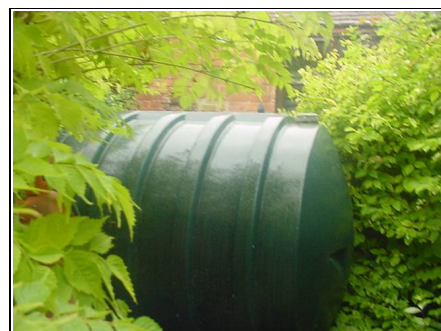
We are advised that the property has oil heating. We were pleased to see that the oil tanks are plastic. These usually replace the older metal tanks that can rust and they typically have a double lining, meaning that if they leak they leak into the outer lining.

Plastic oil tank

All appliances, pipework and flues should be subject to an annual service by a competent OFTEC registered engineer. Unless evidence can be provided to confirm that there has been annual servicing, we would recommend that you commission such a service prior to use to ensure safe and efficient operation.

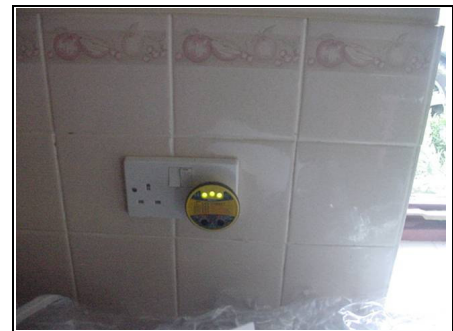
Earth test in kitchen

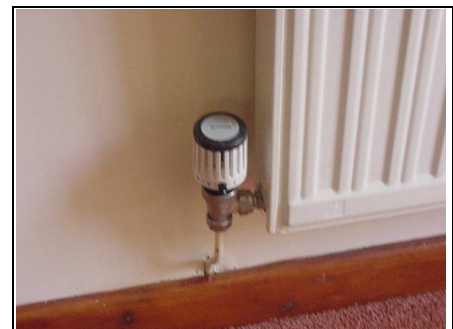
We noted it had a Worcester boiler. This was not tested. This leads to microbore pipes which we are not keen on as they tend to block.

Earth test in kitchen

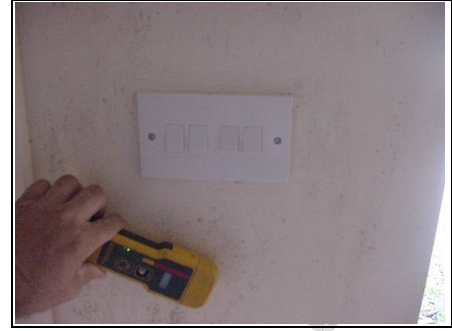
We noticed some dampness visible which we spoke to the owner about. We were advised that during the cold weather when it was recently empty a pipe burst which is why it is newly carpeted in the property.

Finding lateral dampness

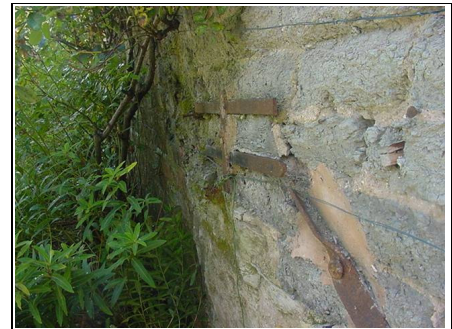
2. The bowing that can be seen to the rear wall. There looked to be signs of old metal braces to the front wall and the general poor condition of the stonework and the lack of even a gutter.

Bracing to wall

ACTION REQUIRED: To the barn major work needs to take place. As recommended in the Executive Summary we would report this to the insurance company. We consider this in very poor condition.

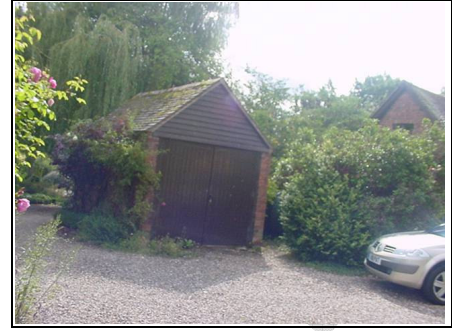
Garage

We have viewed the garage externally only.
