RESIDENTIAL BUILDING SURVEY
OF
**A Terraced Victorian Property, Tilbrook,
Cambridgeshire**

Mr.T

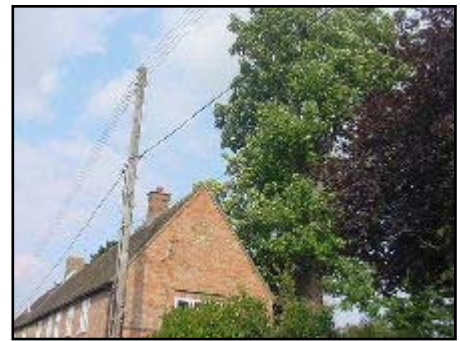
You need to, in our opinion lop the trees; they are too high and will cause further structural movement to the property.

There are physical cracks visible to the layperson on the property. This will mean that future purchasers will often look for discount. There is visible movement to the rear and also internally and also to the front right hand corner. We feel that the contributing factors are the trees and the rainwater discharging directly into the ground.

ACTION REQUIRED: Consult an arboriculturist (not a tree surgeon) and also be aware that the cracks in the property would put many people off. We also feel that the rainwater downpipes contributing to the problems in this area.

ANTICIPATED COST: In the region of £500 to £1,000 we suggest you get a quotation. Further more we would recommend that the work be carried out before you purchase the property from the existing owner.

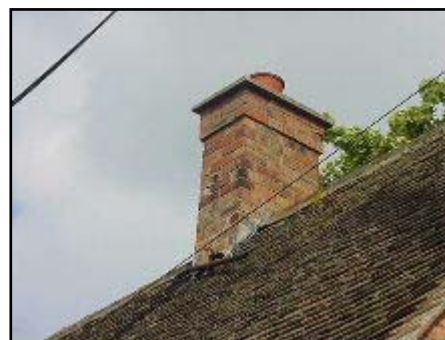
This chimney is brick finished with a lead flashing and one chimney pot. From what we could see from ground level it looked in reasonable condition considering its age.

Unfortunately we were unable to see the top of the chimney known as the flaunching, we therefore cannot comment upon it.

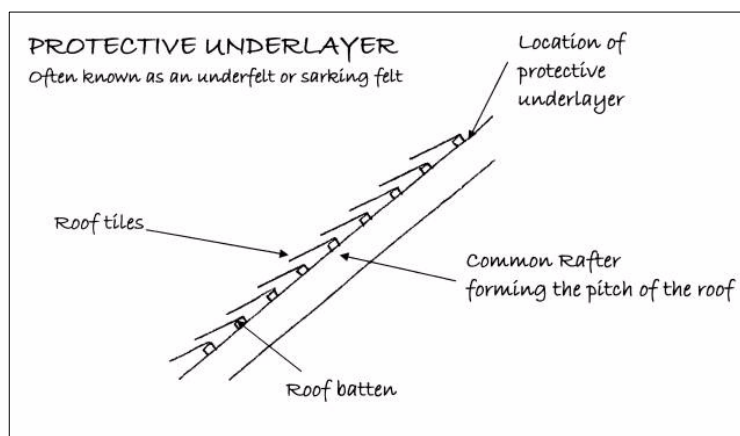
When we inspected the loft space we found a Hessian base Bitumen membrane. This type of membrane has been used since the 1960s. We generally found it to be in average condition, it is damaged in a few places but this is not unusual considering its age.

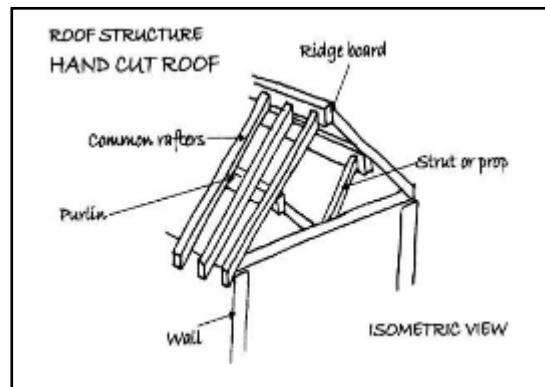
We have inspected the roof for serious active woodworm and found some and also inspected a structurally significant defect to the timber together with dry rot and wet rot. We found condensation staining to the roof indicating that it needs venting.

In this instance we would recommend that the roof be vented, as condensation staining is visible internally. When the property was built ventilation was not a requirement. However, now, where there is a protective under layer and insulation to a roof, cross ventilation is now recommended and required under the current Building Regulations. This is to stop condensation occurring within the roof, which can affect the timbers and also cause dampness.

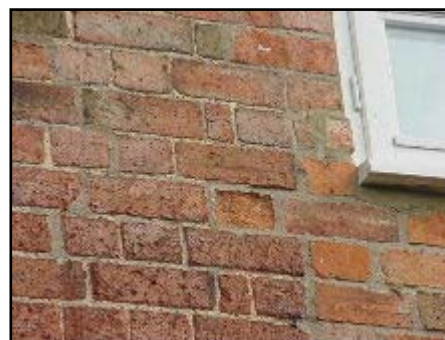
Re-pointed English Bond

This property is brick finished and laid in a lime mortar, which in turn has been "repaired" with cement mortar. This is bedded in what is known as English Bond, which was most commonly used in the early 1800's.

Unfortunately the re-pointing, whilst well meaning, is not appropriate for this type of construction. You are lucky that it is not throughout the entirety of the property. A cement mortar has been used rather than a lime based mortar – remember the phrase “lime every time”. We recommend you use lime mortar in any future repairs regardless of what the builders say! Using lime mortar will limit further damage to the brickwork, which is almost impossible to repair successfully. However, we would add that many, if not most, of the properties that are re-pointed are re-pointed wrongly; it is only in recent years that we have discovered the problems that can occur from it.

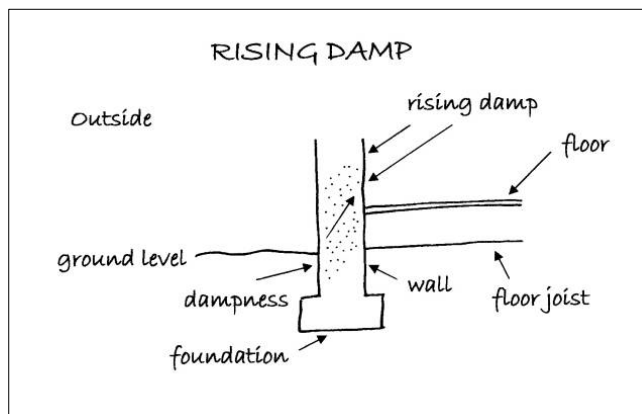
A random visual inspection and tests with a moisture meter have been taken to the perimeter walls and some internal walls. The readings we obtained indicated that there is a lot of dampness in the property.

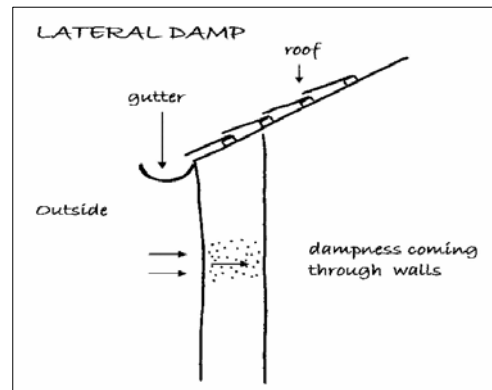
Tests were taken with a moisture meter at random points to internal and perimeter walls. We did find some areas of damp.

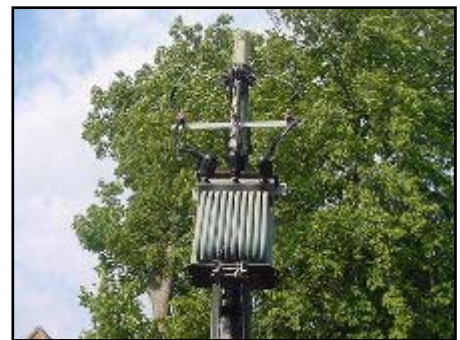
Electric Pylon

There is an electricity pylon within fifty meters of the property. Concerns have recently been expressed with regard to health risks in connection with the above average electro-magnetic fields. Whilst health risks have not been proved some purchaser may be deterred.

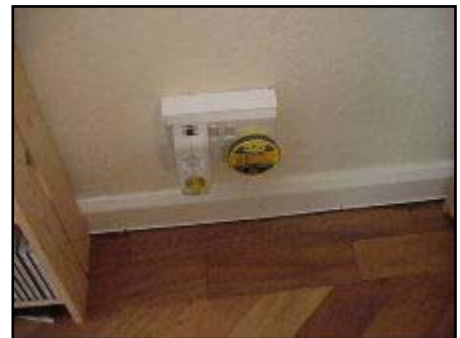
An electric test was carried out. As you are aware this caused the circuit board to switch the electrics off. Whilst the electric circuit board was relatively new there is definitely a fault on the system.

ACTION REQUIRED: Check the electrics.

If there is no record of an electrical test having been undertaken within the last five years, it is recommended that the installation be tested by a competent electrician (NICEIC registered) and all recommendations implemented. Thereafter, the installation should be re-tested every five years.

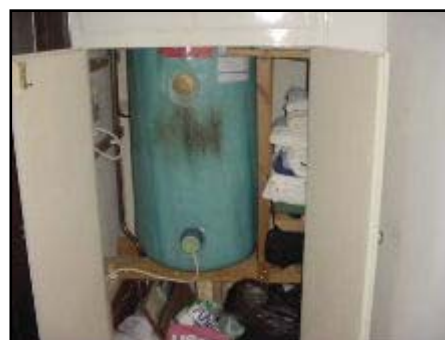
Hot Water Cylinder

The hot water cylinder is relatively new (in this case we mean passed 30 years) as it is factory lagged.

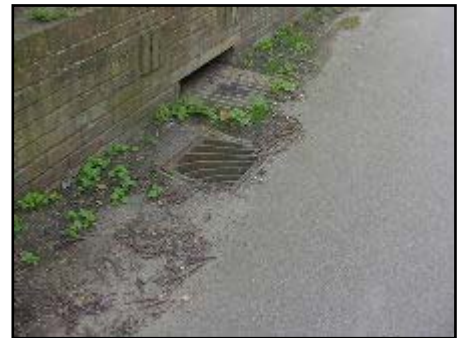
Rear Garden

There is a patio area, which needs minimal gardening!
