RESIDENTIAL BUILDING SURVEY

Bedfordshire

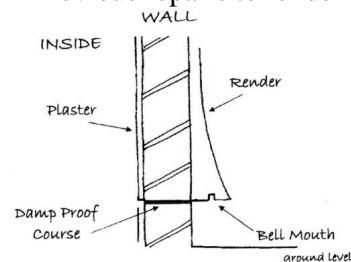
Previous repairs to render

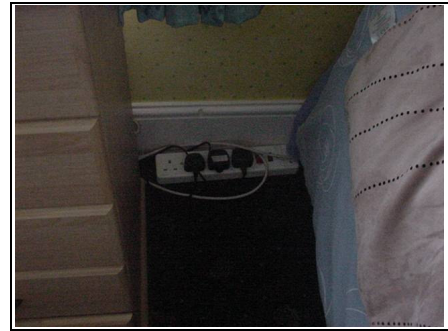
Electrics

You may need to add more socket points.

ACTION REQUIRED: As the property is changing occupancy the Institute of Electrical Engineers (IEE) recommend an NICEIC (or equivalent) registered and approved electrical contractor carry out an inspection, test and report.

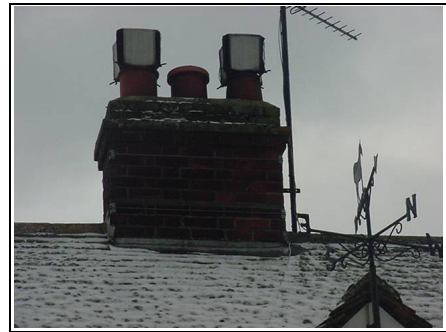
Chimney one

This chimney is brick finished with a metal flashing (usually lead or zinc) and three chimney pots. From what we could see it looks to be in average condition for a chimney of this age. Unfortunately we were unable to see the very top of the chimney known as the flaunching, we therefore cannot comment upon it. However we would recommend a close up check

ACTION REQUIRED: Carry out minor repairs, ideally within the next two to three years.

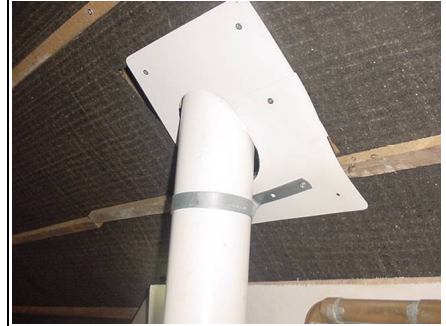
The property has a plastic flue which is for the boiler located in the roof (it should be remembered that you have to give safe access to the boiler in the roof).

Internal view of Flue

ACTION REQUIRED: We can see nothing obvious. We suggest that it is checked next time high level work is being carried out such as the roof repairs we have mentioned.

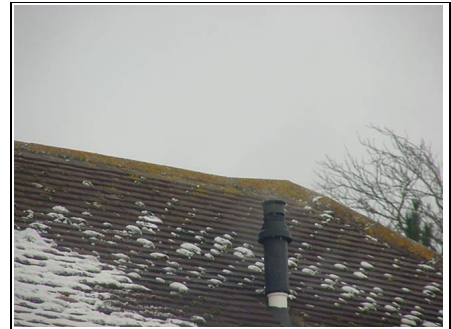
External view of Flue

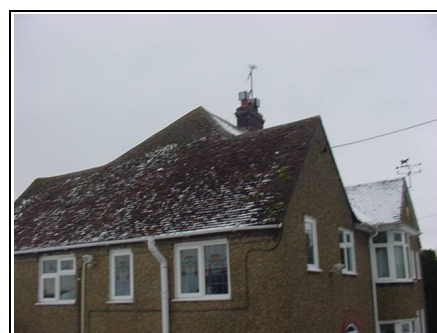
The roof is pitched and clad with a small clay tile and, from ground level this looks in below average condition. There is a mixture of types and/or ages of tiles. From what we can see in the roof with the plastic felt this property has been re-roofed in the 1970's re-using the old tiles mixing in some newer tiles. The surface of the tiles it now deteriorating which is why we can see moss sitting on parts of the roof and therefore a further overhaul is required.

General view of roof

ACTION REQUIRED: An overhaul of the roof is required. It was fairly difficult to be precise due to the snow sitting on the roof. We do feel a roofer spending a few days overhauling the roof and replacing tiles will extend the life of the roof. Please see our comments in the Executive Summary.

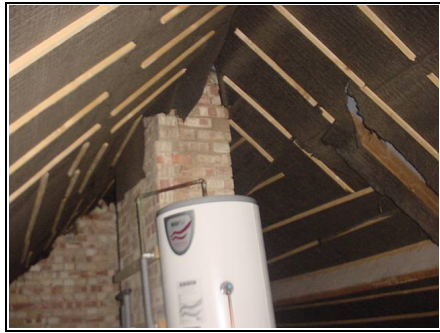
The main property has a plastic underlayer, this was popular in the 1970s and 1980s. It tends not to be used today as it was also common that it sweated therefore dampness occurred in the roof. This is probably why it has been felted a second time with an additional reinforced bitumen felt roof. Ideally this plastic should be removed and replaced with a breathable layer which is the current practice. This would involve complete re-roofing of the property.

Outer hessian underlayer in left hand roof space

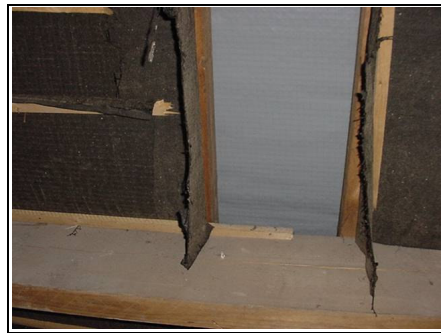
The grey area is the plastic underlayer left hand side

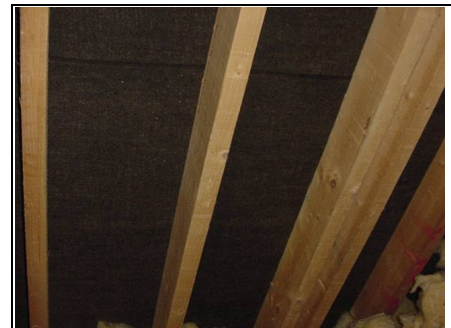
Right hand roof

This is the extension roof where a reinforced hessian was found.

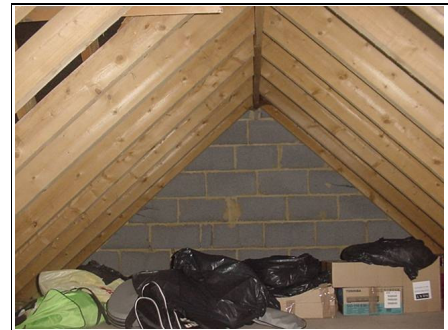
Right hand roof

Our examination is limited by the general configuration of the roof, the insulation and stored items, as mentioned what we could see was generally found to be in an average condition considering its age. It is, however, feasible that there are problems in the roof that are hidden.

ACTION REQUIRED: The only way to be 100 per cent certain is to have the roof cleared and checked.

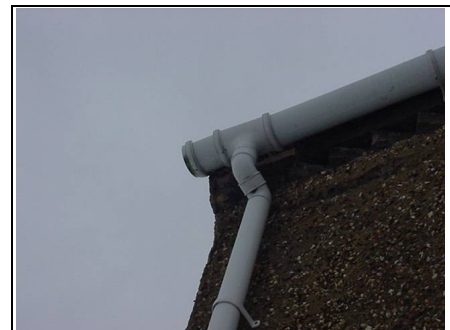
Gutters and downpipes

Generally they appear in average condition with the exception of one area where we could see plants growing out of it.

ACTION REQUIRED: We would always recommend that the gutters and downpipes are cleaned out, the joints are checked and the alignment checked to ensure that the gutters fall towards the downpipes.

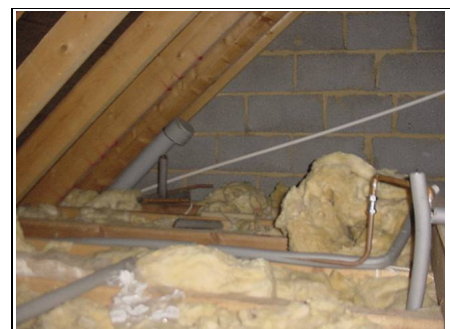
You have both traditional soil and vent pipes on the left hand side of the building and an air inlet valve to the right hand side within the roof. There is a part of the soil and vent pipe which has a minimal fall which is not ideal.

Soil and vent pipe on right hand side and air inlet valve

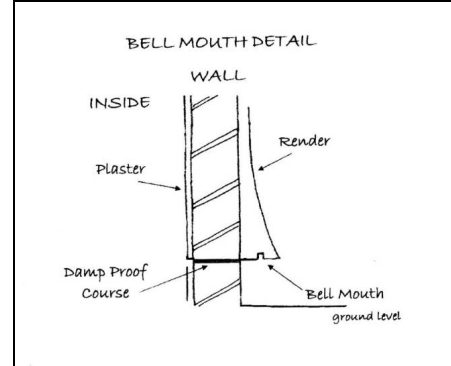
A way of telling the quality of the render, we have found over the years, is by the quality of the render detailing. In this instance the older render which is suffering from hairline cracking and general defects has better detailing with drips over the windows which both the old and the new render suffer mainly from not having a bell mouth detail although we can see some areas of the old render where the bell mouth detail is present.

ACTION REQUIRED: Form details to the render such as drips over windows and bell mouths to the base of the render to stop dampness from getting in. We feel this is a contributory factor towards the dampness that we found internally.

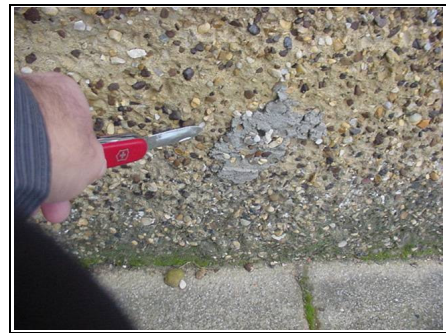
All modern properties should incorporate a damp proof course (DPC) and good building practice dictates that a differential of 150mm (6 inches) should be maintained between the damp proof course and ground levels. In this case, unfortunately we can't see a DPC to the property because of the render. We did find dampness in the property - it is likely to be due to render bridging the damp proof course if it's there or capillary attraction in the render drawing in dampness. If you look at the photo we did see one area where it looked like a damp proof course had been inserted, in which case they need calling back as it certainly isn't working.

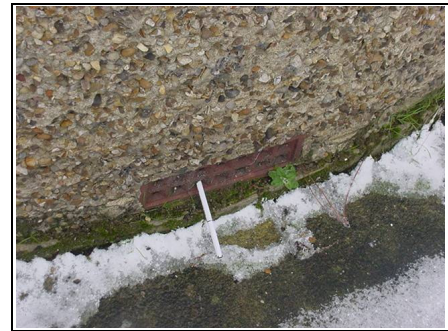
Airbrick

Some air bricks are acting as gutters, this can cause dampness and rot to the floors so they need protecting.

ACTION REQUIRED: We recommend bricks are bedded around the air bricks to stop water getting into them in the first instance although we have recommended French Drains around the property.

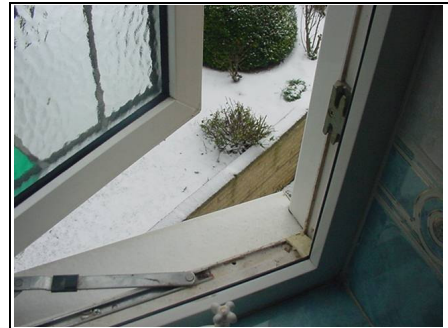
Plastic windows

The property has double glazed windows which we were advised were installed when there was general upgrading to the property so they will be out of the usual ten year warranty. We would say that they are from the cheaper end of the market as we can't see trickle vents on them and we would also say that as their ten year life has passed that they will now start to become susceptible to the units deteriorating.

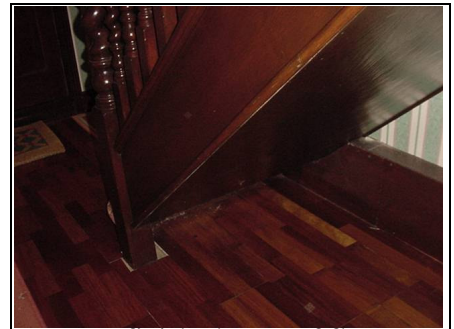
The ground floor construction is still a mystery to us. From the airbricks outside and the general age of property we would expect to find a suspended timber floor however due to the woodblocks internally and the carpet, etc. we have not been able to confirm this. We have expressed our thoughts that we believe the floor is probably predominately a timber floor although it is not out of the question it could have been replaced by concrete. This type of floor needs air circulation under it to reduce deterioration from wet rot and dry rot which we simply can't see enough airbricks; please see our comments in these sections.

Unfinished parts of floor

ACTION REQUIRED: The only option is to take up a section of the floor to check its condition.

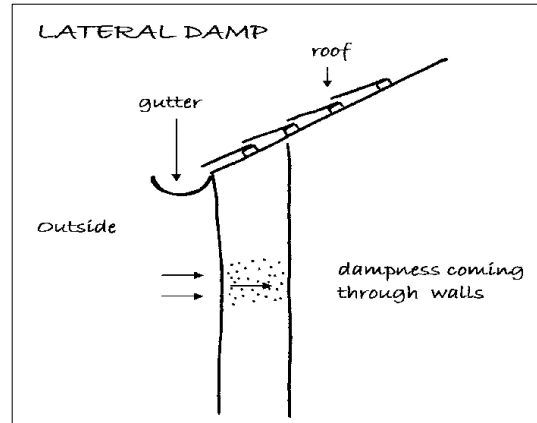
The readings we obtained indicated that there was some lateral dampness in the property. It is not surprising when you see the amount of cracks to the render particularly the hairline cracking.

ACTION REQUIRED: A programme of repairs and replacement to the render is required during the Summer of 2011.

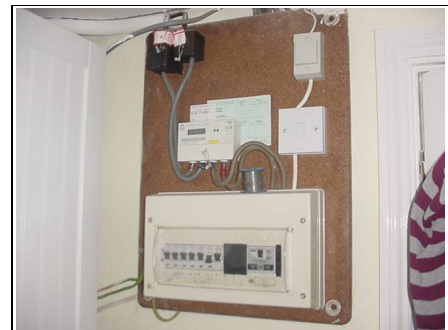
Fuse board

The electric fuses and consumer units were located in the kitchen. We would date the fuse board as being from the 1980s/1990s and, whilst not the best now available, it is reasonable.

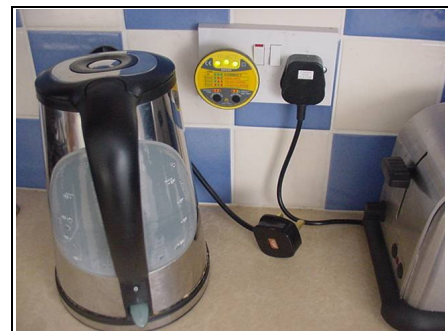
Earth test

We carried out an earth test in the kitchen area to the socket point that is normally used for the kettle and this proved satisfactory.

Neither of these indicators can give certainty as to the condition of the rest of the wiring

ACTION REQUIRED: If there is no record of an electrical test having been undertaken within the last five years, it is recommended that the installation be tested by a competent electrician (NICEIC registered) and all recommendations implemented. Thereafter, the installation should be re-tested every five years.
