RESIDENTIAL BUILDING SURVEY

A 1980's Detached Property, Tring, Hertfordshire, HP23

Mr L

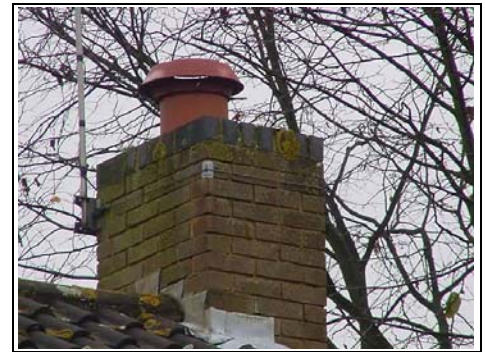
Front of chimney

This property has one chimney, which is located to the right hand side. The chimney is brick finished with one chimney pot with lead flashings. From what we could see the chimney looks in average condition; there may be some minor repointing required in three to five years time. Unfortunately we were unable to see the top of the chimney known as the flaunchings we therefore cannot comment upon them.

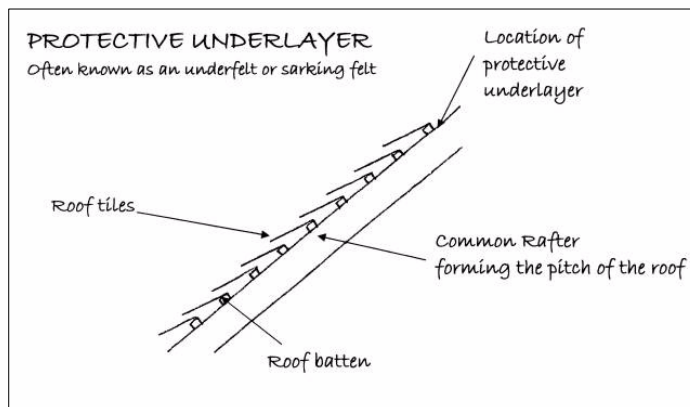
When we inspected the loft space we found a Hessian base Bitumen membrane. This type of membrane has been used since the 1960s. We generally found it to be in average condition with damage in some areas.

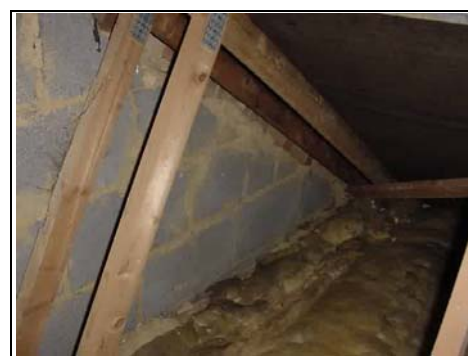
Our examination was limited by the general configuration of the roof and the insulation. What we could see was generally found to be in average condition. We believe that in the summer months some minor condensation could occur; ideally the roof should be vented, please see our comments below. It is feasible that there are problems in the roof that are hidden.

ACTION REQUIRED: The only way to be 100 per cent certain is to have the roof cleared and checked.

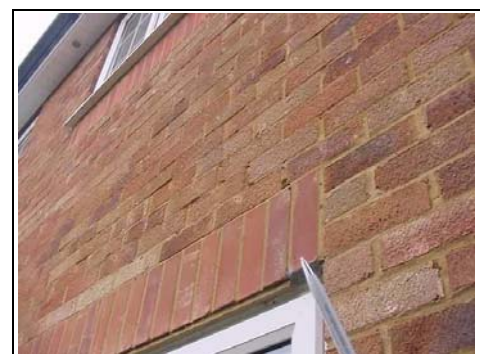
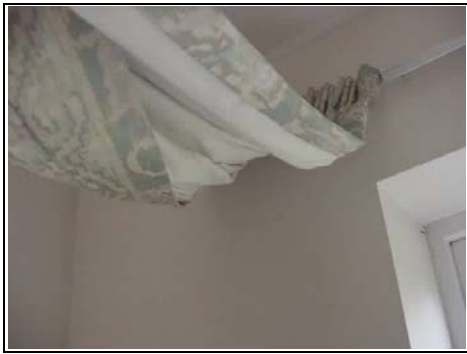
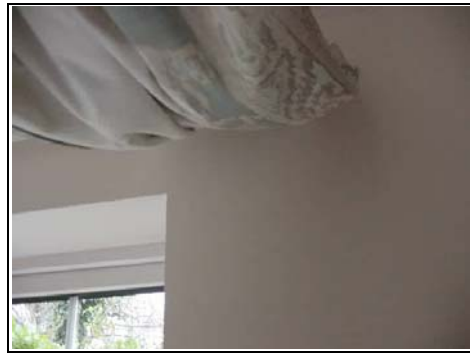
Step Cracking

To the front right hand side of the property there is hairline stepped cracking visible in the mortar both above and below the ground floor window, running for approximately one to one and half meters in length. These cracks appear to be long standing but from a one-off inspection it is not possible to be 100% certain. Normally insurance companies require monitoring for approximately one year, as recommended by the Building Research Establishment (BRE).

We have inspected the inside for similar cracks but found, due to the dry lining that has been used in the construction, that it was not possible for us to inspect the actual wall structure in this area. We have also inspected the rear of the property for similar cracks and the side, although our view was limited, and we could not see any similar cracks. We have also inspected the rooms above and the roof space, none of which show signs of significant movement.

Inspecting for cracking to the inside of the property, opposite the right hand corner.

ACTION REQUIRED: We would therefore recommend, and have agreed this with the owners / vendors, that an insurance claim is made by themselves with their insurer, Legal and General, and that the purchasers utilise the services of the same insurance company. If you would like any further clarification on this matter please do not hesitate to contact us.

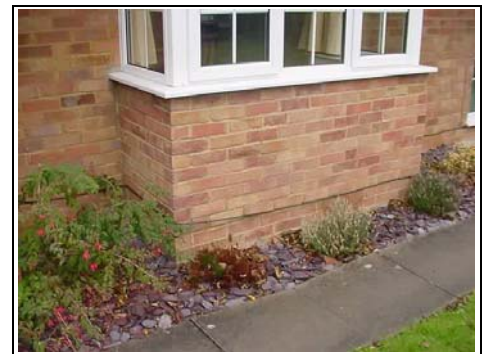
Bay Window

The brickwork section below the bay window has been added by the present owners, as has the radiator within.

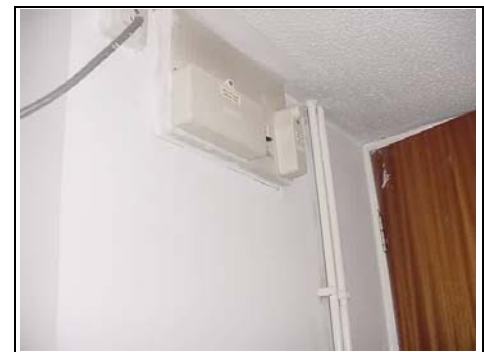
The electric fuses and consumer units were located in the kitchen. We would date the fuse board as being from the 1960s. Rewireable fuses are now superseded. Far better fuse boards are now available.

ACTION REQUIRED: We would recommend that a new fuse board is added at a minimum.

We would also recommend at the same time that the entirety of the system is checked. We have carried out a basic earth test within the kitchen and found this to be satisfactory, but it does not represent an appropriate check which should be carried out by an NICEIC registered and approved electrical contractor or similar to the Institute of Electrical Engineers current recommendations.

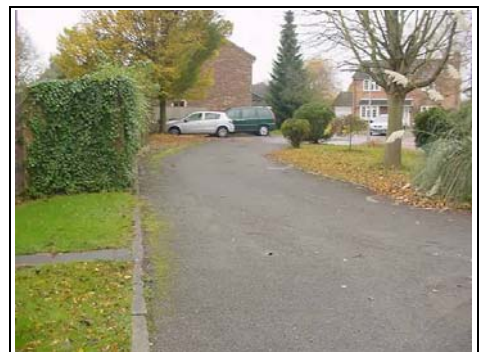
Access road.

We have not made any informal enquiries with regard to the access road.

ACTION REQUIRED: Your Legal Advisor to make enquiries with regard to your responsibilities and liabilities for the access road, which we assume has not been adopted by the Local Authority and therefore maintenance is your responsibility.

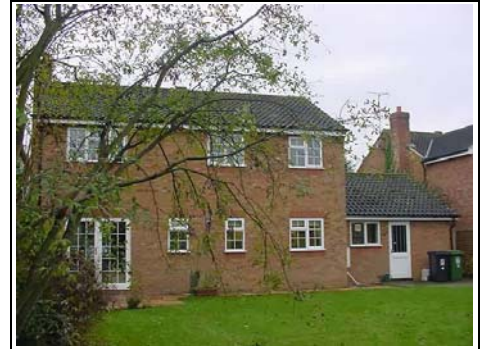
Rear Garden

You have a level rear garden laid mainly to lawn.
