# RESIDENTIAL BUILDING SURVEY

Notting Hill,  
London,  
W11

**INDEPENDENT CHARTERED SURVEYORS**

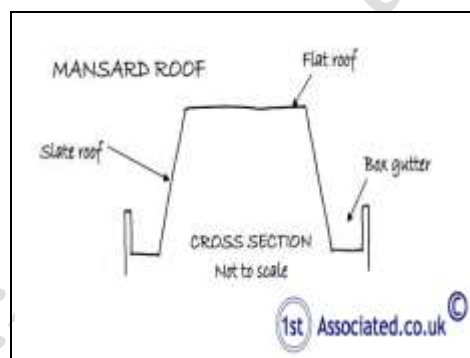
The other issue we have with the roof is that it looks flat. We always like a roof to have fall on it so that no water sits on it.

Regarding the rear roofs that we accessed; we believe water has got underneath the single ply roofing system and into the insulation as we can see a repair on it. This is over the wet room area so there may be problems in this area in the future.

The pen indicates a small circular repair to the roof similar to a bike puncture repair kit

**ACTION REQUIRED:** To change the roofs will be very expensive as this is high level roof work and will require scaffolding. We would therefore suggest that you keep the existing roof until problems occur and then take the opportunity to replace it with a high performance felt roof that has a good fall on it. We feel that from the roofs we have seen the most likely roof to need replacing will be the one over the wet room.

**ANTICIPATED COST:** We could only hazard an educated guess that to scaffold up to the higher levels to the rear of the property for the roof repairs would be in excess of £50,000 (fifty thousand pounds) possibly closer to £100,000 (one hundred thousand pounds). We stress that the roof on a visual inspection seems to be performing satisfactorily ;

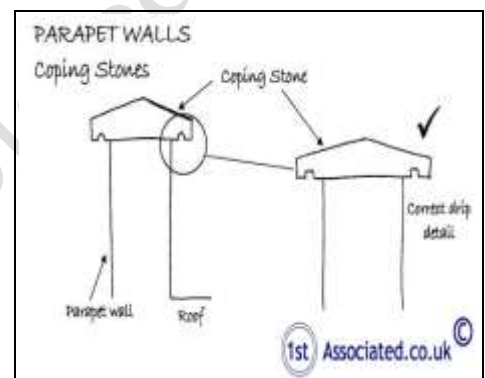
Our sketch shows how the coping stones should be fitted.

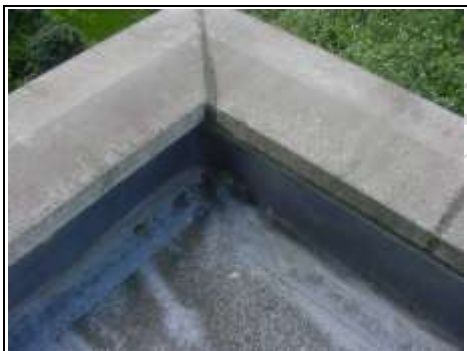
We can see that the coping stones to the rear have been wrongly positioned into the wall structure and without a drip which means that dampness will be getting into the wall. In theory there is no need to have a drip as the entirety of the inside wall is sealed however we would prefer to see this to stop deterioration of the joints

No drip detail on coping stone

**ACTION REQUIRED:** We would recommend a new coping stone is added and a check to ensure there is a damp proof course underneath.

**ANTICIPATED COST:** In the region of £2,500 - £5,000 assuming it can be carried out from on the roof. Please note the single ply roof will have to be well protected or the builders walking on it will damage it; please obtain quotations.

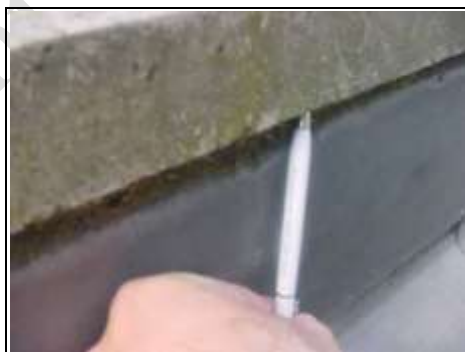
The pen indicates the coping stone is level with the wall

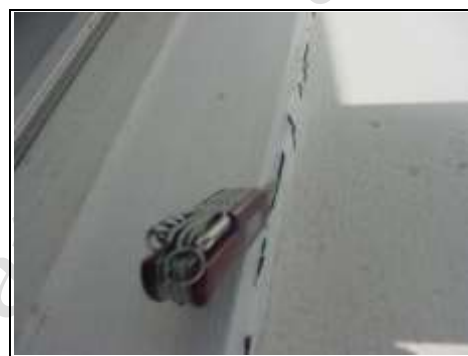
A modern property such as this relies a lot on the mastics that form a seal between materials that have different movement characteristics. Again we are into an area where the mastics we are using today, in our opinion, haven't been used long term in a UK climate by builders to understand how they will work. We have seen various areas where the mastics are starting to perish. You have mastics to the lead flashings and you have mastics around the windows. In both cases we can see these are starting to perish.

Mastic perishing around window

**ACTION REQUIRED:** We would recommend you have a skilled and an experienced person to check all the different mastic seals around the property before the winter of 2012 and seal as necessary.

**ANTICIPATED COST:** £2,000 - £4,000 (two thousand pounds to four thousand pounds) to have the work carried out properly. This could be more if a specific problem is found; please obtain quotations.

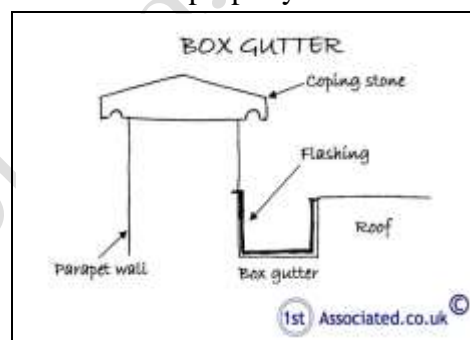
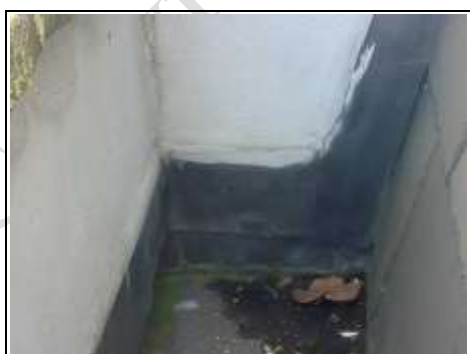
The box gutter to the front of the property is renowned for problems. It looks as if additional masticing had been carried out in this instance. We can't see any damage but then we wouldn't with this type of construction

Box gutter with water sitting in it.

**ACTION REQUIRED:** This is a very difficult problem to resolve as the box gutter needs a fall to make sure all the water gets to the hopper head end and a suitably sized outlet to make sure the water gets transferred to the downpipes. It looks from the deterioration that the downpipe is not taking the water away quickly enough. This may relate to a blocked box gutter but generally we find it relates to a poorly detailed box gutter and poor workmanship. The best way forward is next time it rains heavily is to have a look at the box gutter to see if there are any visual problems.

**ANTICIPATED COST:** Unfortunately you can try to rectify box gutter problems for ever and a day. We personally would recommend relining in a lead. This is a tried and tested method of having a waterproof box gutter; please obtain quotations.

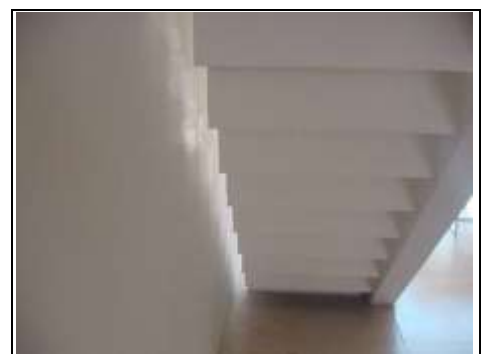
Staircase

The drawings show vertical steels within the staircase wall from which the steps are cantilevered. Having spoken to xxxxxxxxxxxxxxxx we were referred to xxxxxxxxxxxxxxxx. We initially thought the staircase was constructed with the five vertical steels shown in the drawing, however when we researched the project we found it was in fact one

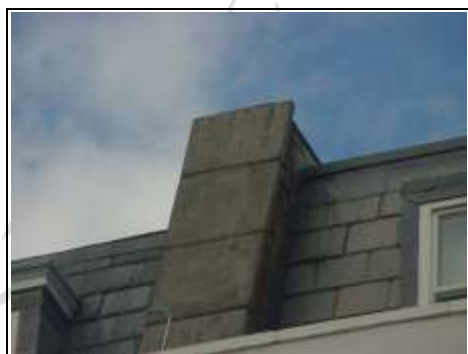
A problem we are finding with modern insulated properties, particularly on upper floors or where there is a roof conversion or a mansard roof with glazed areas, is thermal gain in the summer and thermal heat loss in the winter. This is unless they are particularly well designed and thought through.

Black slate on mansard roof

**ACTION REQUIRED:** We would recommend that you live in the building to see how it suits your style of living before you make any major changes. You may wish to add air conditioning in specific rooms that you use most frequently or for long periods of time such as the lounge, an office room or even a bedroom.

**ANTICIPATED COST:** A proper air conditioning system costs tens of thousands of pounds; please obtain quotations.

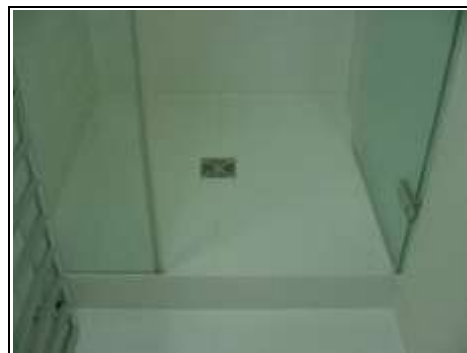
We are not great fans of shallow showers where there is a minimal fall in the shower tray. This is not from a design point of view as we appreciate that in theory the rooms are tanked and lined beneath the floor. However from a practical point of view water can escape from these trays in a way it cannot from a traditional shower tray.

Shallow shower tray on the top floor

**ACTION REQUIRED:** Live with the showers for a while and see how they suit you

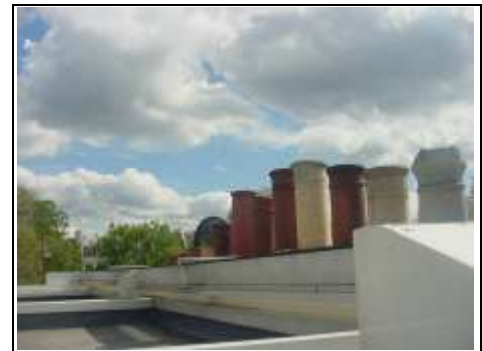
Chimney - left

This chimney is finished in painted render with numerous chimney pots of different sizes and shapes. From what we could see from roof level it looked in average condition considering its age, type and style.

Unfortunately we were unable to see the very tops of the chimney, known as the flaunching, we therefore cannot comment upon them.

**ACTION REQUIRED:** Periodically inspect the chimney. Ideally we would prefer an access hatch within the roof to allow you get onto the roof. We think for health and safety reasons as well this

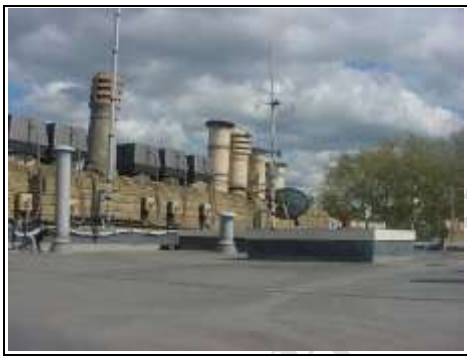
Chimney pots – right hand side

This chimney is brick built with lead flashing and again with numerous chimney pots. This is slightly bigger and also has an extraction system. Again we would remind you we were balanced up a ladder whilst looking at these. From what we could see from roof level it looked in average condition considering its age, type and style with the chimneys relatively straight and true. With regard to the flaunchings we would prefer you to the previous chimney and make the same comments here that we could not physically see the flaunchings.

**ACTION REQUIRED:** Periodically inspect the chimney.

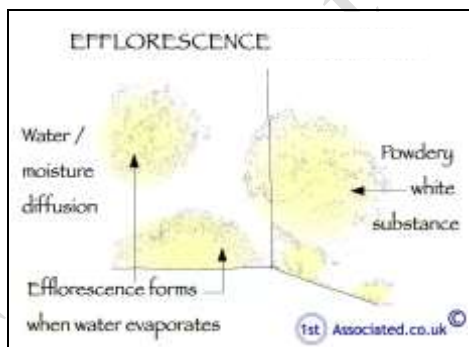
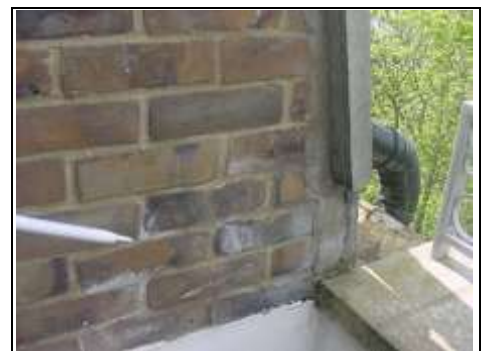
Efflorescence to rear left hand parapet wall

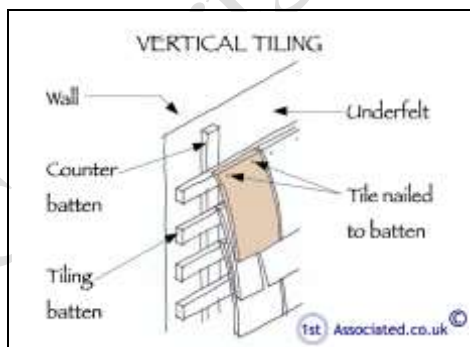
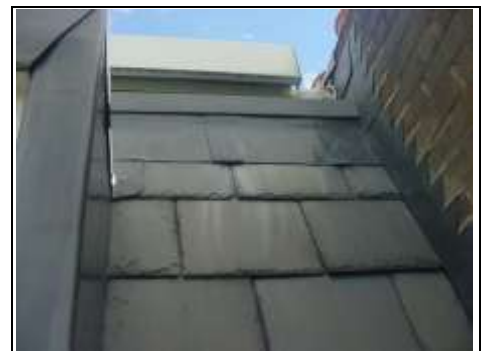
There are vertical slate tiles in reasonable condition.

Near vertical slate

**ACTION REQUIRED:** Carry out periodic inspections and maintenance of the roof, as required.

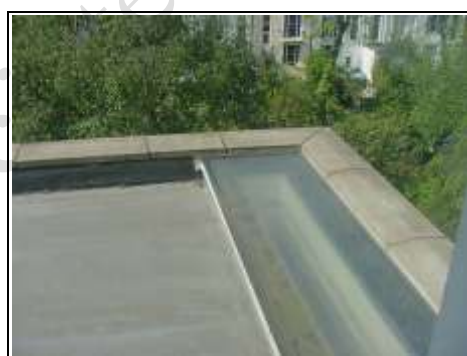
This has a single ply roof. Please see our comments in the Executive Summary with regard to this.

High level roof with roof light into the wet room/sauna area

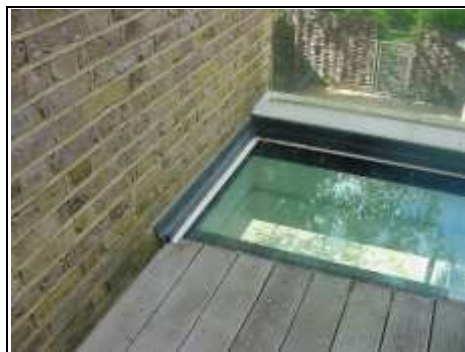
This is boarded over but we suspect it has a single ply roof system as the rest of the roofs have. Please see our comments in the Executive Summary.

Balcony/terrace roof over kitchen area.

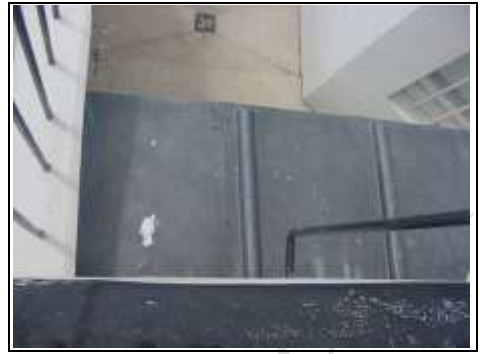
Rolled lead roof

This looks as new and in good condition.

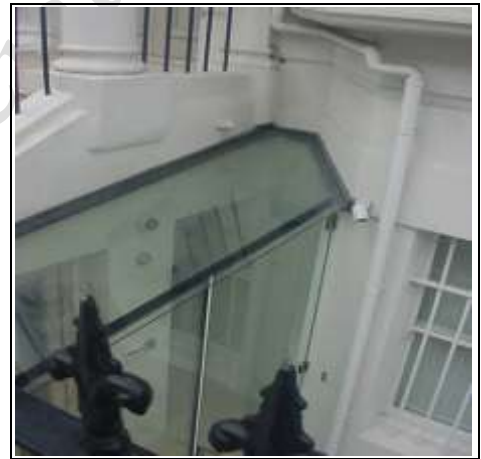
Glazed roof

We have come across problems with the mastic seals on these. Please see our comments about having a man check these seals with a mastic gun.

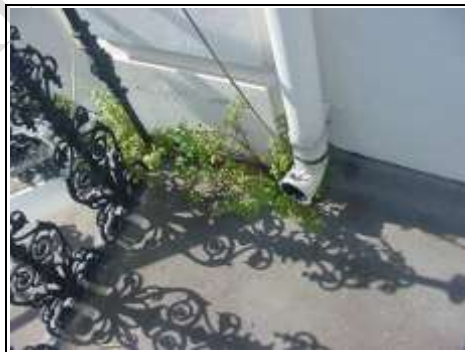
This is the original traditional balcony with an asphalt roof. We would recommend that a roofer spends half a day on this to check and clear the plants from it. Asphalt is a great flat roof material having a good history of long life and is relatively easy to maintain.

First floor balcony with plants growing out of it (this is never a good sign)

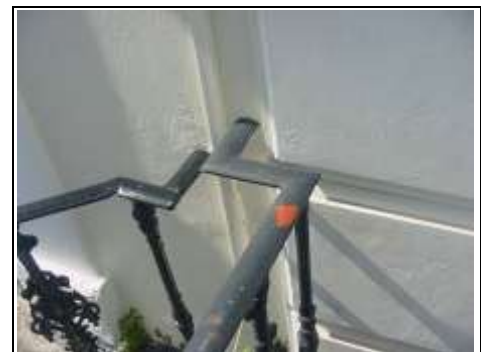
Balcony hand rails are in need of decoration

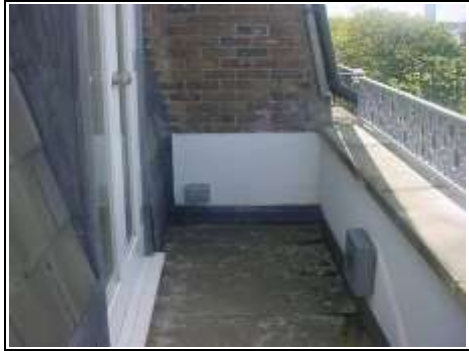
Top Floor balcony

This is paved and has a lead flashing. Having said that, we can see some single ply to the hopper head that does lead us to believe that a single ply roofing system has been used underneath the paving slabs.

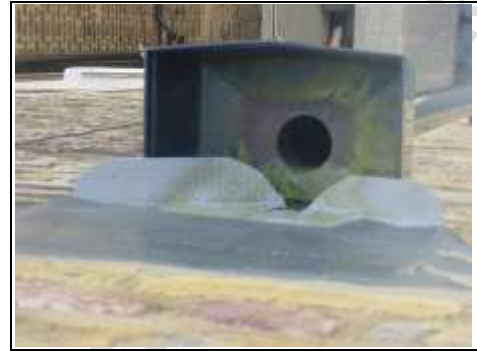
Single ply to the hopper head

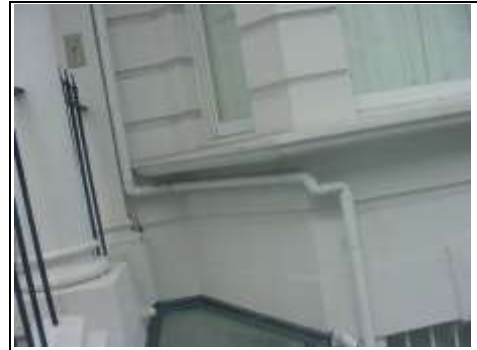
The front gutter from the balcony does take a torturous route with a ninety degree bend to travel around the new glazed roof area and we would expect this to leak once it is unblocked at the balcony level.

Ninety degree angle downpipe added due to glass covered area on lower ground floor

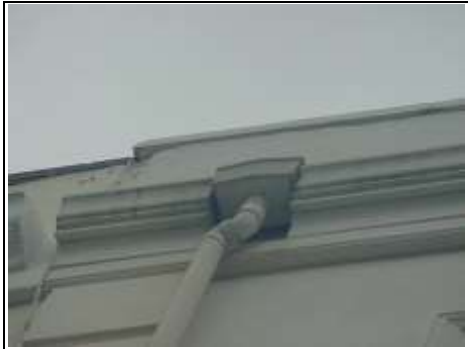
Hopper head in cornice

To the rear of the property are modern hopper heads. These are smaller than the traditional size and do tend to overflow.

**ACTION REQUIRED:** We would recommend you stand outside the property next time it rains heavily and see how well the drains cope with the rainwater particularly looking at the guttering and the joints.

We would also recommend that the gutters and downpipes and hopper heads are cleaned out, the joints are checked and the alignment checked to ensure that the gutters fall towards the downpipes.

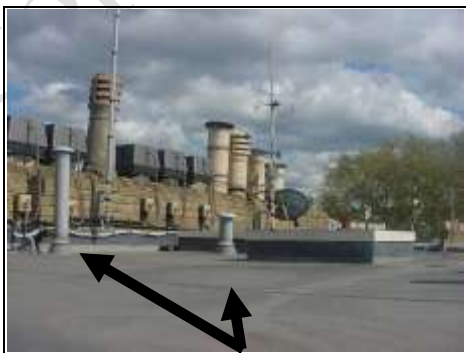
Flues

The property, due to the internal drainage system, has a number of flues on the roof. They are plastic but we did not have a close up inspection of where they went through the roof and therefore cannot comment upon them.

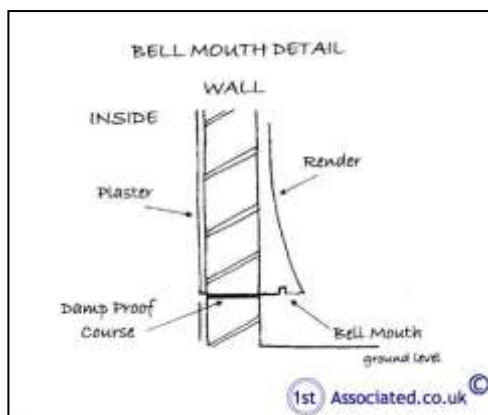
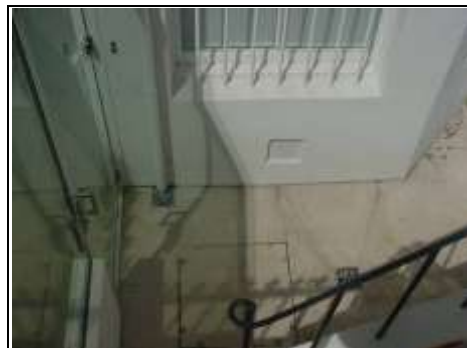
There is no bell mouth to the base of the property which is common in this era of construction.

No bell mouth

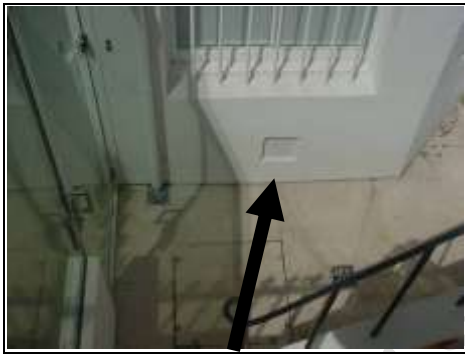
Air brick

You have both low and high level air bricks. The airbricks may be present to vent the dry lined cavity to the front of the property as there is no grill visible internally.

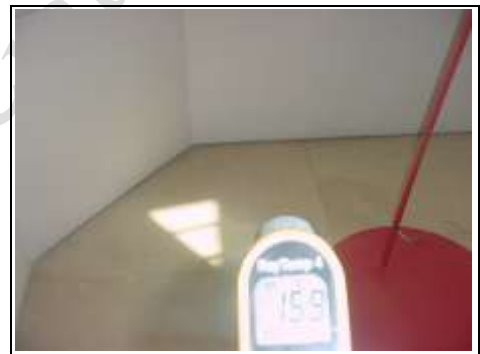
No vent internally

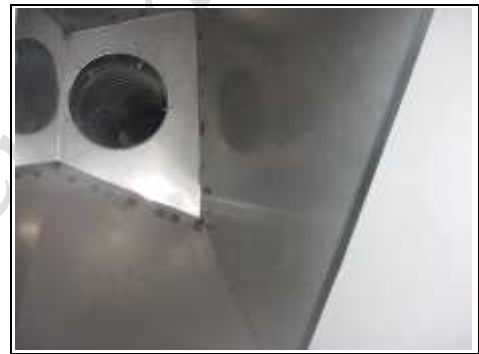
Looking up chimney flue

We discussed at the time of the survey whether it was possible instate a real fire. We think upon reflection that if this is going to take place it would be best to put flue linings throughout the entire chimneys that you would like to use.

It is strongly recommended that flues be cleaned and checked for obstructions prior to use to minimise the risk of hazardous fumes entering the building.

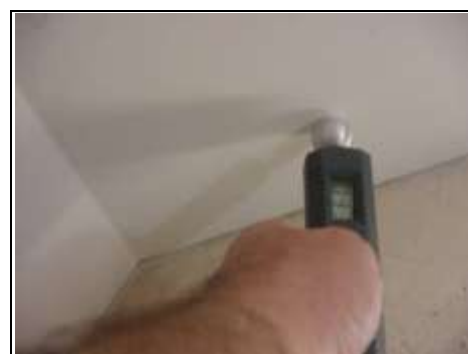
A random visual inspection and tests with a moisture meter have been taken to the perimeter walls. In this particular case we have found no rising damp. However please read our concerns with regard to hidden dampness earlier in the report particularly to the lower ground floor front elevation.

Testing for rising damp

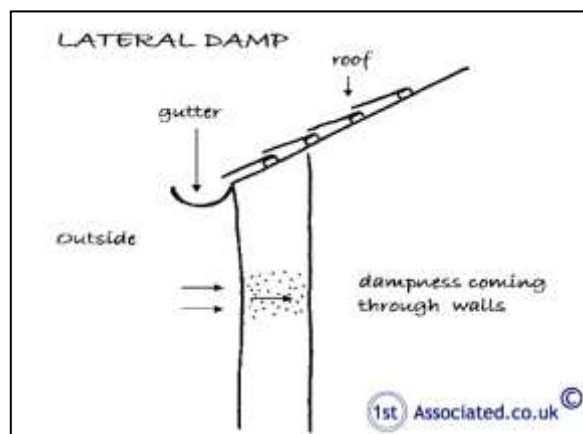
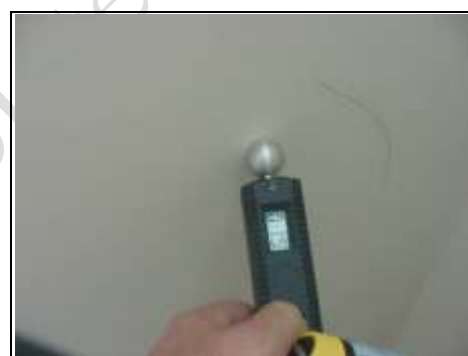
We used a damp meter on the external walls. We were unable to test for lateral dampness as the walls are dry lined..

Unable to test for lateral dampness

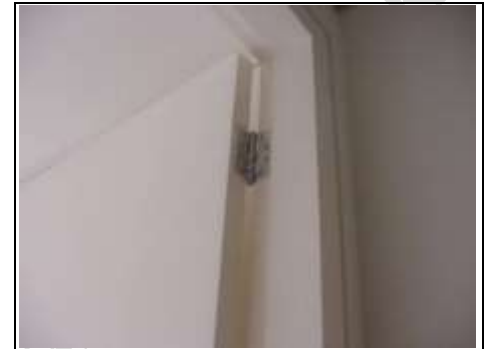
Internal Door

The property has large, no doubt, purpose made doors throughout.

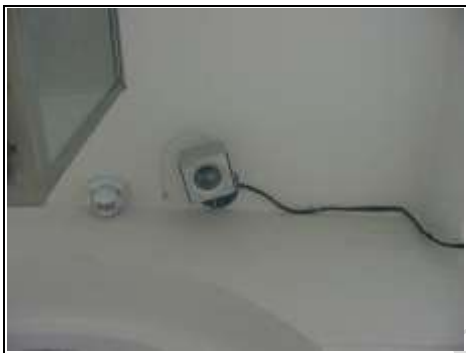
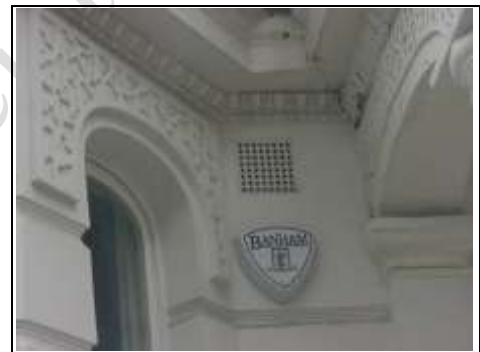
A security system has been installed. A good alarm system should not only help reduce break-ins but also your insurance. We are not experts in this field and therefore cannot comment further.

**ACTION REQUIRED:** Further information should be obtained from the vendor prior to purchasing the property and the installer at a later date.

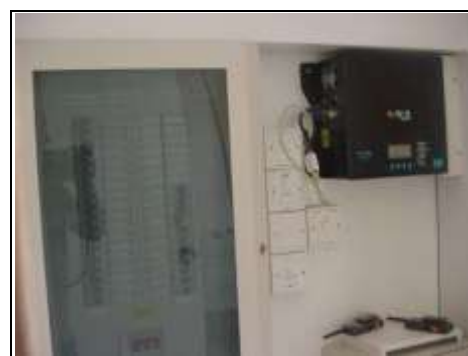
Electrics

The electric fuses and consumer units were located on the lower ground floor and the top floor. We assume that the fuse boards were installed at the time of the refurbishment. The electrics we could see were far and above what we would expect to see in a residential property and do need a specialist check

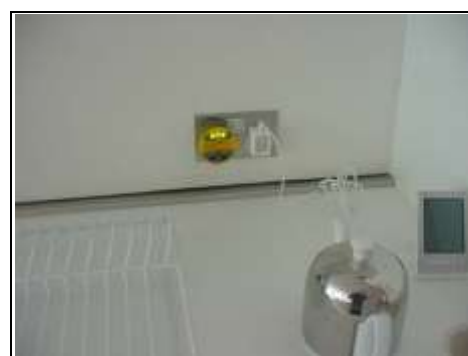
Earth Test

We carried out an earth test in the kitchen area to the socket point that is normally used for the kettle, this proved satisfactory. This does seem relatively insignificant in the whole scheme of the electrics within this property.

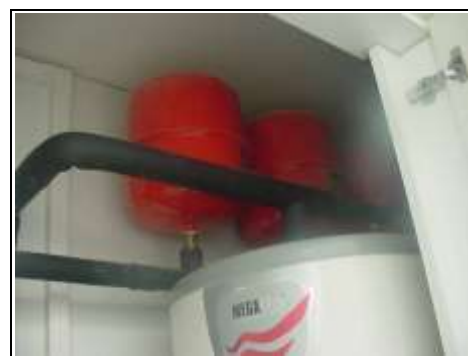
Megaflow system

The property has two large Megaflow systems that we personally have always found to work very well when we have had them in our properties.

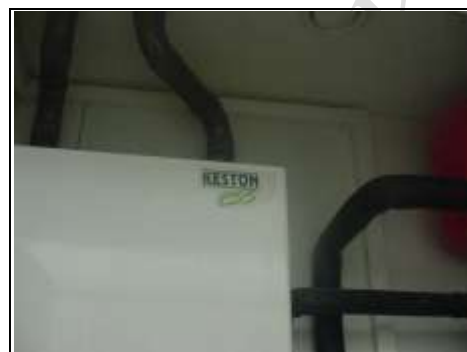
Keston boiler

Our inspection has been limited as the heating is by way of a heated floor.

**ACTION REQUIRED:** It is important that you obtain a guarantee on this type of flooring as we have come across problems with it in the past. It is obviously very difficult to carry out any maintenance work upon unless this has been a requirement of the client. We often find that architects have no interest in making anything maintainable.

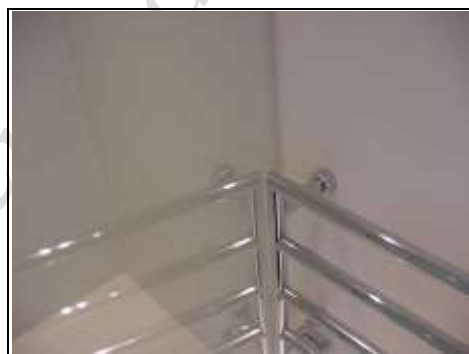
En-suite shower door bumps into towel rail- third floor.

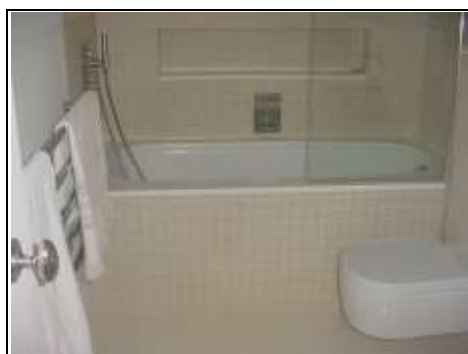
Where there are en-suite bathrooms the baths look to be short and are predominantly for shower use.

Short bath in the third floor en-suite bathroom

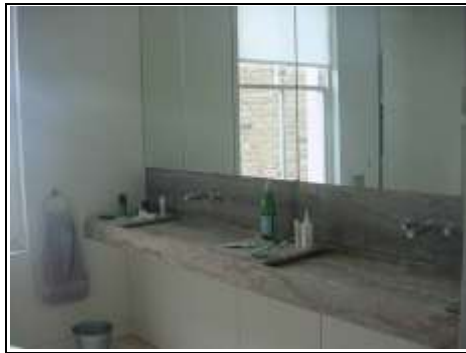
Shallow sinks in En- suite Bathroom to Master Bedroom

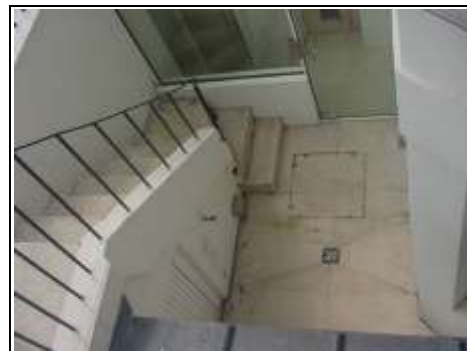
Manhole – front lower ground floor

We were unable to lift this.

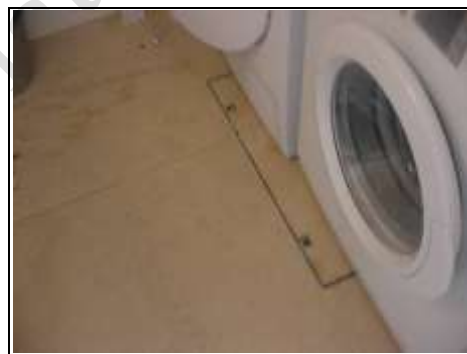
Manhole in utility room

We were unable to lift this

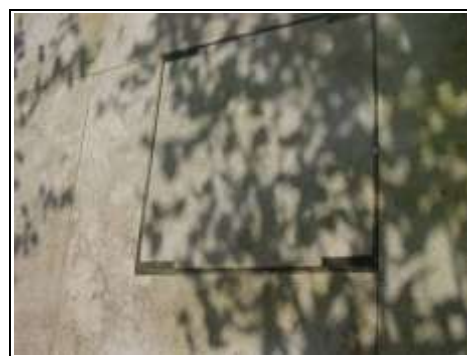
Manhole in garden -rear

We were unable to lift this.

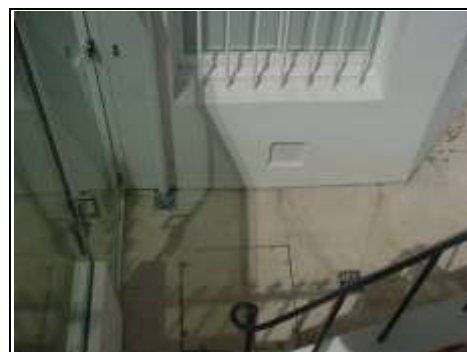
Small courtyard

There is a small courtyard at the front of the property at lower ground floor level. These areas are renowned for flooding when it rains, allowing dampness into the property.

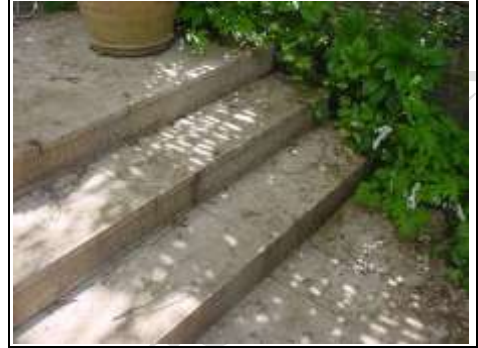
Paving slabs can get slippery

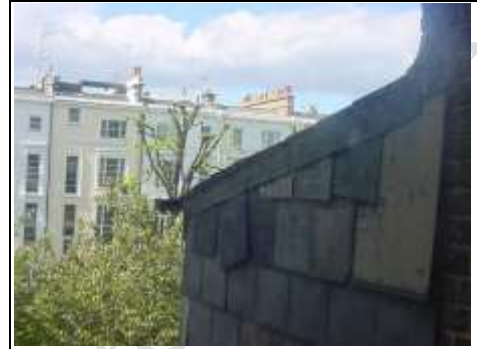
You do need to speak to your right hand neighbour because, as you can see in the photo, their vertical slate wall is many years old and the slates are literally hanging off. We would suggest a cup of tea meeting with them.

Vertical slates are hanging off over your balcony.
