JOB REFERENCE: XXXXXXXXX

RESIDENTIAL BUILDING SURVEY

XXXX
Warlingham
Surrey
CR6 XXX

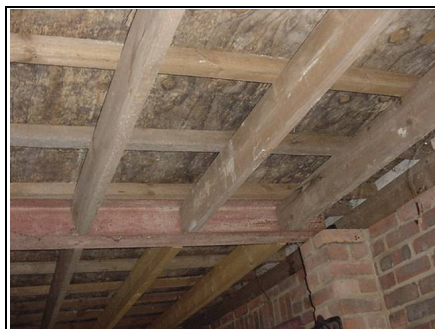
The garage roof is letting in rainwater particularly to the rear right hand corner (all directions given as you face the property). From viewing on the roof itself this leak is directly over the gully that is within the flat roof.

View inside garage roof, mould to the roof decking.

ACTION REQUIRED: Re-roof and partially replace the decking.

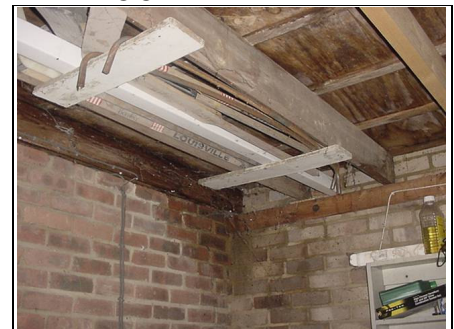
Rear right hand corner of garage roof

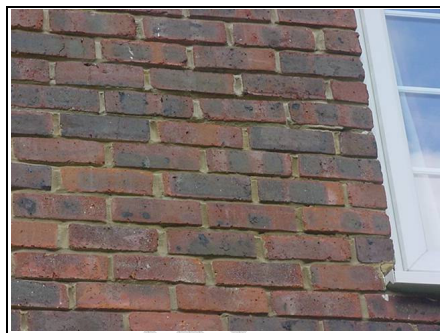
Messy pointing to brickwork

ACTION REQUIRED: Carry out ad hoc re-pointing work over the next few years.

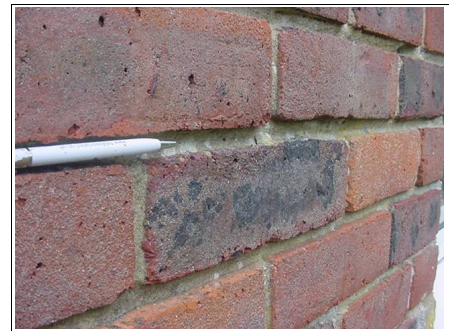
Close up of messy pointing to brickwork

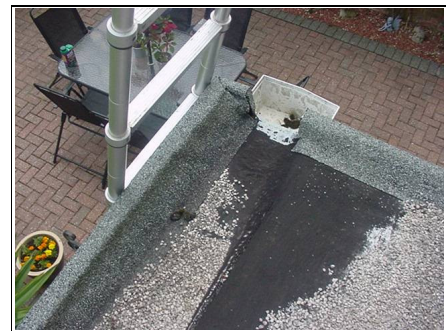
There is a small flat roof single storey extension to the right hand side (all directions given as you face the property) of the property.

Right hand side flat roof 15

ACTION REQUIRED: We would recommend the addition of a pitched roof rather than the current flat roof that is within five years of the end of its natural life.

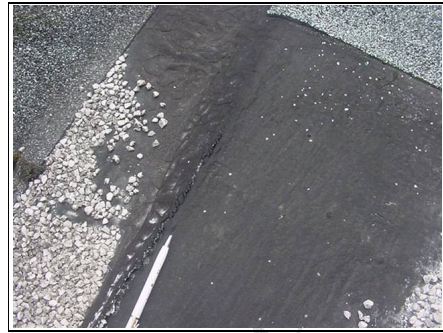
Splitting starting to occur

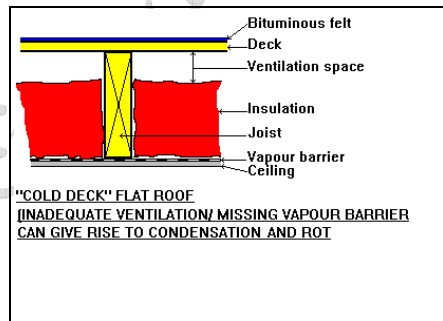
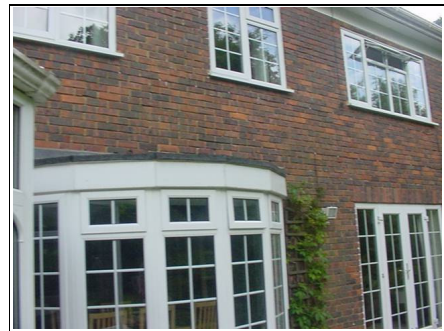
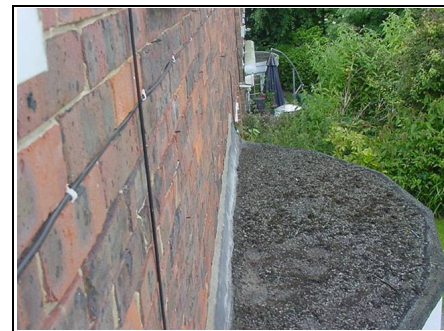
7.0) Rear Bow window

The property has a rear bay window which has a felt roof which is dated.

Rear Bow window

Bow window to rear 16

ACTION REQUIRED: We recommend when you have the roof work carried out to the garage that you also have this area re-roofed with a modern high performance felt sometimes known as an elastomeric felt.

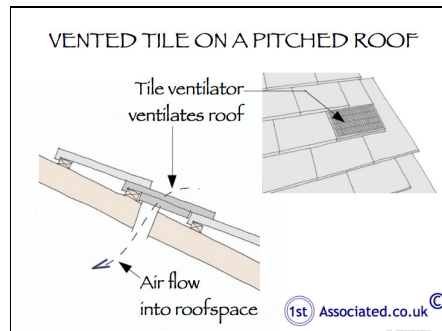
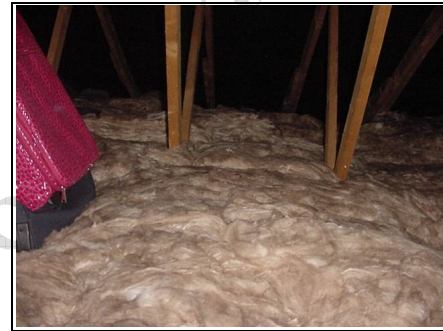
1.0) Is the roof insulated?

The main roof has insulation which is 300mm in depth and having spoken to the current owners during our question and answer session they advise that insulation was added in 2010.

Roof space mass of insulation
more ventilation required

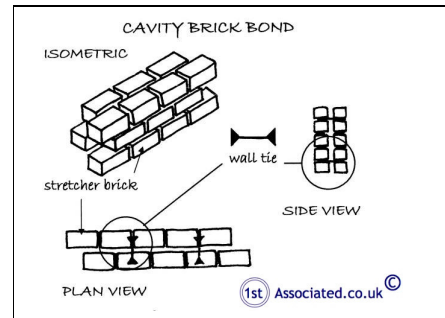
2.0) Walls

We also spoke to the existing owners about the walls which appear to be Stretcher Bond (assumed) from the external brickwork pattern which means there is likely to be a cavity within. We were advised by the current owners that they believed the cavity has been insulated as they were going to add insulation but the insulation company advised this was already present when they drilled holes to check.

ACTION REQUIRED: Your Legal Advisor to check and confirm in writing that the cavities are insulated.

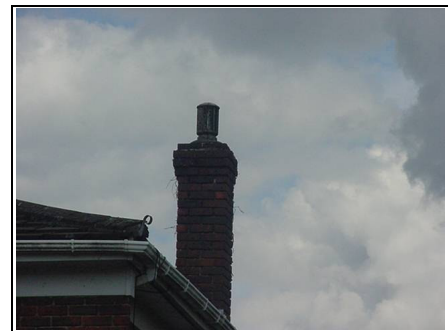
Chimney One

This chimney is brick finished with a lead flashing and one chimney pot. From what we could see from ground level it looked in average condition considering its age, type and style.

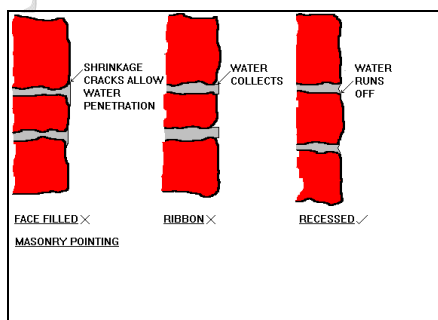
The brickwork on this property has a very deep recess, far deeper than we are keen on as it allows rainwater to sit in it and this is particularly so at high level.

Re-pointed required

ACTION REQUIRED: We would recommend re-pointing work to be carried out to the chimneys and would suggest this is carried out in the summer of 2014. Periodically inspect the chimney.

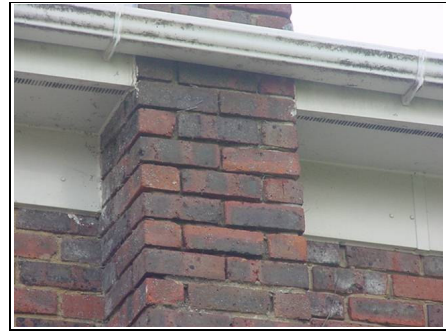
Re-pointed required

Unfortunately we were unable to see the top of the chimney known as the flaunching, we therefore cannot comment upon them.

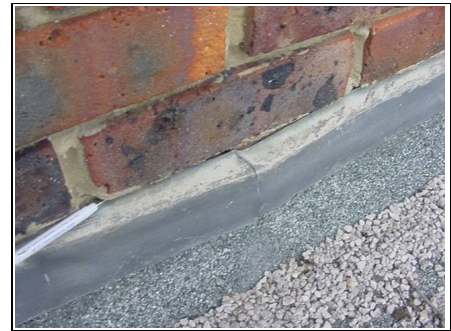
Flashing coming away to the right hand side

ACTION REQUIRED: Patch repair or a full repair dependent upon your budget.

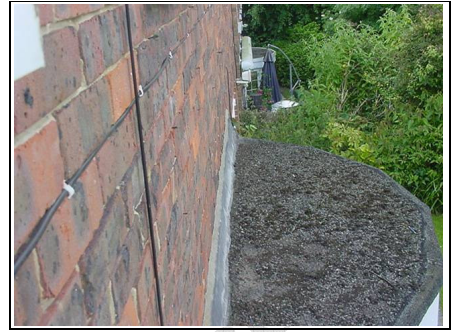
Bow window roof

The property has a flat bow window roof which is dated although there are no visual signs internally of any problems.

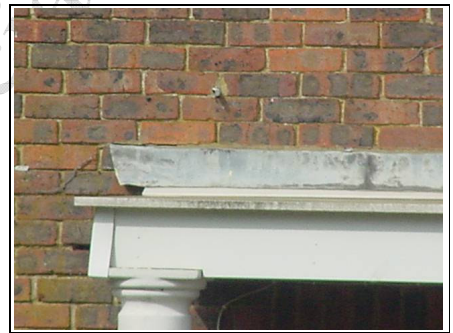
Roof over entrance porch

There is a flat roof over the entrance porch.

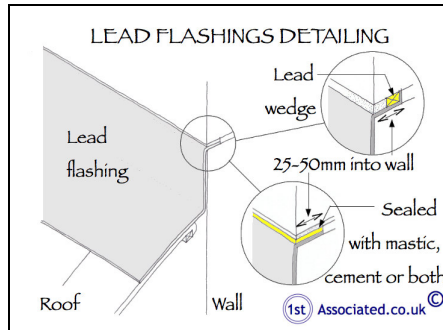
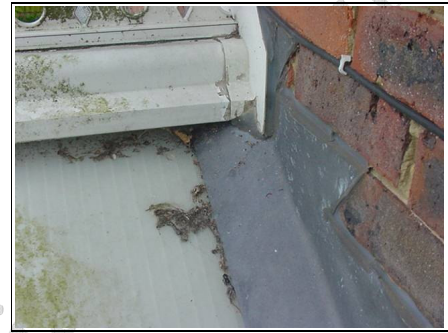
Close up of lead flashing where conservatory meets the main building

ACTION REQUIRED: Please see our comments in the Executive Summary.

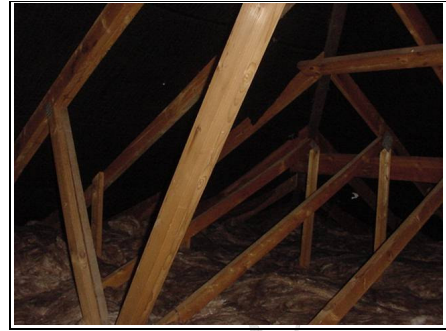
Our examination was limited by the general configuration of the roof, the insulation and stored items. What we could see was generally found to be in average condition for its age, type and style. It is, however, feasible that there are problems in the roof that are hidden.

General view of inside of main roof

ACTION REQUIRED: The only way to be 100 per cent certain is to have the roof cleared and checked.

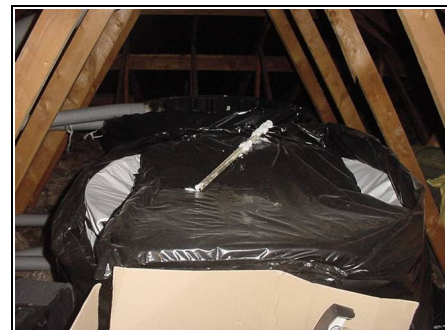
Water tank

The property has a water tank.

We would always recommend that water tanks be drained down and cleared of any debris etc. (we have seen dead birds and other unmentionable things in these tanks). As you

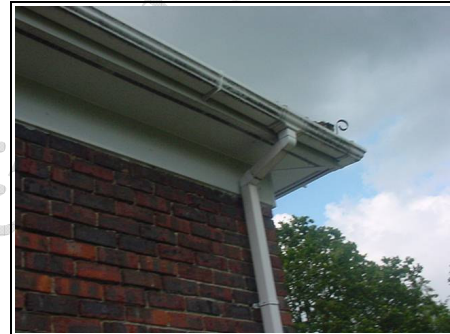
Gutter and downpipe

The property has plastic gutters and downpipes which we believe is a profile gutter. The condition is fairly typical of what we see; they are in average condition for their age, type and style.

There may be some minor leaks but most people would be happy to live with these providing repairs are carried out within the next six to twelve months.

ACTION REQUIRED: We would recommend you stand outside the property next time it rains heavily and see how well the drains cope with the rainwater particularly looking at the guttering and the joints. We would also recommend that the gutters and downpipes are cleaned out, (as they are more than likely to require a clean), the joints are checked and the alignment checked to ensure that the gutters fall towards the downpipes.

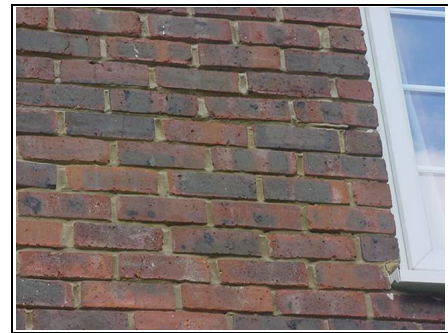
Please see our comments in the Executive Summary regarding poor quality pointing.

Brickwork with poor quality pointing

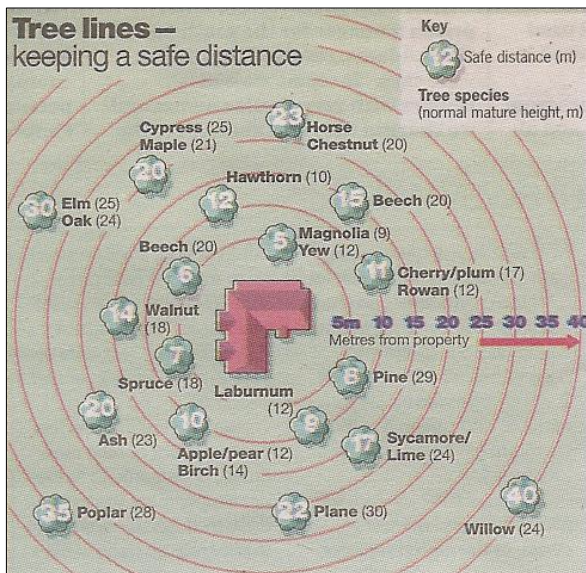
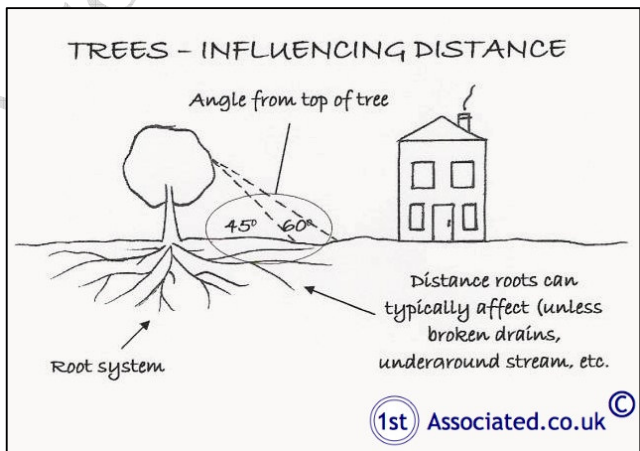
Tree cut down to the front of the property

ACTION REQUIRED: Seek advice from an aboreturist not a tree surgeon as the root system is still in place which could affect the property.

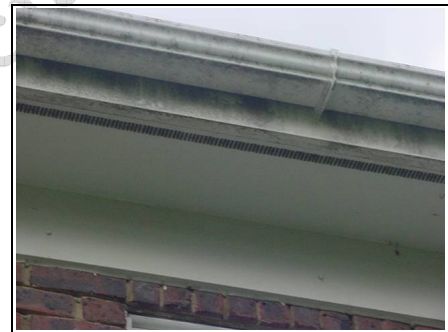
Fascias and soffits

The fascias and soffits are plastic. We would comment they are in average condition for their age, type and style.

ACTION REQUIRED: Make sure gutters and downpipes are watertight before carrying out any work on fascias and soffits.

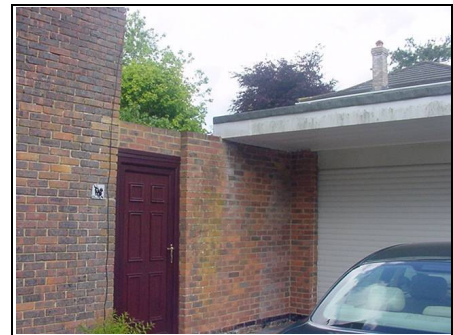
With regard to the colour of the gutters and the fascias and soffits the sort of moss that gets on these areas is very typical of where there are trees surrounding the property.

Moss to garage fascias and soffits

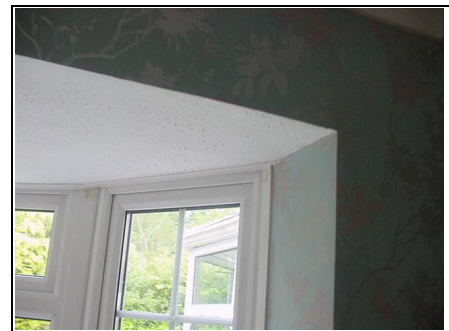
Looking for lateral dampness underneath bow window – no visible signs

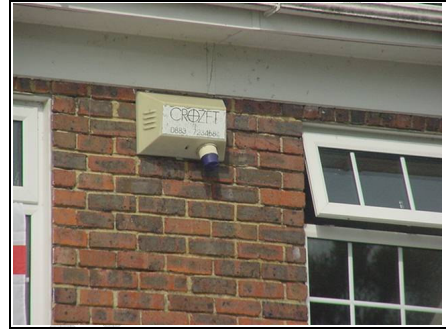
Security system

A security system has been installed. A good alarm system should not only help reduce break-ins but also your insurance. We are not experts in this field and therefore cannot comment further.

ACTION REQUIRED: Further information should be obtained from the vendor and the installer.

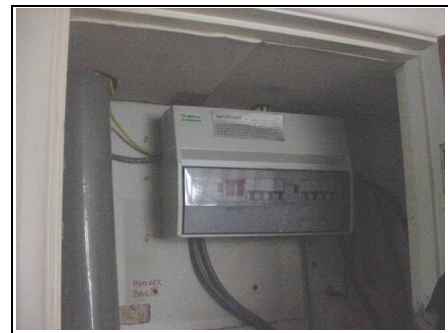
Fuse Board

The electric fuses and consumer units were located in the cupboard to the left hand side of the entrance (all directions given as you face the property). The fuse board looked dated and better are now available.

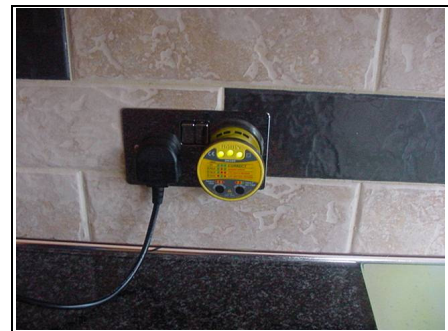
Earth Test

We carried out an earth test in the kitchen area to the socket point that is normally used for the kettle, this proved satisfactory.

ACTION REQUIRED: As the property is changing occupancy an Institute of Electrical Engineers (IEE) test and report should be carried out by a NICEIC registered and approved electrical contractor or equivalent.

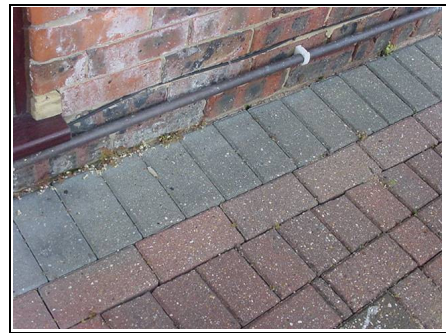
External gas pipes

We are advised that the property has mains gas. The consumer unit is located in a cupboard to the left hand side of the entrance (all directions given as you face the property).

ACTION REQUIRED: As a matter of course it is recommended that the entire gas installation is inspected and made good, as necessary, by a Gas Safe registered contractor. Thereafter the installation should be serviced annually.

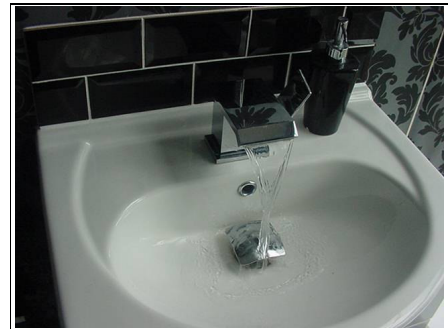
Tap test

When the taps were run to carry out the drainage test we checked the pressure literally by putting a finger over the tap and this seemed average. The Water Board have to guarantee a certain pressure of water to ensure that things like boilers, particularly the instantaneous ones have a constant supply of pressured water (they would blow up if they didn't!).

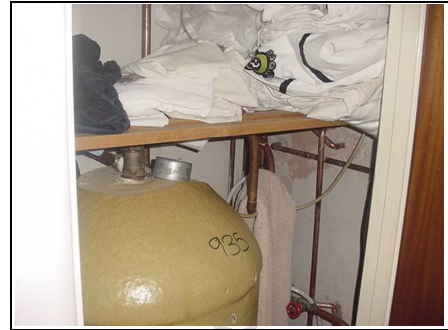
Hot water cylinder

There is a hot water cylinder located in the airing cupboard. It is factory insulated, which indicates that it is relatively new (in this case we mean in the last 30 years). This cylinder will therefore have a good thermal efficiency, although not as good as the more modern hot water cylinders.

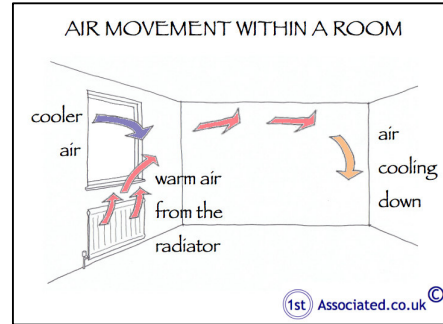
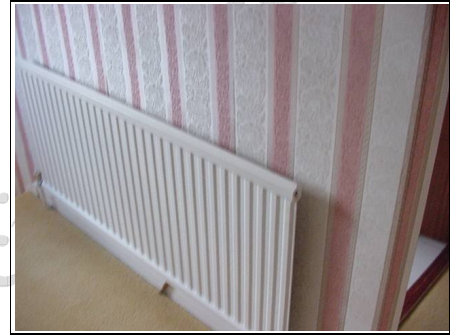
Internal radiator

We noted the radiators are internal in some areas. This is often carried out on cheaper central heating systems to save the labour and piping costs of taking the radiators underneath the windows. However, it then reduces the air movement in the room.

ACTION REQUIRED: We would live in the property and then if there are problems we suggest you move the radiators underneath the windows as this gives a better circulation of air and reduces the chance of condensation.

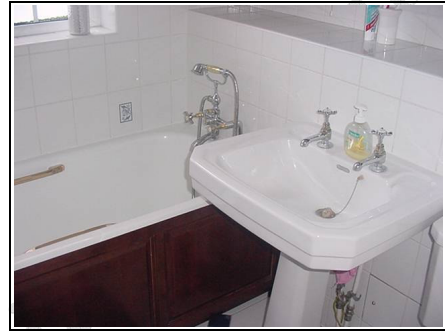
Family bathroom

The property has a four piece bathroom suite, consisting of a bath, shower, wash hand basin and WC, which looks in average condition, subject to some day-to-day wear and tear, as one would expect.

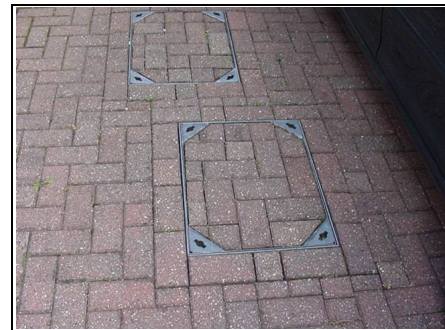
Front manholes

We were unable to lift the manholes at the front of the property during our inspection.

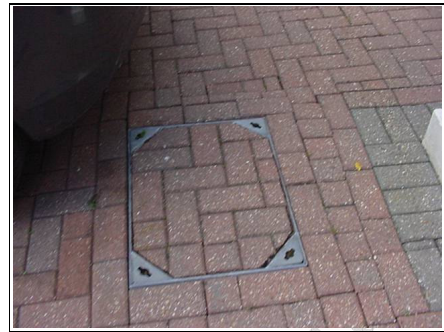
Manhole Three

Again, we were unable to lift this manhole at the time of our inspection.

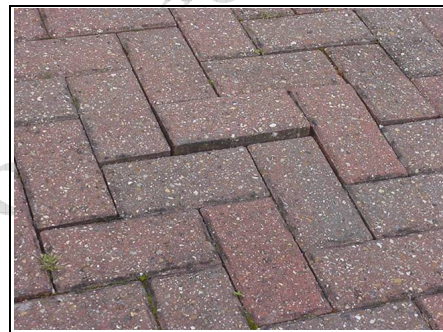
The front garden has brick pavers allowing off road parking. We noted the area to the front had a pavier which has lifted indicating movement.

Front Garden – pavier lifting indicating some movement

ACTION REQUIRED: Monitor for movement. Re-bed brick pavier.

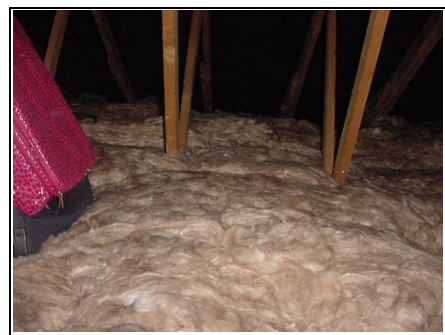
Mass of insulation

Unfortunately in this instance our inspection has been very limited as there was a mass of insulation in the roof space and as we were not able to open up the ground floor or the first floor.

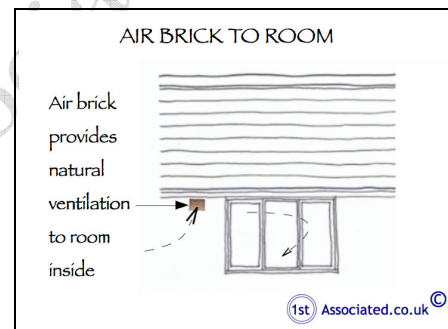
If you are thinking about adding an air brick then you need to be aware that airbricks don't actually allow that much air through. Although externally a nine by three air brick has a lot of gaps, as these gaps taper, it is generally considered that only about one inch square of air regularly passes through the grills.

Air brick may not ventilate room enough

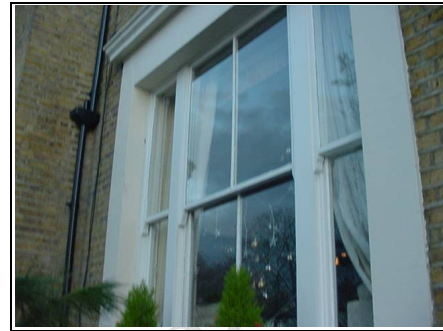
Sliding sash windows can swell in the winter months

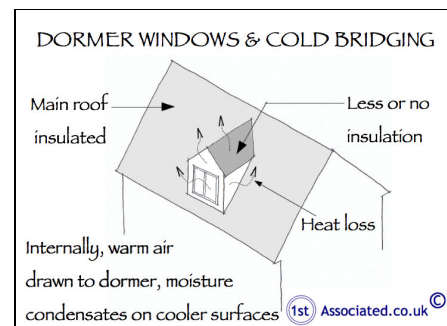
Increasingly we are coming across problems where properties have been extended and it has not been planned or thought through properly. We have come across dormer roofs that simply have no insulation so any heat in the property is going straight out of the dormer roof. We have also come across property problems where an extension has resulted in colder areas within the property and which although not problem areas, as such, our clients have found them not nice areas to be in. It is not a great outcome if you have just spent tens of thousands of pounds on a new extension that you are not happy with.
