RESIDENTIAL BUILDING SURVEY
OF
A 1960's End of Terrace Property, Welwyn Garden City,
Hertfordshire

FOR
Mr G and Ms T

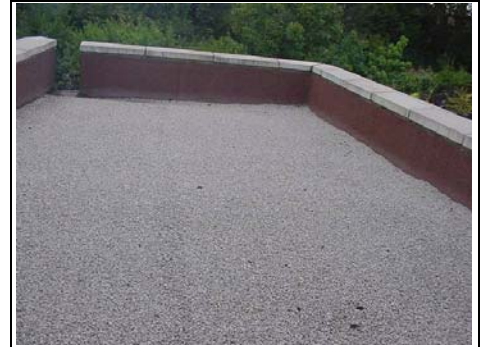
The flat roof to the rear extension is very flat and we think rainwater will sit on it. This is a relatively new roof and it does look to have had work carried out to the parapet wall (unless the builder simply used a different colour brick when constructing it). Deteriorating to a parapet wall can often be caused by a poor flashing detail.

ACTION REQUIRED: We would recommend that in the near future the felt flashing is replaced with a lead flashing (you already have a lead flashing where the flat roof meets the main property; it seems strange that they have not used one to the perimeter). In the long term we would recommend that a 'fall' is added to the flat roof. A good way of doing this in our experience is to use an insulation cut to falls on the flat roof, as this guarantees a fall and it also adds insulation to reduce the heat loss from the roof.

To re-roof we would expect costs to be in the region of £3,000 - £5,000, depending upon the quality of felt used, we would recommend a high performance felt (known as a HP felt). Quotations should be obtained.

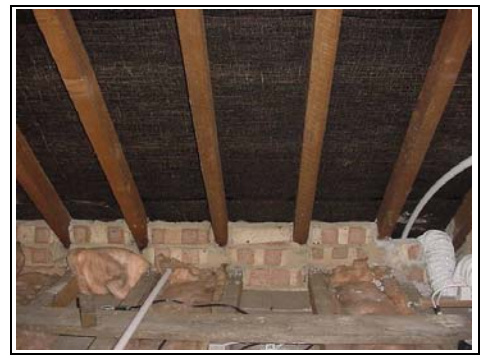
Main Roof

When we inspected the loft space we found a Hessian base Bitumen membrane. This type of membrane has been used since the 1960s. We generally found it to be in average condition, although it is damaged in a few places but this is not unusual considering its age.

This photo shows the common rafters (the ones that form the pitch of the roof) and the dark area between is the underlayer.

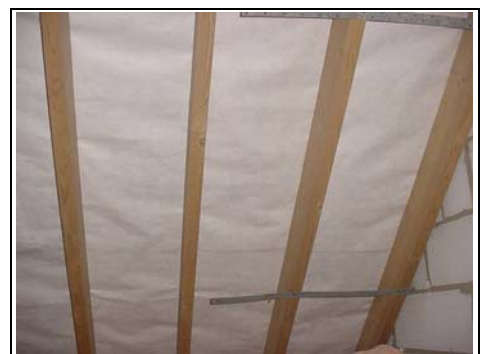
Left Hand Roof

We found a modern breathable underlayer to the left hand roof, which is more akin to a Gore-tex finish than the original felt roof that you have to the main property.

This photo shows the common rafters and the white area between is the breathable underlayer.

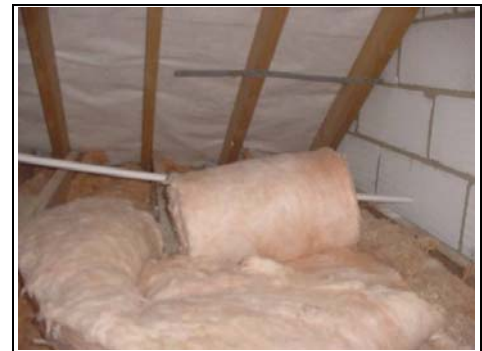
Left Hand Roof

The second roof access is for the extension roof and is located within the left hand bedroom. There is no loft ladder, electric light or secured floorboards. We recommend that these be added, as it will make the loft space safer and easier to use. The loft has been viewed by torch light, which has limited our viewing.

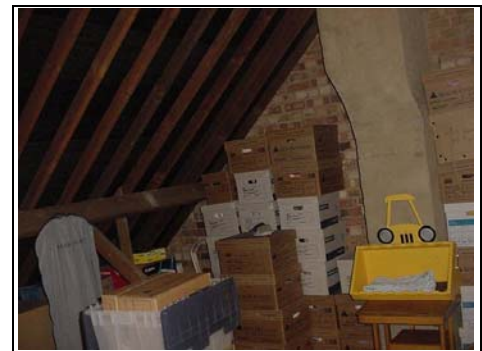
Our examination is limited by the general configuration of the roof, the insulation and stored items, as mentioned what we could see was generally found to be in an average condition considering its age. It is, however, feasible that there are problems in the roof that are hidden.

ACTION REQUIRED: The only way to be 100 per cent certain is to have the roof cleared and checked.

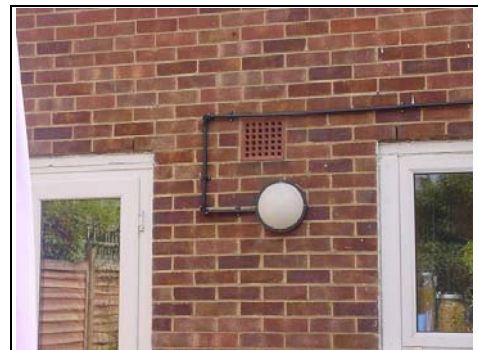
Brickwork

The walls are built in brick and bedded in cement mortar in what is known as stretcher bond brickwork. Stretcher bond brickwork came into common use after the Second World War throughout the United Kingdom.

We generally found the brickwork and pointing in average condition. However, you have stretcher bond brickwork from before and after 1970, which can be quite different; the early stretcher can have problems with wall tie failure and generally is not insulated.

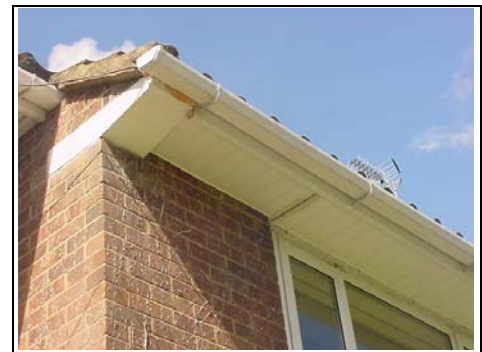
Fascias and Soffits

The property has plastic fascias and soffits and these are in average condition. We were pleased to see that there is a vent in the soffit that will, providing it is not blocked, allow ventilation to the base of the roof to reduce condensation.

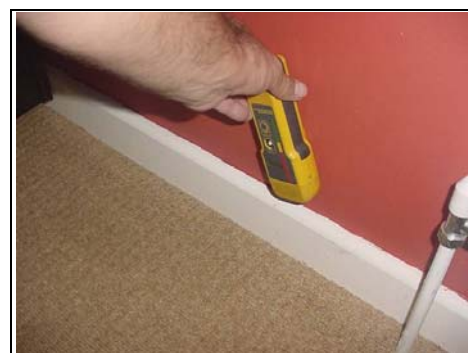
We carried out tests with our electronic damp meter and were surprised to find rising damp.

ACTION REQUIRED: Please see our comments in the Executive Summary.

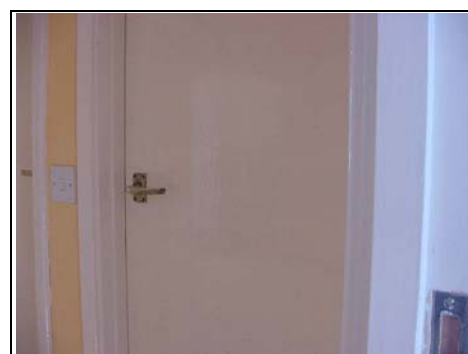
The property has some painted flush-faced doors; in this case they are dated and are probably the original doors.

ACTION REQUIRED: You may wish to supply and fit new doors throughout with associated ironmongery.

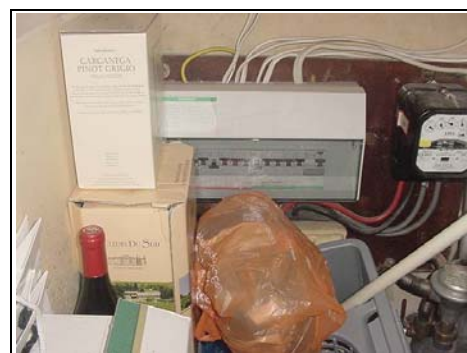
Fuse Board

The electric fuses and consumer units were located under stairs. We would date the fuse board as being modern, probably from the 1990s.

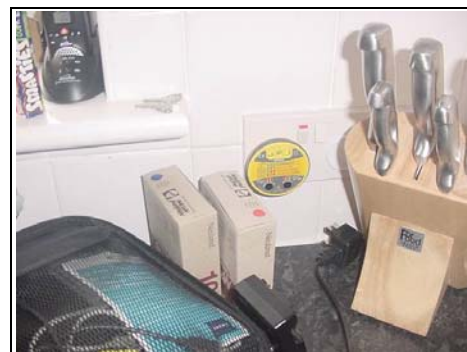
Earth Test

We carried out an earth test in the kitchen area to the socket point that is normally used for the kettle and this proved satisfactory.

Neither of these indicators can give certainty as to the condition of the rest of the wiring; in a property of this age you could have much of the original wiring.

ACTION REQUIRED: As the property is changing occupancy an IEE report should be carried out by a NICEIC registered and approved electrical contractor. It is generally considered that wiring lasts about 30 years; as this property was built in the 1960s that means that it should have been re-wired in the 1990s. You need to take specialist advice on this.

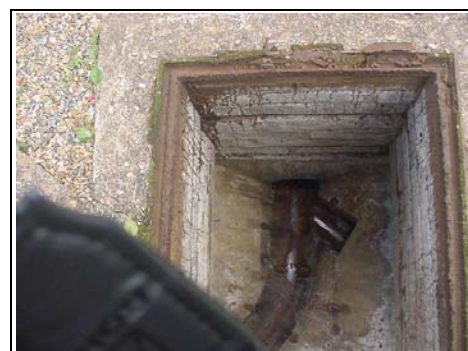
Inspection Chamber / Manhole One – To the Front of the Property

We duly lifted the man hole / inspection chamber cover and found the drain to be clear.

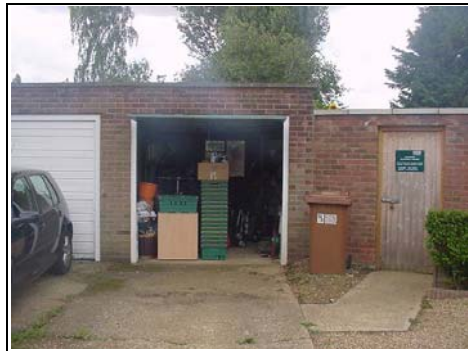
Garage

This is a brick built garage with what we believe to be a flat asbestos roof that has then been covered with a mineral felt.

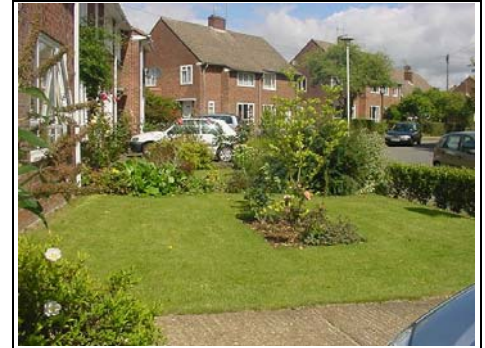
Front Garden

There is a reasonable sized front garden with a driveway and the rest of the area is grassed.

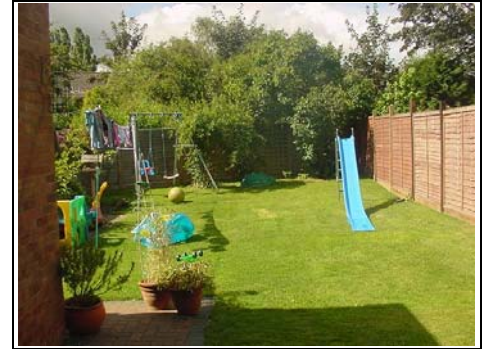
Rear Garden

There is a reasonably sized grassed rear garden with a timber fence and hedging to the back. There also looked to be an access passage from the allotment behind the back of the garden.

ACTION REQUIRED: Your Legal Advisor to check and confirm if there is a Right of Way behind the garden.
