RESIDENTIAL BUILDING SURVEY

Weybridge, Surrey KT13

INDEPENDENT CHARTERED SURVEYORS

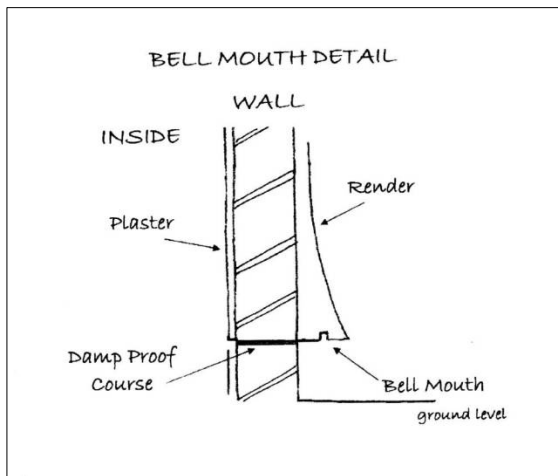
Dampness was found in the property; generally we would classify this as 'minor', however to the rear reception roof that faces the garden we feel it is unacceptably high. We believe that it is damp for a combination of reasons, which includes the poor quality of rendering without a bell-mouth and also ideally there should be a French gulley running around the perimeter of the property.

ACTION REQUIRED: We recommend that a BWPDA (British Wood Preserving and Damp Proofing Association) approved contractor offers a quotation for the damp proofing work. They will nearly always recommend inserting a damp proof course but you do need to insist that they need to quote for the French gulley and the bell-mouth to the render in the first instance. We recommend that they carry out a full quote on the entire house as it may be more economical to get the entire house carried out and thereby having a guarantee for future years when you come to sell the property.

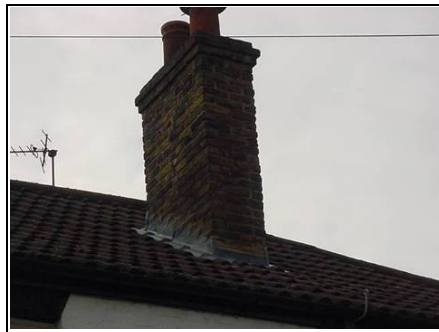
Front Chimney

This chimney is brick finished with two chimney pots with a metal flashing that we believe to be lead. From what we could see the chimney looks in average condition. Unfortunately we were unable to see the top of the chimney known as the flaunchings we therefore cannot comment upon them.

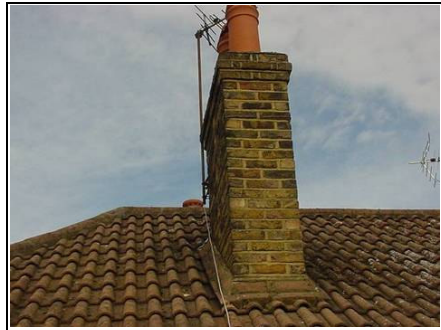
Rear Chimney

This chimney is brick finished with a tile on edge flashing and two chimney pots. The chimney has been re-pointed over the years and is in average condition.

ACTION REQUIRED: The tile on edge flashing should be replaced with a lead flashing as these keep a much better watertight seal as they are more pliable.

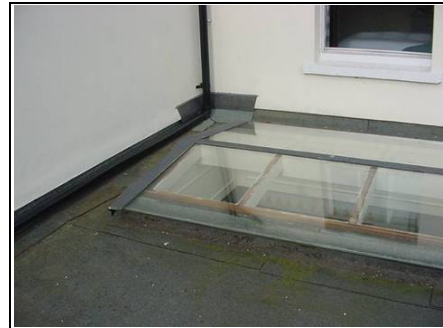
Low Level Roof Window

Please see our comments in the Executive Summary. Ideally the roof windows should be replaced and we also recommend that the high level one within the shower room is made openable. Both the current roof windows are purpose made, so it may actually be difficult to buy off-the-shelf. We would always recommend the bubble-type of roof window for a flat roof, i.e. this means that the water cannot sit on it. Having said all of that it seems inevitable with roof windows that they will sooner or later leak. If this doesn't occur then they seem prone to condensation. Keep a cloth handy!

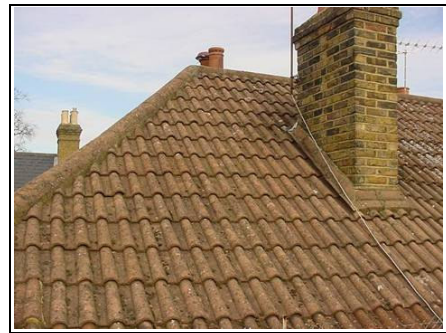
The main roof is pitched and clad with concrete tiles, known as a Roman tiles; from ground level this looks in reasonable condition. With this age of roof there will usually be a few missing, displaced or cracked tiles, this is nothing unusual.

ACTION REQUIRED: Carry out periodic inspections and maintenance of the roof, as required.

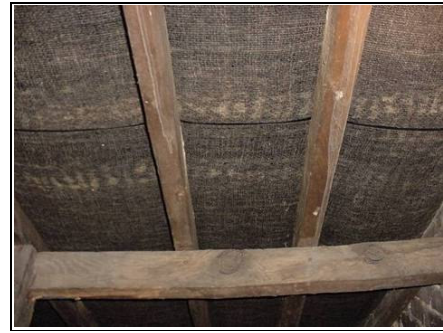
When we inspected the loft space we found a Hessian base Bitumen membrane. This type of membrane has been used since the 1960s. We generally found it to be in average condition, although it is damaged in a few places but this is not unusual considering its age.

This photo shows the common rafters (the ones that form the pitch of the roof) and the dark area between is the underlayer.

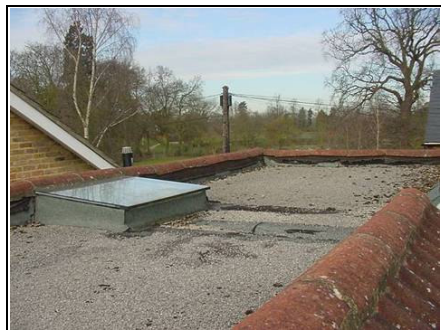
The high level flat roof is over the rear bedroom and shower room. This roof has a felt finish with pea-shingle over it. This type of roof finish has not been in general use for the past twenty-odd years, although we do occasionally come across it. It has a very awkward central valley gutter detail and the flashings around the edge are in felt and look to be starting to deteriorate. We did not access this roof but viewed it off a ladder.

General View of high level flat roof. The roof window in this photo is the one that gives light to the shower room.

ACTION REQUIRED: Please see our comments in the Executive Summary. We would recommend that this roof is re-felted and insulation is added.

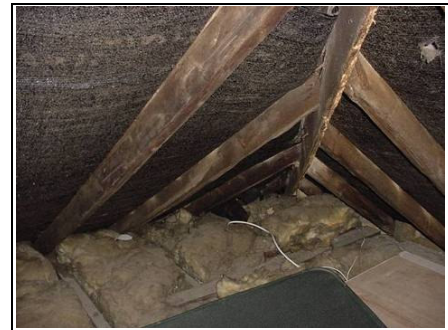
General view

The dark areas on the timber are from condensation occurring.

We found condensation in the roof in the form of darker areas in the timber, indicating dampness. The roof therefore needs to be vented. We also believe it needs more props. There has also been movement in the roof and these defects have in turn caused deterioration to the timbers.

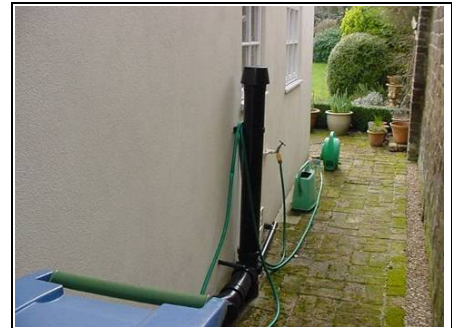
We noted an external air inlet valve; these are normally seen internally. We believe that under the current Building Regulations that they should discharge above roof level; we assume that the builder did this to avoid the difficulty of running the soil and vent pipe up to the roof.

External air inlet valve.

ACTION REQUIRED: You need to decided to either maintain the cast iron or replace with plastic.

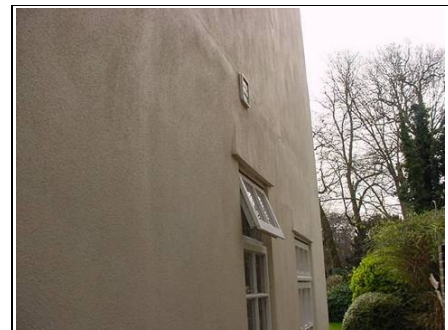
The side and rear walls to this property are finished in a smooth faced painted render. We have carried out a tap test to the render at low level (literally hitting the render with the back of a hammer) to try to establish if there are any hollow areas. We have found some areas but this is typical for this age of property.

The render to the base in this instance goes down to the ground; unfortunately this will help dampness get into the structure.

ACTION REQUIRED: Form a bell-mouth to the base of the render. We would also recommend a French gully.

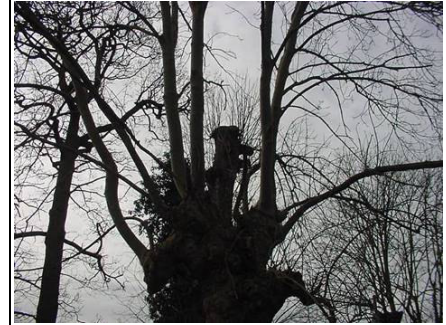
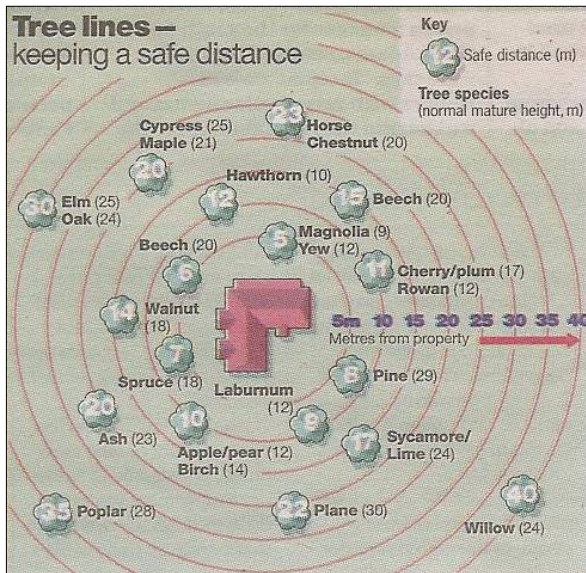
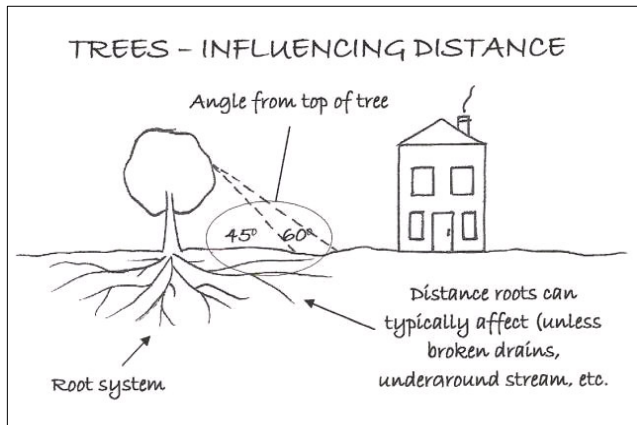
There are some trees surrounding the property. It should be remembered that trees need professional maintenance on a regular basis, particularly when they are of this height. We could see that the trees have been pollarded in the past.

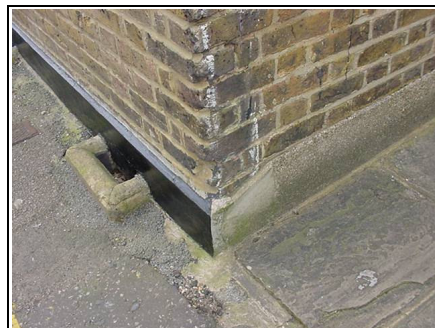
Unfortunately we could not see a damp proof course (DPC) because of the render plinth. It is possible that there is a slate damp proof course behind the render and in the newer construction we believe that there is probably a damp proof course built in. What is happening is that the render is bypassing the damp proof course, almost like blotting paper, and the dampness is drawn into the property.

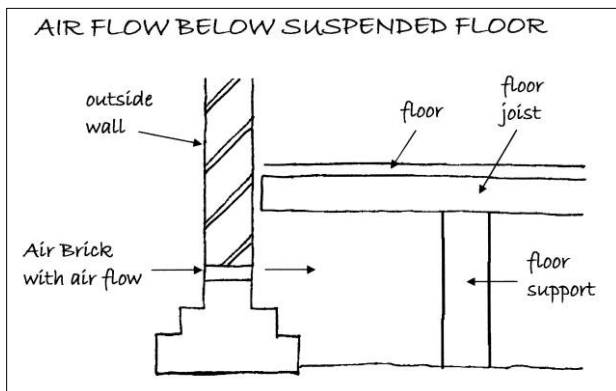
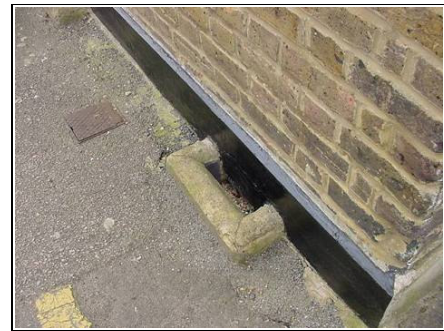
We were pleased to see airbricks that are guarded from allowing rain water in, as if this was not the case it can lead to deterioration in the floor structure.

The edging around the airbrick stops rain water getting in

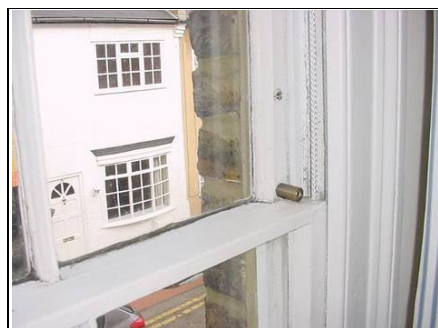
The property predominantly has painted timber sliding sash windows with some more modern casement windows, which are single glazed. Generally we consider the windows to be in slightly below average condition.

Sliding sash window to front

ACTION REQUIRED: Maintenance required in the form of redecoration.

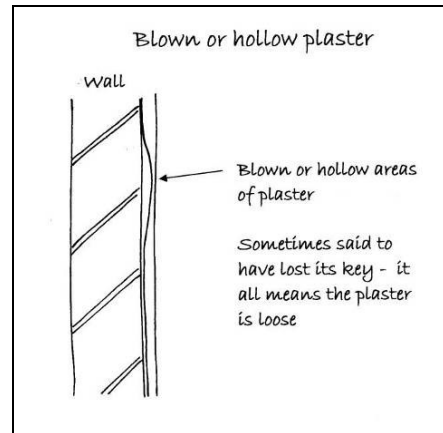
To the perimeter we found some areas of blown plaster, which is not uncommon in properties of this age, particularly around the window and door openings and around the chimney area. We would also specifically mention the damp rear reception room where the plaster is hollow. When redecorating you may have to do some re-plastering or use lining paper.

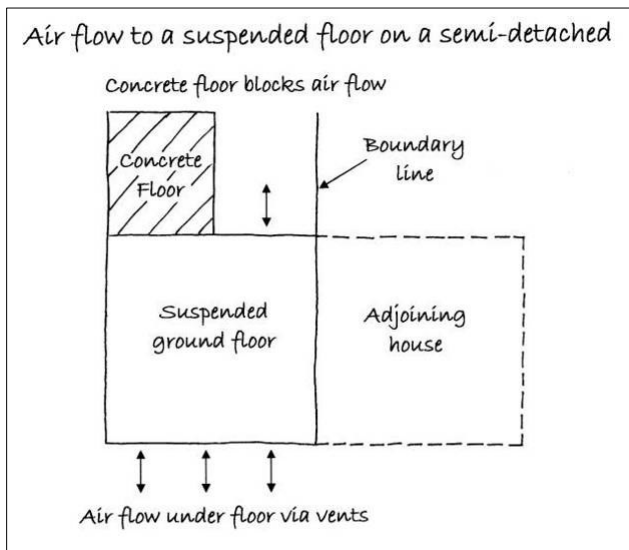
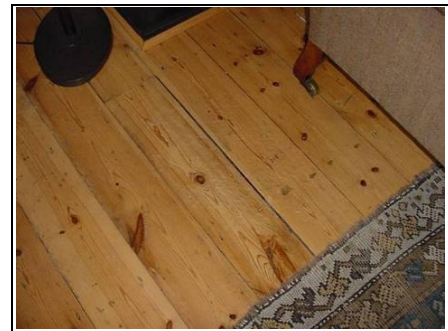
The ground floor is suspended timber to the front part of the property and solid under foot to the rear part of the property, assumed to be concrete. This type of floor needs air circulation underneath it to reduce deterioration from wet rot and dry rot; please see our comments in these sections and also the sketch to see how the rear extension effectively blocks the ventilation of the floor.

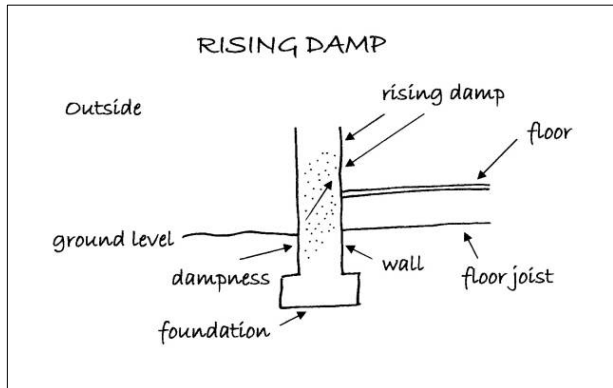
We did find dampness in the property and feel that it is unacceptably high in the rear reception room. We recommend that the entire property is re-checked.

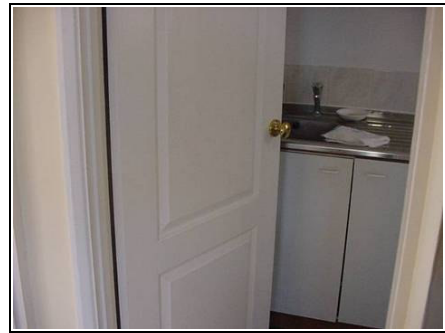
Hollow core door

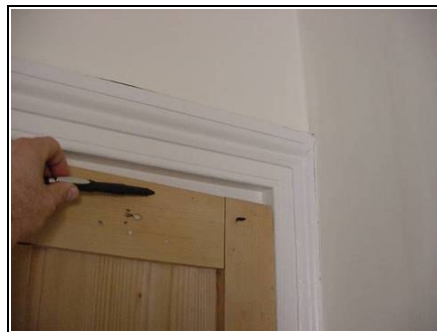
New doors fitted into old frame

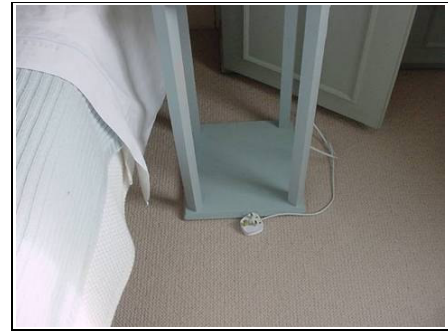
The house was presented to sell, often known as 'dressed', for example there were lights where we could not find any socket points!

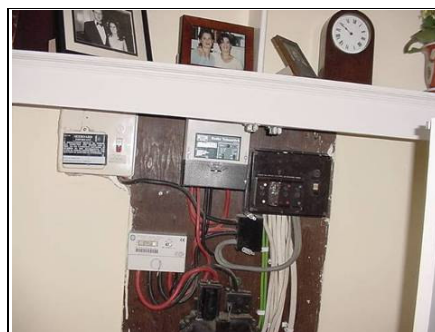
The electric fuses and consumer units were located in the lounge to the left hand side. We would date the fuse board as being from the 1960s. Rewireable fuses are now superseded. Far better fuse boards are now available.

ACTION REQUIRED: Replace the fuse board.

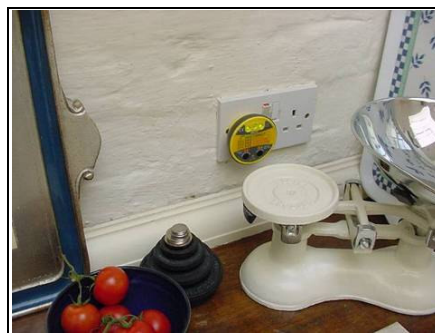
We carried out an earth test in the kitchen area to the socket point that is normally used for the kettle and this proved satisfactory.

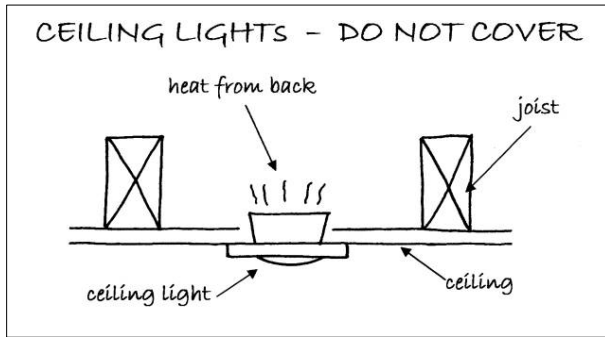
The property has electric inset lights to the ceiling. In some instances these can cause problems as the heat given off has in some cases lead to outbreaks of fire; these tend to be in the older type of ceiling lights and we recommend that where ceiling lights are used that the rear of the light is not covered; this is particularly the case in rooms with a loft space above it where stored items are placed in it.

Inset ceiling light

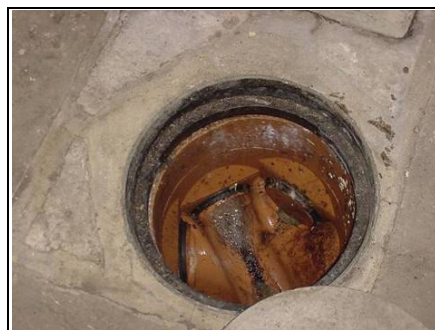
We duly lifted the manhole/ inspection chamber cover and found the drain to be free flowing and pre formed in plastic.

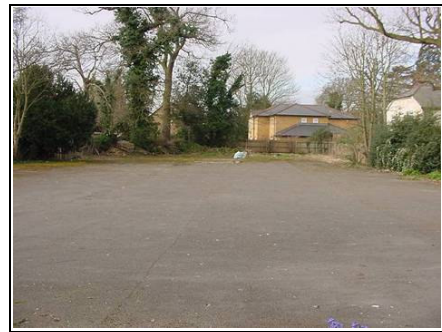
There is a car park to the rear of the property; we are advised that this is for the Working Men's Club.

Car park to the rear of the property

ACTION REQUIRED: Your Legal Advisor needs to check that there is no pending or future planning on this land.

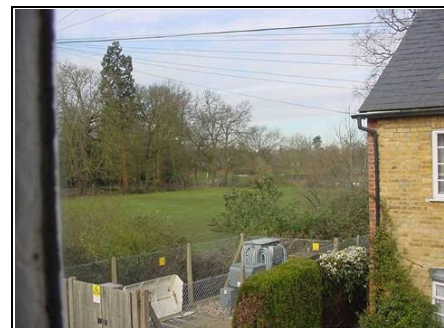
There is an electricity sub station near the property. Concerns have been expressed with regard to health risks in connection with the above average electro-magnetic fields. Whilst health risks have not been proven some purchaser may be deterred.

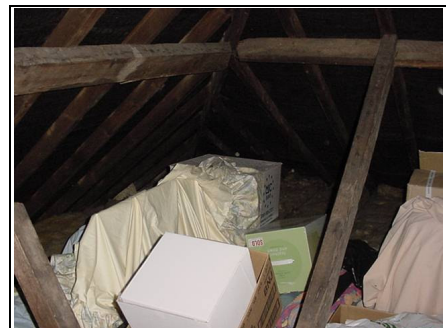
Unfortunately in this instance our inspection has been very limited due to a large number of stored items within the roof space, which limited our view and also we were unable to gain access under the floor areas.
