RESIDENTIAL BUILDING SURVEY

Welwyn Garden City, Hertfordshire AL8

INDEPENDENT CHARTERED SURVEYORS

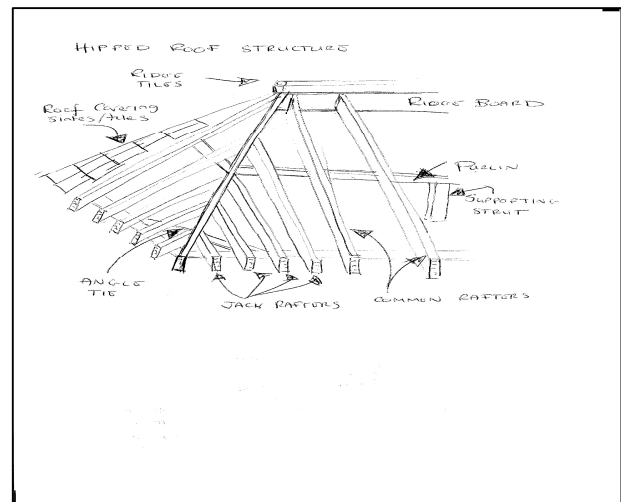
Moss on concrete tiles can cause problems with damage to the face of the tiles and blocked gutters. The side that we can see has minor moss but we often find the sides near the trees have excessive moss

You need to check the entire roof and clear it of moss.

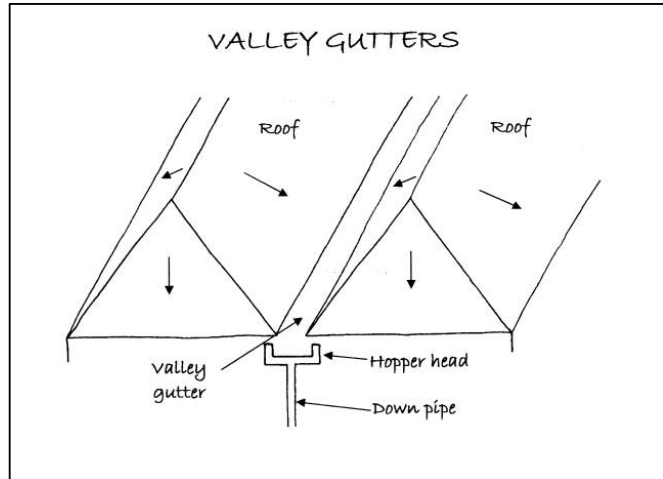
Valley Gutter

There are several valley gutters to the property. Valley gutters occur where two roofs join and are generally considered weak areas. In this instance we can see that it is getting blocked with leaves etc.

ACTION REQUIRED: Remove the leaves from the valley gutters and also check the sides of the valley gutters as these often come away.

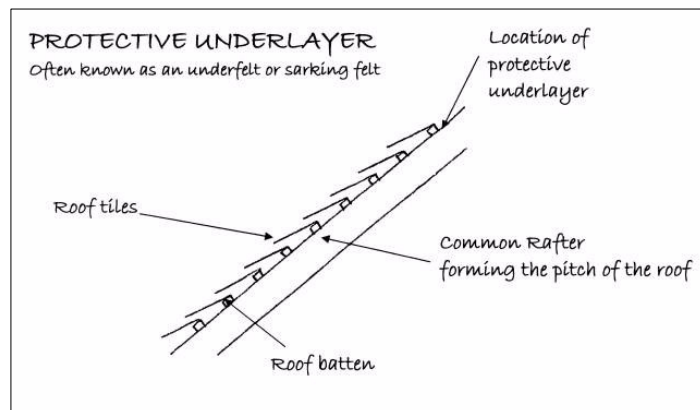
The underlayer is formed from a Bitumen based paper which is brittle and fragile. Although it is not in good condition it is very difficult to advise to replace it, as to remove and replace the underlayer is a very expensive job because the entirety of the roof covering has to be removed.

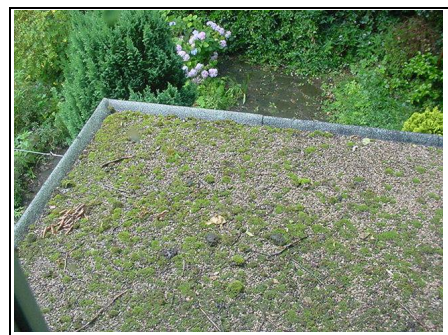
Flat roof to front of property

Where the roof meets the main building we could see a felt flashing.

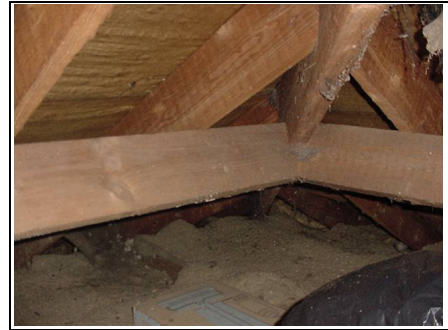
Photograph of the junction of the hipped roof

Our examination was limited by the general configuration of the roof, the insulation and stored items. As mentioned what we could see was generally found to be in average to above average condition considering the property has movement. We would normally expect to find some movement to the actual hips of the roof. It is, however, feasible that there are problems in the roof that are hidden.

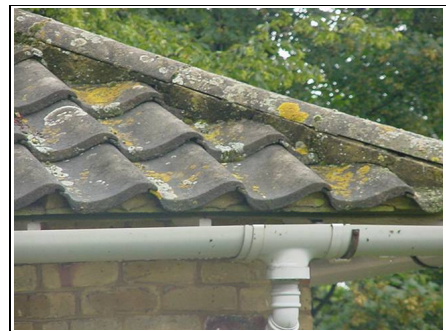
We believe the gutter is what is known as a deep flow gutter, which is a wider gutter than you would normally find, which in our opinion is a great help where you have the likelihood of leaves going in the gutter, as in this instance. There may be a few repairs, but we feel that most people would be happy with getting these carried out.

ACTION REQUIRED: We would always recommend that the gutters and downpipes are cleaned out, the joints are checked and the alignment checked to ensure that the gutters fall towards the downpipes.

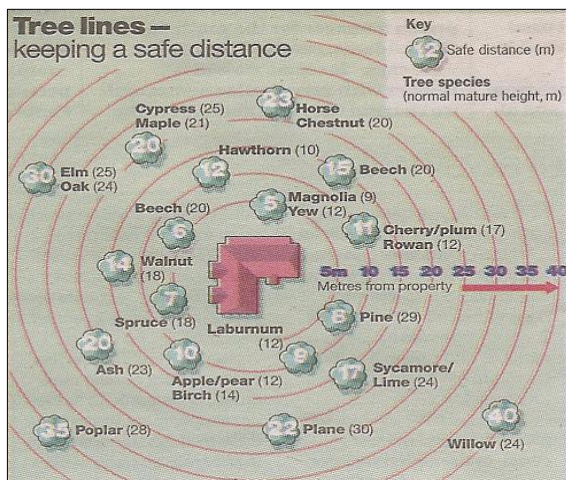
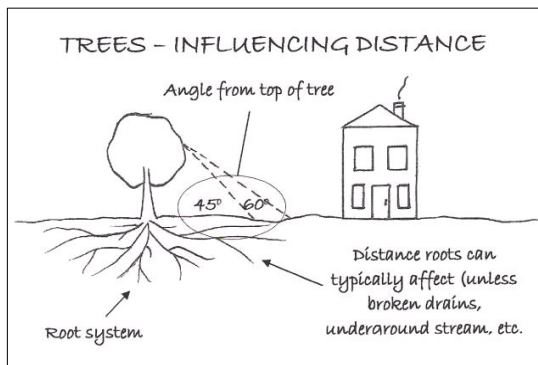
As this is a clay soil it can affect the condition considerably. Unfortunately, the oak trees are not within the bounds of your property and therefore you do not have control over their maintenance. You only receive the resulting problems from lack of maintenance. It is a fine balance with trees such as these between maintaining them in such a way that it is going to create subsidence by extracting too much water from the soil, or heave by extracting too little water from the soil. The clay type soil in this area (according to the report) can be affected considerably by the water content.

ACTION REQUIRED: You need to obtain advice from an arboriculturist (not a tree surgeon).

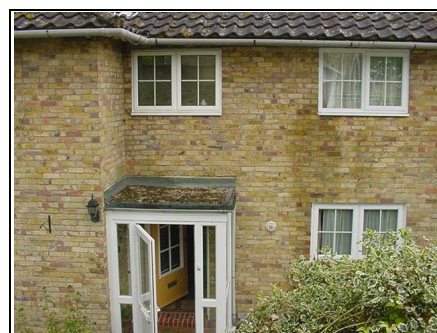
We would draw your attention to the fact that sealed double glazed units can fail, particularly as a result of poor workmanship during installation. Failure of the seal leads to condensation between the two panes of glass and simply replacing the affected units may not provide a satisfactory long-term solution. In this case they are in average condition.

A selection of front windows and doors

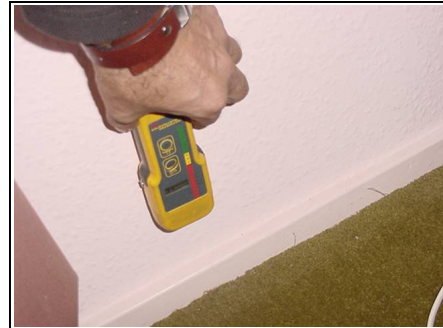
No evidence of any significant rising dampness was detected in the random areas checked. The property sits on a sloping site with a proof course not being consistently two bricks above ground level. It is not unusual in a property of this type and age to have minor damp particularly to the rear. We believe most people will be happy to live with this.

Checking for rising damp

ACTION REQUIRED: If you wish to be 100% certain, we would recommend a damp proof test by a BWPBA approved contractor, who can offer an insured guarantee for any work carried out.
