RESIDENTIAL BUILDING SURVEY
OF
A 1980's Detached Bungalow, Whittlesey, Cambridgeshire

FOR
Mr.Q

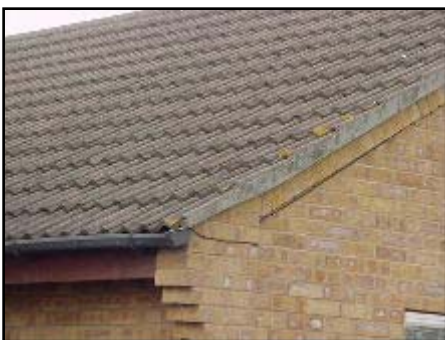
The main roof is pitched and clad in a large inter locking concrete tile. From what we could see the concrete tiles are lying level and true and look in reasonable condition considering their age. Sometimes we find that deterioration to the ridges and the perimeter. You should periodically check these areas.

A general view of the roof.

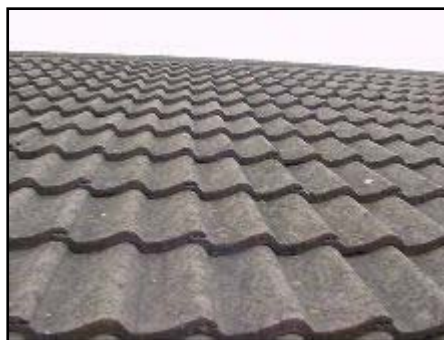
This is a close up view of the roof.

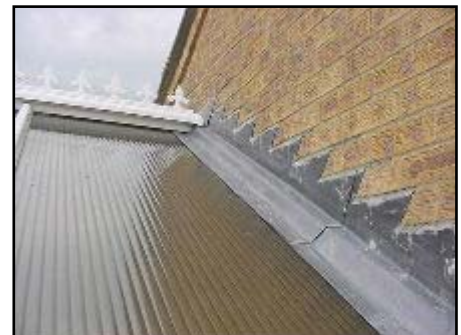
The conservatory roof is in a polycarbonate (polycarbonate is a plastic, in this case a reinforced plastic). The roof generally looks in reasonable condition. We did not notice any ponding or staining. We generally find that roofs that have a reasonable fall on them tend to be the most watertight. We would warn that these roofs tend to leak sooner or later, this is just part of the fact of life on a modern conservatory. Where the conservatory meets the main building there is a lead flashing, which in our opinion is the best type of flashing.

The polycarbonate conservatory roof meeting the main building with a lead flashing.

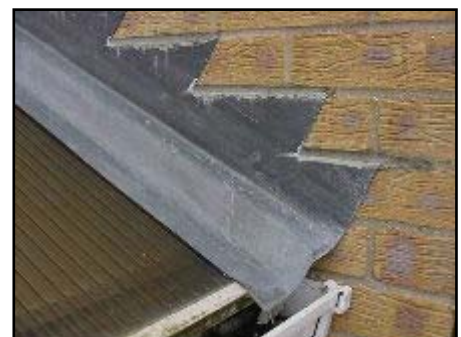
Close up of lead flashing.

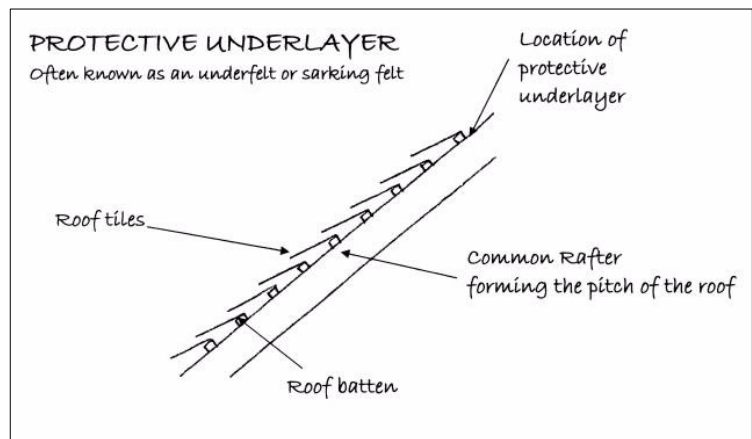
To the main roof, the property has a Hessian based underlayer, which is in reasonable condition. As you would expect to find to some areas there is minor deterioration. This is acceptable given the relatively newness of this property.

This photo shows the common rafters (the ones that form the pitch of the roof) and the dark area between is the underlayer.

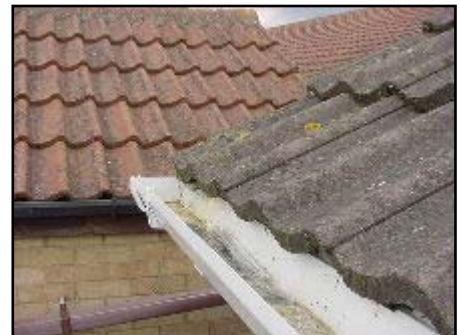
From ground level the gutters and downpipes looked to be plastic and appeared in reasonable condition. There may be some minor leaks, but we feel that most people could live with these.

ACTION REQUIRED: We would always recommend that the gutters and downpipes are cleaned out, the joints are checked and the alignment checked to ensure that the gutters fall towards the downpipes.

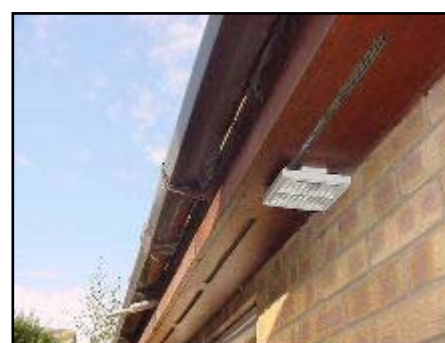
We noted that the timber fascia and soffit boards had air vents. You need to check in the roof that there is no insulation in the way and that these will allow airflow. When we were in the roof it certainly did not feel like there was any flow as it was very still and hot in the roof area.

Vented soffit to the left hand side.

This may be because of the plastic fascia and soffit boards that have been added that are stopping a through flow.

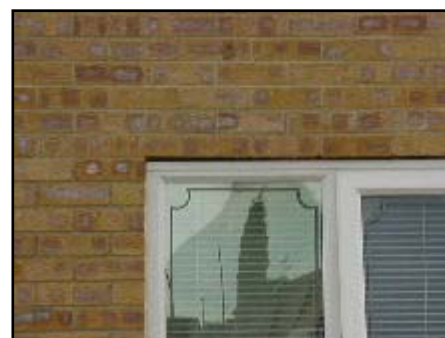
The property has plastic double-glazed windows, which generally look to be of a reasonable quality, although we did not note any trickle vents (trickle vents allow an air flow into the property). We would add manufacturers are getting better at hiding them.

We would draw your attention to the fact that sealed double-glazed units can fail particularly as a result of poor workmanship during installation. Failure of the seal leads to condensation between the two panes of glass and simply replacing the affected units may not provide a satisfactory long-term solution. In this case they are in average condition.

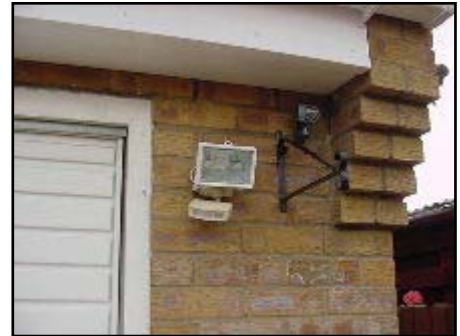
A security system was noted. We discussed this during our question and answer and where advised it only partly works at present.

It is a personal decision as to whether you feel one is necessary. We are not experts in this field and therefore cannot comment further. We suggest you contact a member of NACOSS (National Approval Council for Security Services), obtainable through directory enquiries, or your local Police Force for advice on a security system.

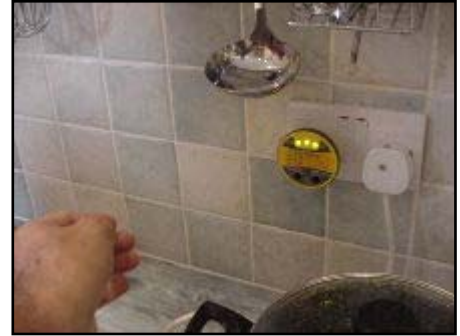
We carried out an earth test in the kitchen area to the socket point that is normally used for the kettle, this proved satisfactory.

ACTION REQUIRED: If there is no record of an electrical test having been undertaken within the last five years, it is recommended that the installation be tested by a competent electrician (NICEIC registered) and all recommendations implemented. Thereafter, the installation should be re-tested every five years.

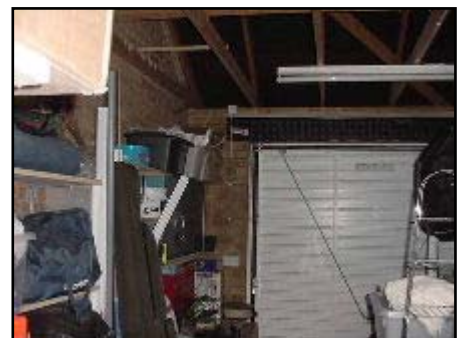
The property has an integral garage and off road parking on a shingle driveway.

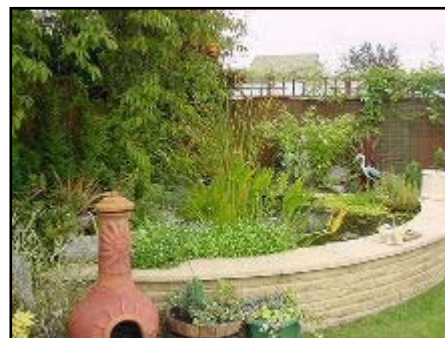
Boundaries: The left hand boundary (all directions given as you face the property) is usually the responsibility of the subject property.

Finally, whilst we note the boundaries, these may not be the legal boundaries. Your Legal Advisor should make further enquiries on this point and advise you of your potential liability with regard to any shared structures, boundary walls and fences.
