RESIDENTIAL BUILDING SURVEY
OF
A 1900's Semi-Detached Property, Whittlesford,
Cambridgeshire

Dr M

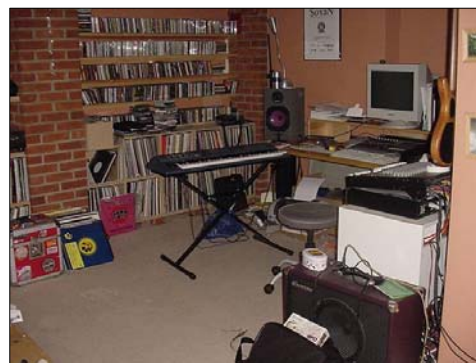
We found some minor areas of rising damp in the kitchen. We were expecting to find more. Our inspection was limited by the furniture, particularly the massive LP collection, the likes of which we have not seen before! (We assume from the equipment that the owner was a musician/DJ).

An example of the record collection that got in the way of us checking the walls properly.

ACTION REQUIRED: To be on the safe side we recommend that you have a damp proof estimate but insist that the owner moves the record collection away from the wall. Have a damp proof contractor carry out quotations for damp proofing work. The owner of the property will need to ensure that the record collection is moved back from the wall!

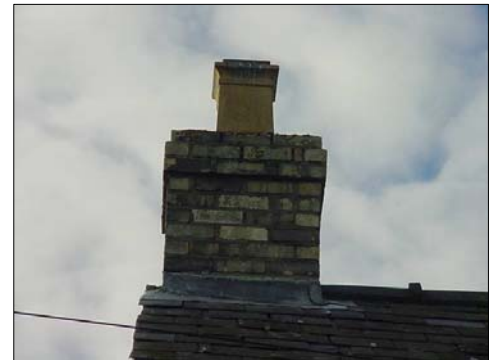
The property has one chimney which is located to the left hand side on the main roof. This is a brick chimney finished with a lead flashing which has one chimney pot. The chimney is in reasonably good condition although in need of some minor repointing. Unfortunately we were unable to see the flaunchings, we therefore cannot comment upon them other than to say the chimney is standing up straight which is a fairly good indicator that the flaunchings are in reasonable condition.

Front view of the chimney.

ACTION REQUIRED: Ideally a general repointing of the chimney, the sooner this is carried out the better in the summer of 2005.

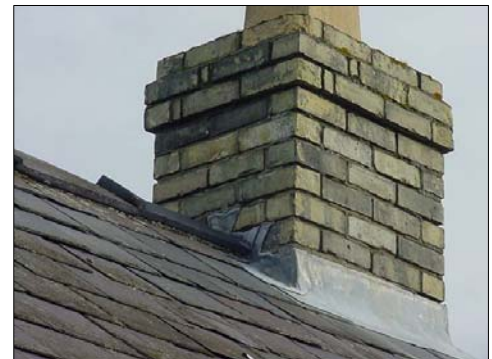
Rear view of the chimney.

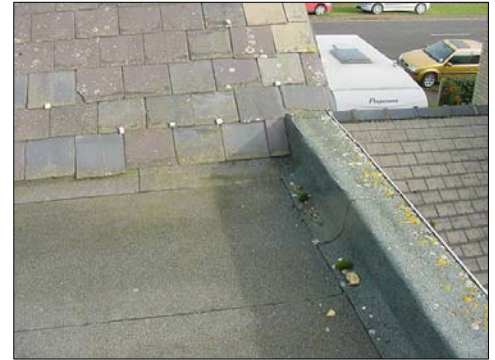
These are brick built with a felt flashing and looked in reasonable condition, although there was some hairline cracking to the face of the brickwork. Please see the Walls section.

We carried out tests internally with a damp meter to check if there was any water getting through. We found one area with some dampness but nothing to be overly concerned with (this is in the main rear bedroom).

A view of the high level parapet wall.

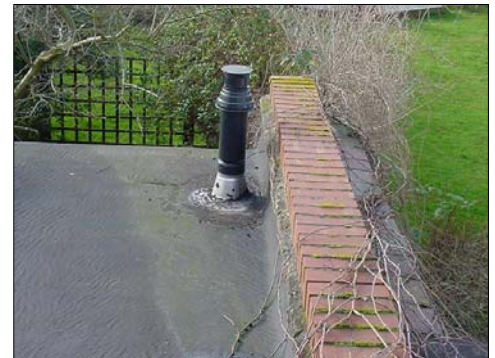
This is completely covered in felt with a brick coping stone. Dampness typically gets in through this type of brick coping stone and weakens mortar joints, although at present we cannot see any dampness getting in. We did note deterioration in one area; this should be picked up by the Roofer that we recommend to have a look at this roof in general. Ask him to repoint the parapet wall. You need to specifically ask him as the work simply won't be carried out unless you do.

In this photo you can see the weak area of mortar that is common in this sort of parapet wall.

A general view of the parapet wall.

ACTION REQUIRED: We did note one area of deterioration. This needs to be picked up by a Roofer.

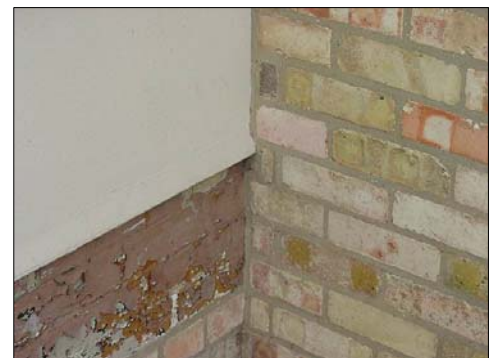
The render at the base of the wall has been formed into a bell-mouth drip detail, which should help stop dampness getting into the structure.

The bell mouth drip detail to the base of the render.

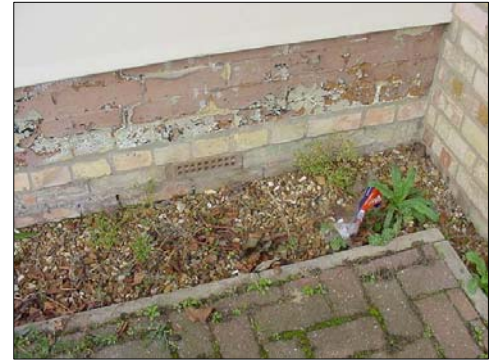
An example of an airbrick in the centre of the photo.

This indicates that the property had suspended timber floors. These appear to have been replaced in some areas with concrete floor. We do feel that there is probably a suspended timber floor to the front of the property; unfortunately this will have deteriorated due to there being a lack of air flow underneath the floor.

ACTION REQUIRED: There is no real easy solution to this as we believe there is likely to be rot under the floor. Apart from opening it up to check the extent of the rot we don't feel that it will be necessary at this time to replace the floor, although in the long term it may well be. We suggest that you phone us with regard to this point to discuss it further.
