RESIDENTIAL BUILDING SURVEY

Wimbledon, London. SW19

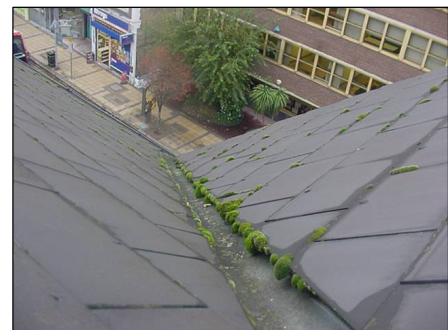
Moss

The roof is pitched and clad in manmade slates, which sit fairly true, although there is some moss and missing verge detail with slipped and cracked slates. Whilst we would not normally comment on this on an older quarried slate roof, with a manmade slate roof this means it is in fairly poor condition.

If you look closely at the photograph you will see that moss has gathered, we rarely come across this and we believe it is due to wind driven rain which will ultimately lead to deterioration of the slates.

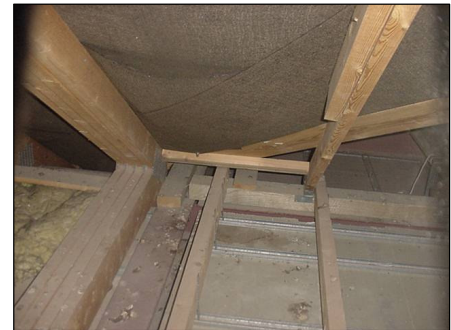
When we inspected the loft space we found a Hessian base Bitumen membrane. This type of membrane has been used since the 1960s. We generally found it to be in average condition, it is damaged in a few more places than we normally find.

This photo shows the common rafters (the ones that form the pitch of the roof) and the dark area between is the underlayer.

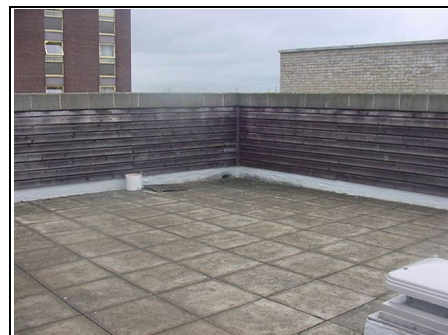
The other main roof is a flat Asphalt roof with paver slabs on the top of it, this is commonly known as a warm roof. We are not certain of what the decking beneath is, it could be timber or a metal or concrete structural frame.

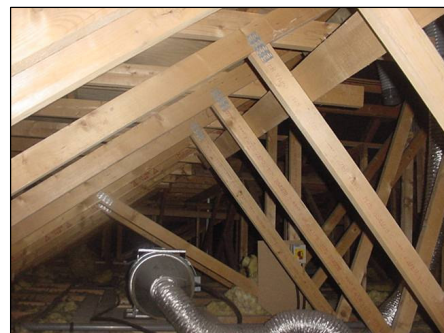
Inside roof

These are made in a factory and transported to site and then lifted into place. Without the manufacturer's calculations and/or structural engineers calculations and installation details we cannot comment categorically on the roof structure. We would however comment that we were surprised to see that there is a flat roof above it which was hidden from our viewing.

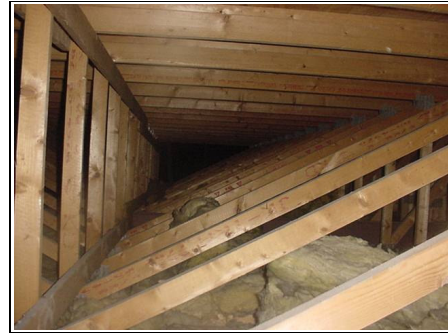
Inside main pitched roof

Our examination is also impeded by the general configuration of the roof, the insulation (in some cases where it had been put down), as mentioned what we could see we generally found to be in an average condition considering its age but our view was limited. It is, however, feasible that there are problems in the roof that are hidden. We did note that pigeons had

got into the roof space indicating there are holes in the fascia soffit or roof itself although we did not find these (these should be repaired during a general maintenance check that the management company should have in place).

ACTION REQUIRED: The only way to be 100 per cent certain is to have the roof cleared and checked.

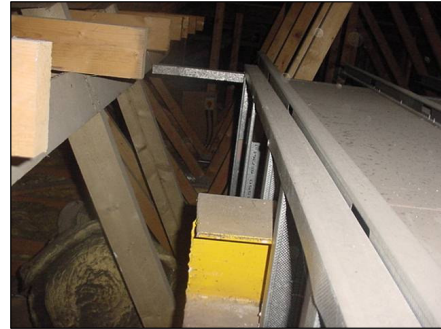
Steels in roof

We believe this property is to have been built with a structural frame as are many properties of this size and this age. We have not been able to see the structural frame, possible exception of in the roof, where we could see metal I beams. Equally the steels could be supporting the lift shaft area only and the property could be built with a modern timber frame construction.

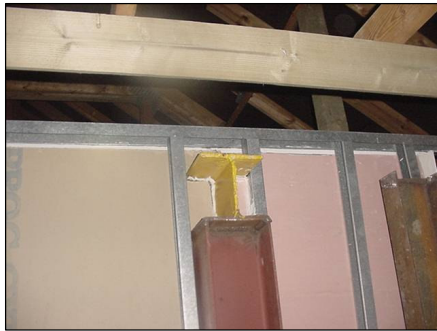
Photograph shows steel structure

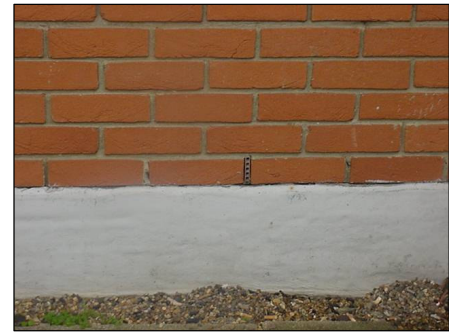
Close up of
brickwork

The Brickwork forms the cladding to the external of the property, where we could see it at ground level the brickwork was in average condition as was the pointing. The Brickwork is likely to be cladding on a structural frame. The inner walls are likely to be formed in blockwork and bonded to the Brickwork outer walls with wall ties. This gives the impression of a traditional stone built property externally.

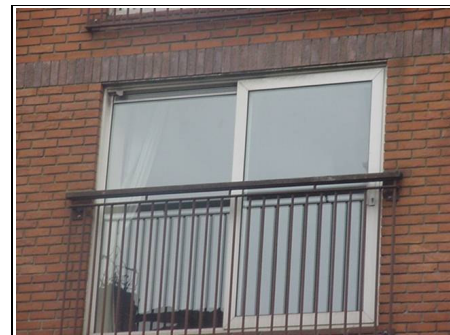
Double glazed window and Juliet balcony

particularly as a result of poor workmanship during installation. Failure of the seal leads to condensation between the two panes of glass and simply replacing the affected units may not provide a satisfactory long-term solution. In this case they are in average condition.

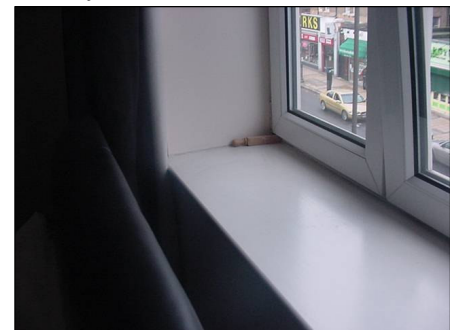
Internal view of window

The property has metal, double glazed windows, set in almost flush to the brickwork we have viewed all the windows from ground level so our view has been limited. We have been able to open the windows although they did have restrictors on them. We were pleased to see trickle vents on the windows.

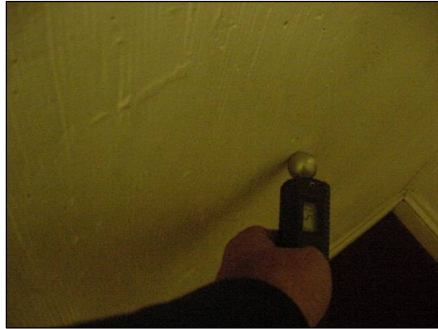
We would normally carry out tests with an electronic damp meter. However, as your property is dry-lined we were unable to do this within your rooms. We have however gone down into the basement and where we could see we noted a concrete formed structure, we checked this for dampness and found it to be acceptable for the area it is in. We therefore carried out a visual inspection and did not find any signs of significant dampness coming through.

Checking for lateral dampness in basement

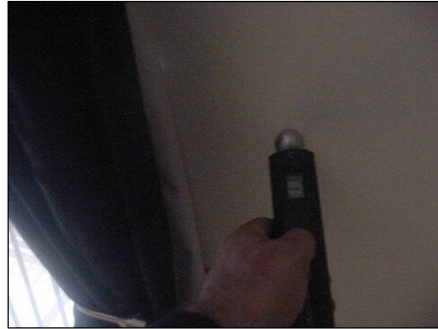
Checking for lateral dampness readings 13-20 indicating dry lined

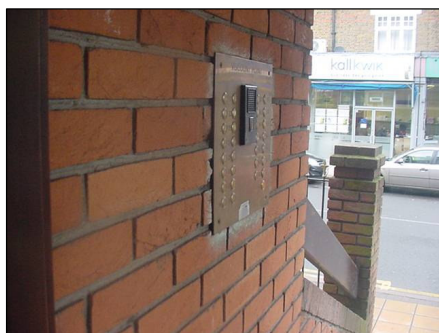
Entry phone system

We noted a door entry intercom on the main door, whilst we prefer video entry systems this is step in the right direction. You need to review all your security needs, the Police will usually be very helpful.

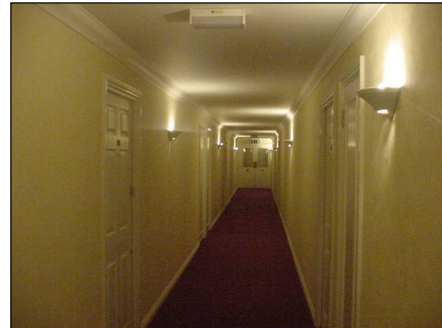
Access corridor

It is important that these are maintained to a good standard, you will also be charged for a share of the lighting costs as well as redecoration costs, your solicitor to check and confirm there is no anticipated future replacement costs.

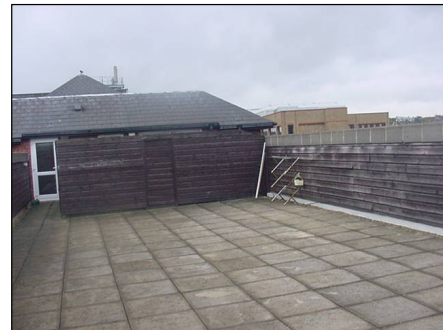
Flat roof area

We have not been made aware of any communal gardens. We did however note that some people were using the flat roof to sit out on, whether this is located space or just that people have decided to use this your legal advisor needs to check this.

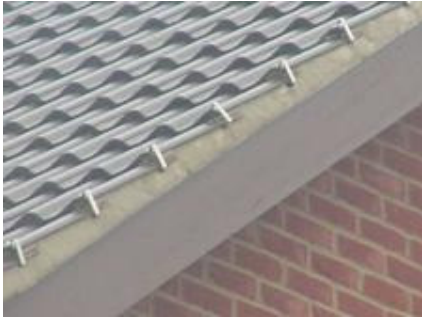
This is a cement verge which has been clipped which tends to happen in high wind areas. To be sure the tiles don't lift, clips also tend to be in areas where cracking can occur to the verge

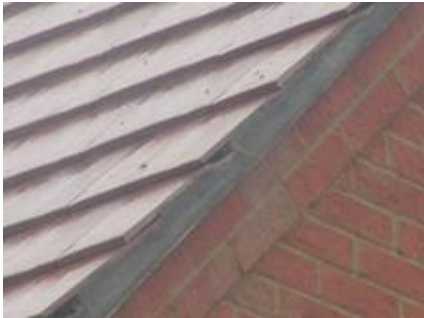
Close up of gaps
