# RESIDENTIAL BUILDING SURVEY

Windermere, LA23

**Mr and Mrs G**

**INDEPENDENT CHARTERED SURVEYORS**

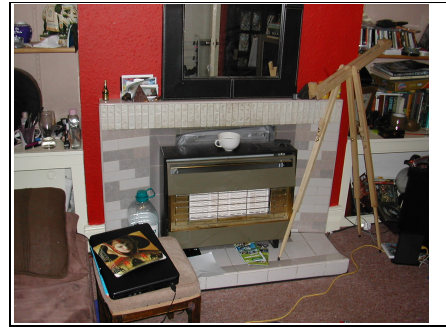
Gas fire

Reference is made in the report to the fact that it was not possible to confirm that the chimney breasts follow through from ground floor (with support in the cellar to the roof space). You need to confirm the precise position and ascertain whether there is a working flue to the gas fires, providing appropriate support if necessary.

**ANTICIPATED COST:** Worst case - allow a budget cost of £3000.

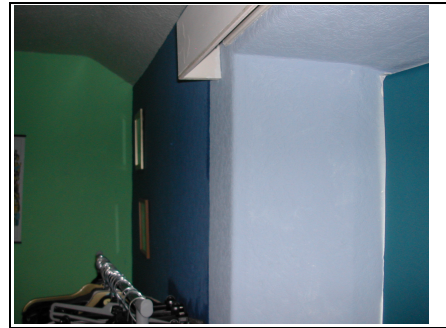
Reference is made to the fact that from the inside the front elevation wall appears to bow outwards. This may suggest that the floor joists have lost their key. Further investigation is required.

Wall appearing to bow

**ANTICIPATED COST:** Worst case – allow a budget of £3000 to rebuild the wall if necessary.

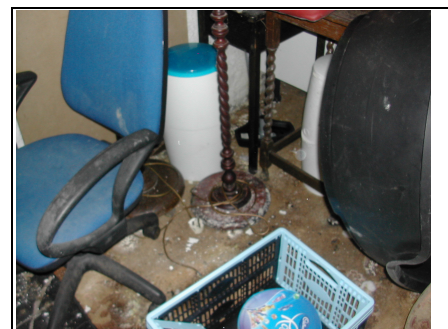
In addition to the comments made about dampness in the property the cellar requires extensive works, including, drying out, the removal of any defective plaster and repair, tanking, and decoration.

**ANTICIPATED COST:** Allow a budget sum of £3500.

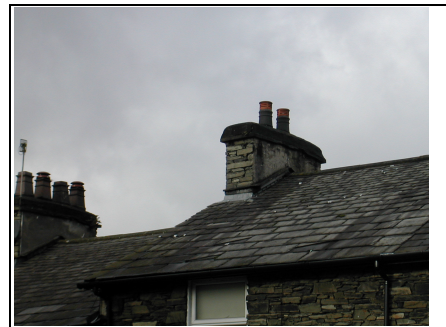
Front view of chimney

This chimney is constructed of Lakeland stone finished with a lead flashing and two number chimney pots. The area around the chimney pots appears to have been filled with cement mortar. From what we could see from ground level it looked in average condition considering its age, type and style. The reverse side of the chimney appears to have been rendered with mortar. Unfortunately we were unable to see the top of the chimney known as the flaunching, we therefore cannot comment upon them.

The chimney to the right of the property with the party wall to the retail outlet appears in similar condition with an area of cement mortar affixed thereto.

Chimneys are the most exposed part of the house and therefore do weather and need re-pointing. Avoid using pure cement when re-pointing, as it is too hard and inflexible. The re-pointing should be carried out with a lime based mortar.

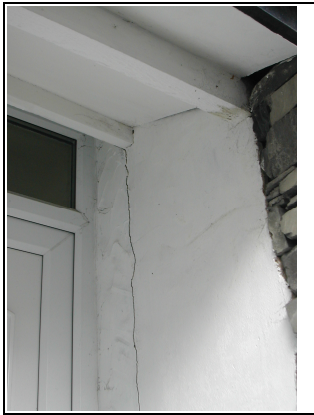
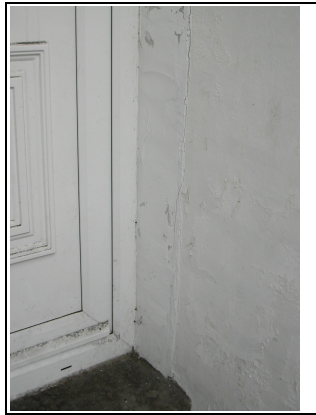
There appears to have been patching around the door frame and there is a hairline crack around it.

Hairline cracking around door frame

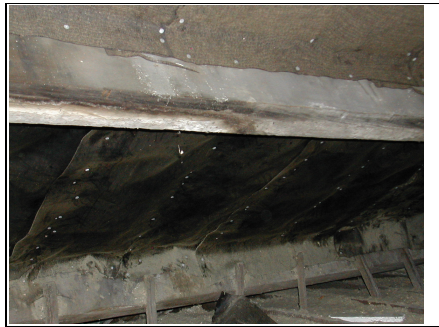
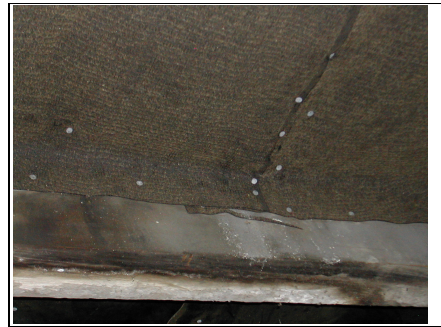
In this case inspection within the roof space showed a roof lining of an unknown material (possibly hessian based) nailed to roof timbers. It was unclear whether there is a further roof lining behind this.

There is a hole in the roof lining near the ridge above the loft hatch.

Roof lining in unknown material

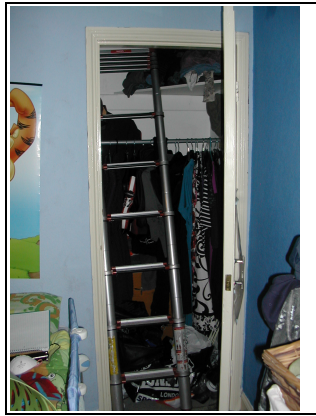
Loft hatch and ladder

The main roof is accessed via the loft hatch located in a cupboard in the front bedroom. There is no loft ladder, electric light or secured floorboards. We recommend that these be added, as it will make the loft space safer and easier to use.

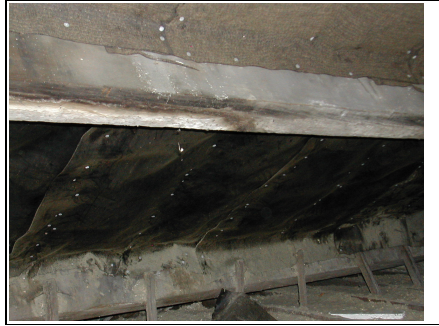
Roof purlins

We consider that the amount of ventilation into the roof space is poor and contributing to the damp and moist conditions found there, including staining to roof timbers.

Further investigation is required to the condition of the purlins and the existence of rot within the timber.

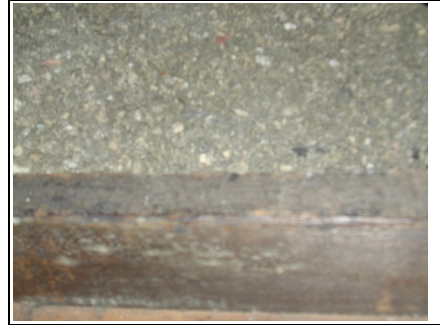
Joist and loose fill insulation

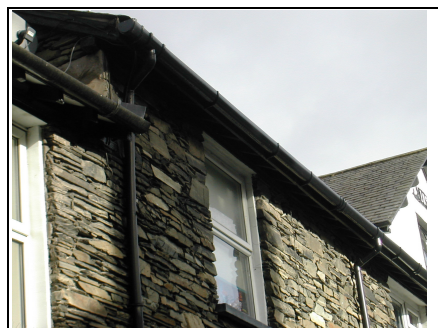
The property has mostly plastic gutters and downpipes (assumed). There are some cast iron sections. The condition is fairly typical of what we see; they are in average condition for their age, type and style.

There may be some minor leaks but most people would be happy to live with these providing repairs are carried out within the next six to twelve months.

Gutters and downpipes

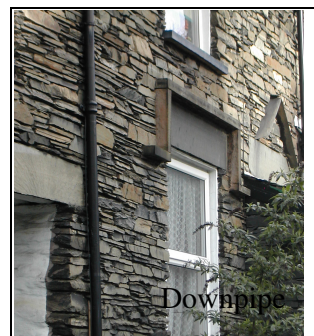
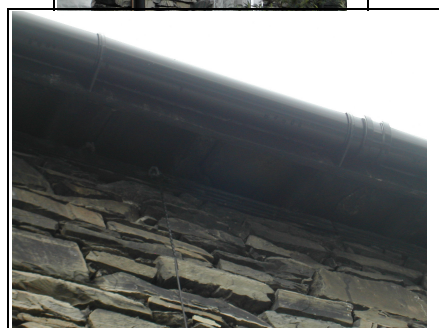
Plastic gutter to rear

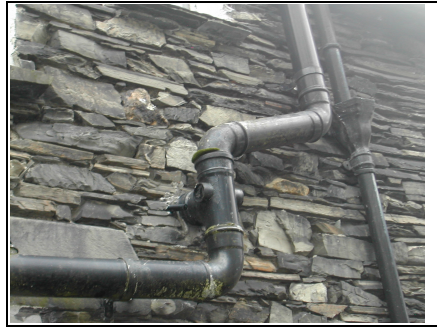
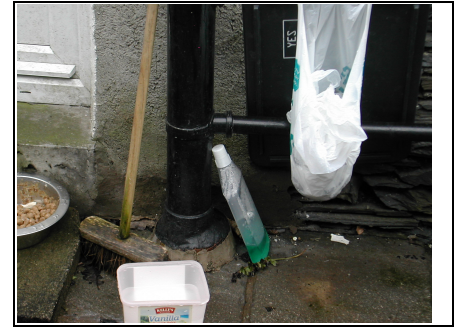
Combined drainage entering the ground

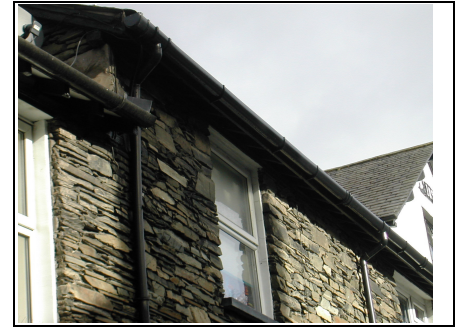
Lakeland stone

Taking into consideration the age, type and style of this property we would say that the stonework and pointing overall is in average condition.

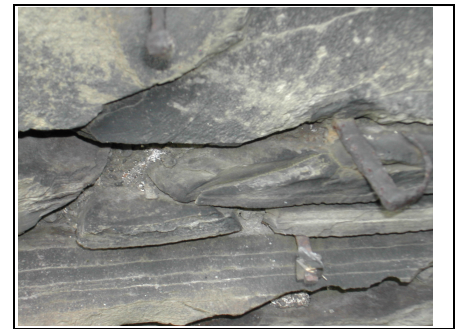
Close up of Lakeland stone

In this particular case the original mortar was of a lime mortar/putty variety. This means, due to the mixture of characteristics, cement being brittle and lime mortar/putty being relatively flexible, deterioration will occur relatively rapidly - re-pointing should be carried out on a like for like basis, i.e. lime mortar/putty re-pointed with lime mortar/putty. Where the lime mortar still exists this is generally in poor condition.

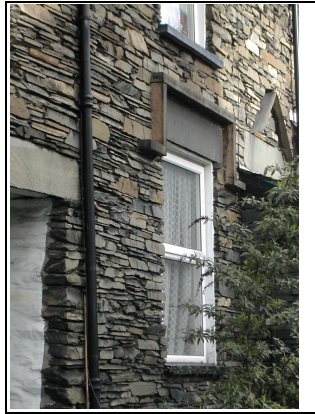
The wall at the rear appeared true and vertical. We also inspected the front elevation wall in view of what we found on the inside face. It appeared generally true; there is a large lintel above the front window which may be stressing the structure and giving rise to the wall appearing to 'bow' when viewed on the inside face.

Front elevation wall with large lintel above

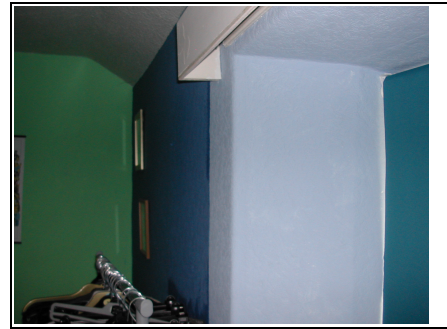
Wall appears to be bowing

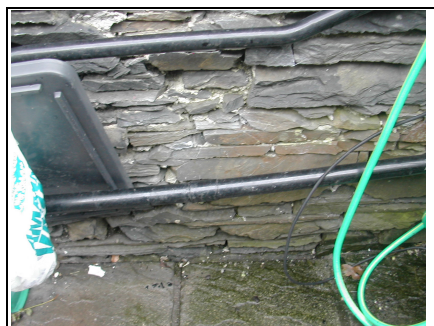
No damp proof course

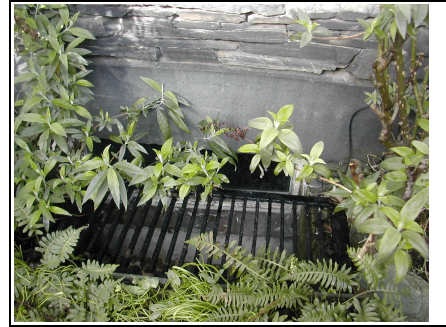
There is a cast iron grid at the base of the front elevation providing ventilation to the cellar.

Cast iron grid to front of property

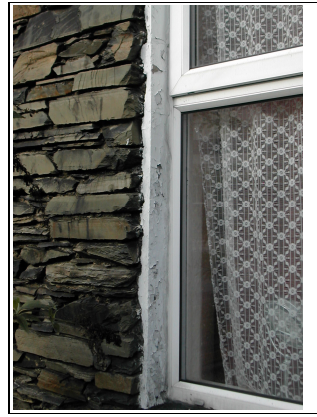
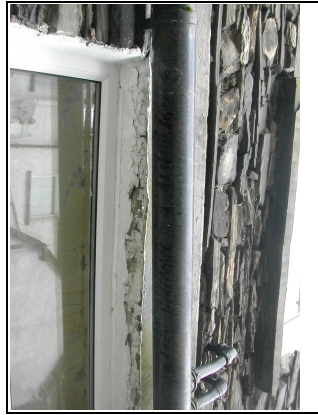
One timber casement to the bathroom was noted. This was in poor condition.

Windows in poor condition

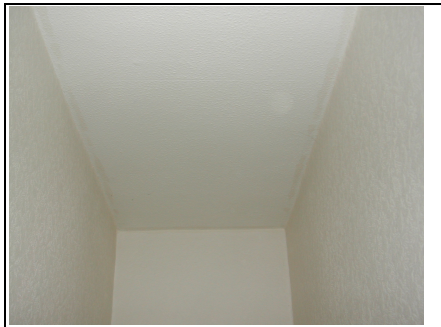
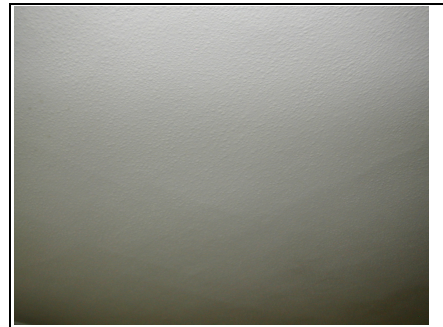
Ceiling

From our visual inspection the ceilings appeared in reasonable condition.

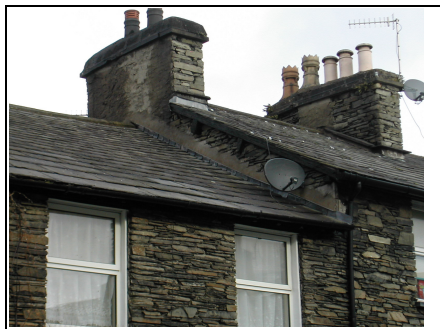
Chimney

We took meter readings on your chimney with our electronic damp meters and found dampness is coming through. This is probably due to the chimney and flashing being defective.

At the time of the survey no chimneys were in use. Any chimneys that you do not propose to use should be capped and ventilated to prevent dampness.

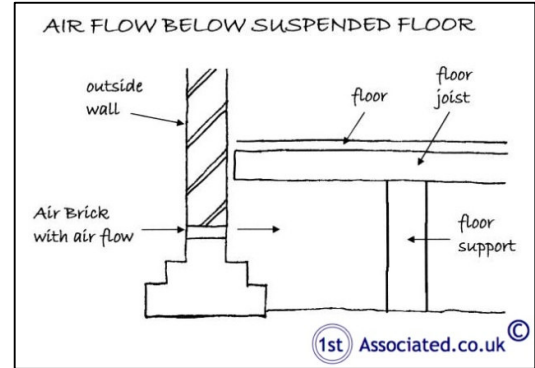
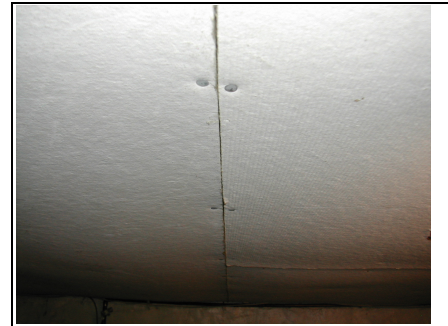
Ground floor concealed by boarding in the cellar

We noted evidence of woodworm through a small gap in the ceiling board to the cellar.

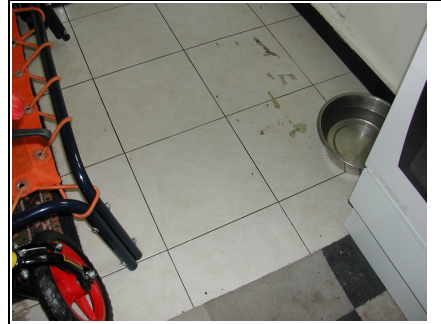
The floor felt damp, and the occupier advised that water penetration occurs during periods of rain.

Solid floor in kitchen

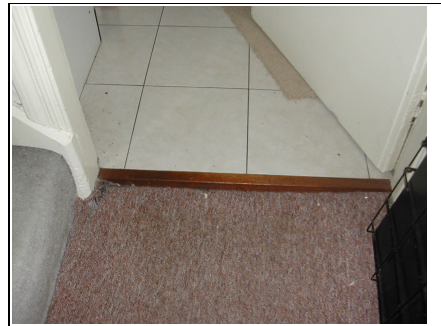
Kitchen floor higher than hallway

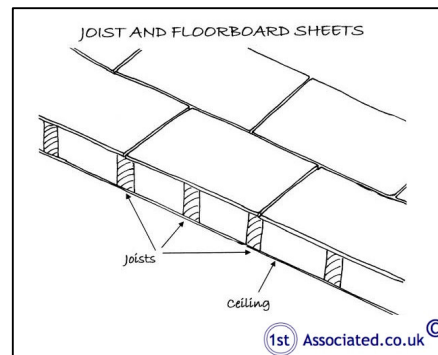
The floor in the rear bedroom has a perceptible slope to it, to the rear of the property.

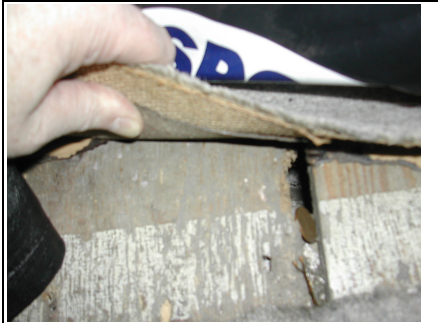
Evidence of woodworm in front bedroom

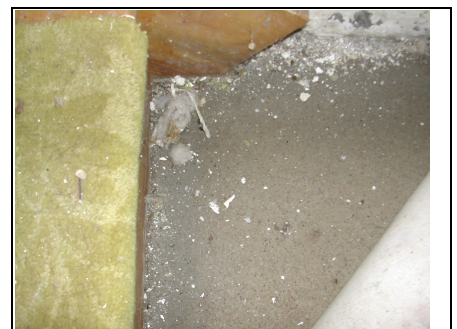
Cellar floor

The perimeter walls in the cellar were also in very poor condition being particularly damp.

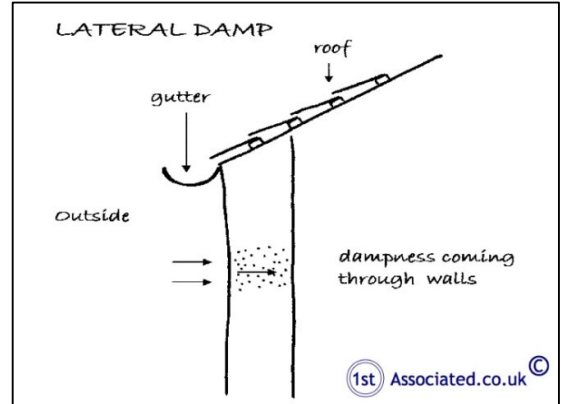
Tests were taken with a moisture meter at random points to internal walls, floors and other surfaces. We generally got high dampness readings and/or visually noticed dampness coming through the property.

The external pointing needs some work to stop the dampness coming through.

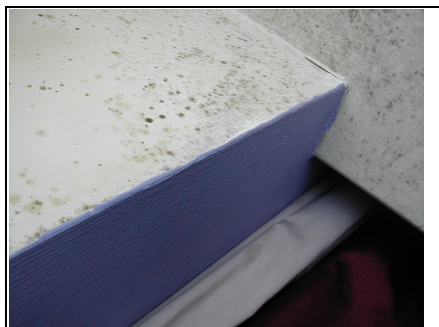
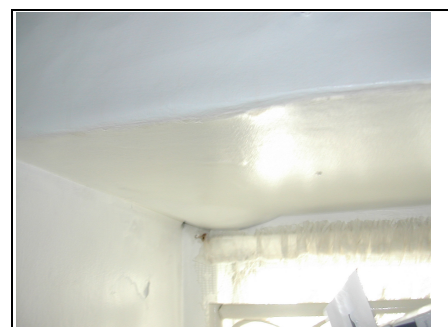
At the time of the inspection there were several areas where there are signs of condensation. We feel that the lack of ventilation in the property means that there is a serious condensation problem.

A way of helping to reduce condensation is to have good large extract fans within the kitchens and bathrooms which are moisture generating areas. We would recommend humidity controlled extract fans be added to kitchens and bathrooms.

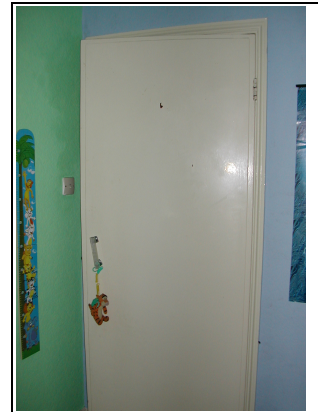
The original doors have been replaced with hollow core doors (sometimes referred to as egg box doors, as this is what the internal of them looks like when they are opened up), they have a paint finish and are slightly marked but nothing unusual.

Hollow core door

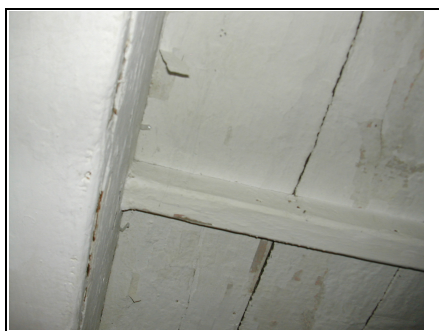
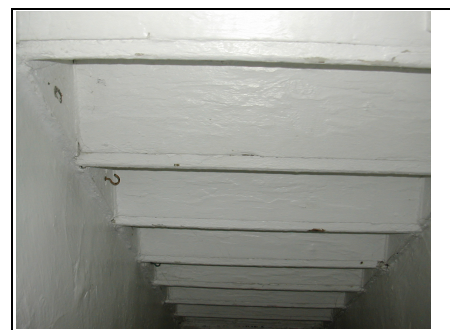
We noted that the underside of the staircase was exposed. It is more normal today to have a half hour fire barrier to stop fire spreading from the ground floor to the first floor in a worst case scenario. You may wish to take a view on whether you add this.

Exposed underside of stairs

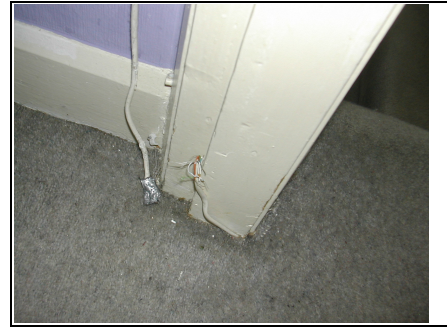
The skirtings have been replaced with a more modern version.

Modern skirting

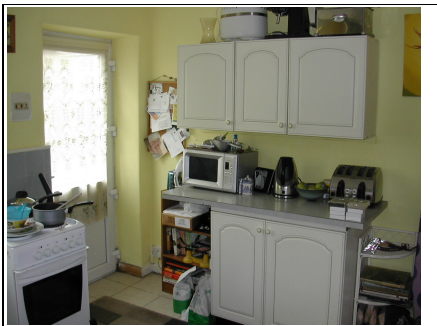
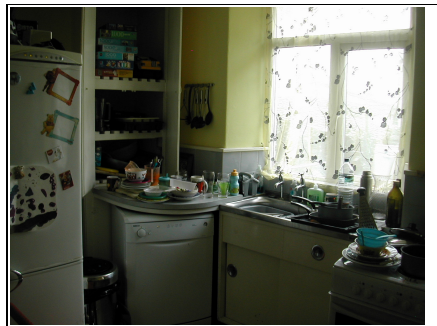
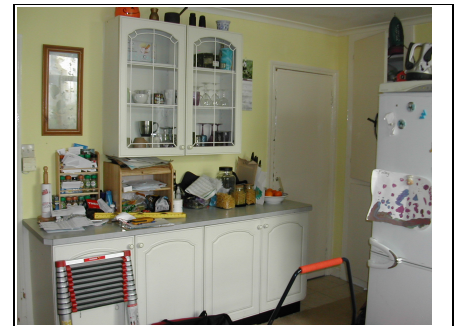
Kitchen

We found the kitchen in poor condition.

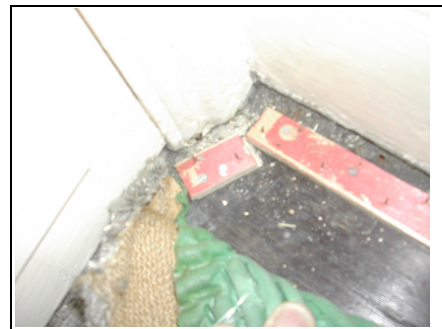
Front bedroom

Within the floor we found signs of woodworm activity at the entrance to the cupboard in the front bedroom, in the ceiling timbers to the side passageway and, in the underside of the lounge floor.

Finally, when you move into the property, floor surfaces should be carefully examined for any signs of insect infestation when furniture and floor coverings are removed together with stored goods. Any signs that are found should be treated to prevent it spreading. However, you need to be aware that many damp and woodworm treatment companies have a vested interest in selling their products and therefore have fairly cleverly worded quotations where they do not state if the woodworm they have found is 'active'. You should ask them specifically if the woodworm is active or not.

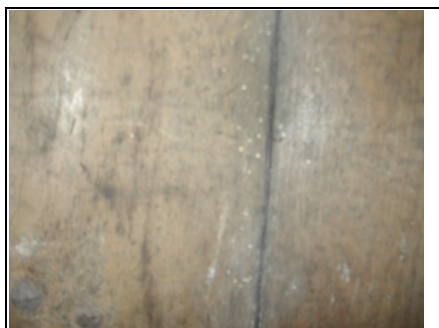
Signs of woodworm activity in the floor

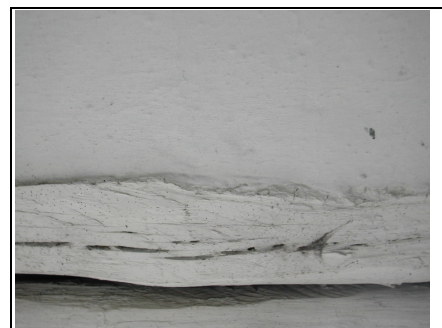
Signs of woodworm activity in timber in roof above passageway

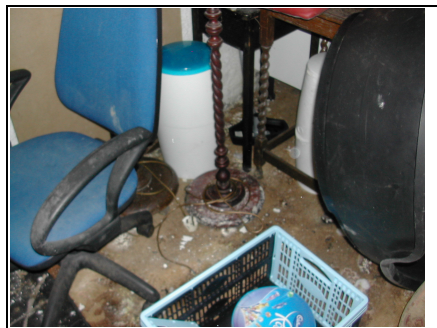
There is evidence of extensive dampness at the front left (possibly caused by a rainwater downpipe gully on the outside), the front right and at the base of the stairs.

Damp floor

Due to dampness usually found within the cellars, we would recommend that only non-perishable goods are stored in this area.

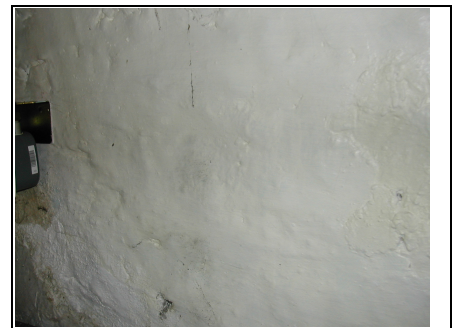
Damp walls

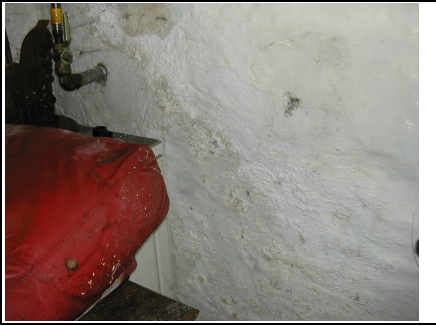
Damp walls

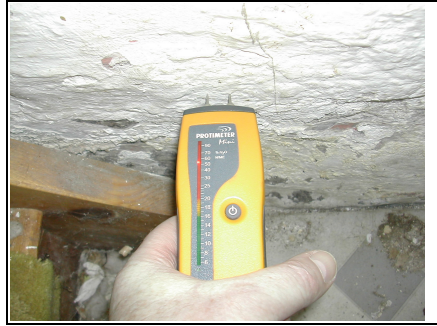
High damp readings

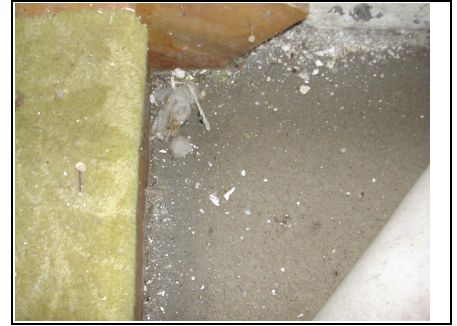
Damp floor

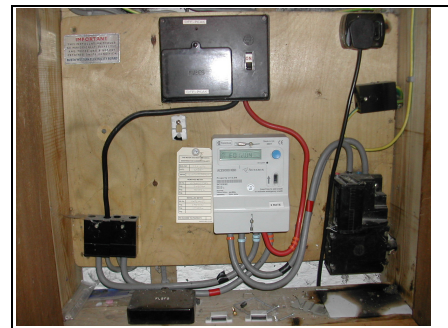
Fuse board

We noted that some ceiling lights did not operate.

In this age of property we would expect to find a mixture of different types of electrical cable, from the original to more modern updates in PVC.

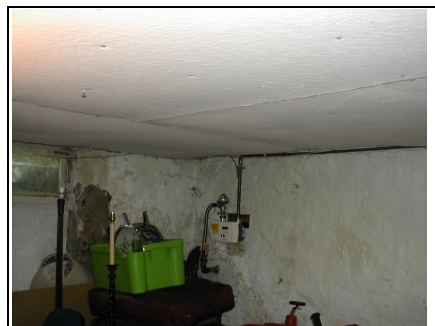
Consumer unit in cellar

We are advised that the property has mains gas. The consumer unit is located in the cellar.

All gas appliances, pipework and flues should be the subject of an annual service by a competent engineer, i.e., a member of Gas Safe; works to gas appliances etc., by unqualified personnel is illegal. Unless evidence can be provided to confirm that there has been annual servicing we would recommend that you commission such a service prior to use to ensure safe and efficient operation.

As a matter of course it is recommended that the entire gas installation is inspected and made good, as necessary, by a Gas Safe registered contractor. Thereafter the installation should be serviced annually.

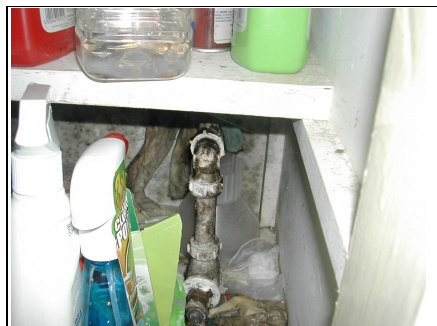
The controlling stopcock was located beneath the kitchen sink. We believe that there may be some lead pipe work in this location.

Stopcock under kitchen sink

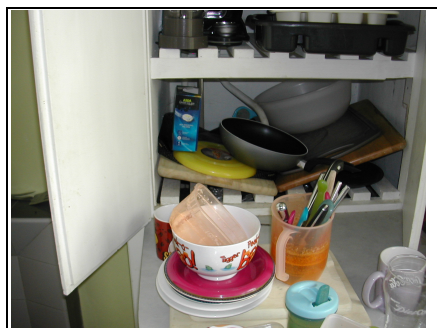
There is a hot water cylinder located in the kitchen cupboard. It has an insulation jacket which indicates that it is relatively new (in this case we mean in the last 30 years). This cylinder will therefore have a good thermal efficiency, although not as good as the more modern hot water cylinders. This provides the hot water for the property.

Hot water cylinder is in kitchen cupboard

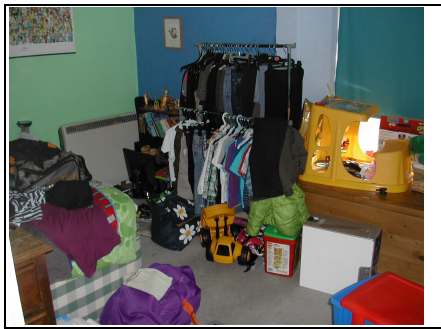
Night storage heater

There is no boiler in the property. Heating is via gas fires in the lounge and kitchen and night storage heaters.

Our limited inspection of the hot water and central heating system revealed no evidence to suggest any serious defects but we would nevertheless recommend that the system be tested and overhauled before exchange of contracts and that a regular maintenance contract be placed with an approved heating engineer.

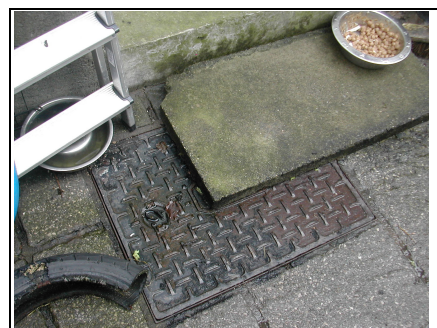
Manhole

We have identified one inspection chamber / manhole.

The drain run appears to be to the rear of the terrace of cottages on XXX Street.

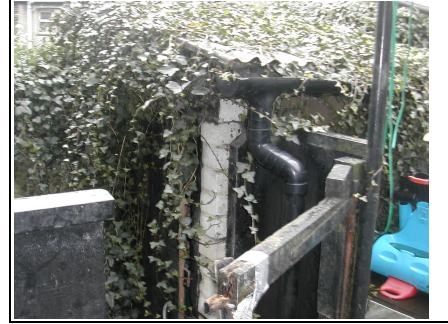
There is a dilapidated shed at the rear of the property. It appears to be of brick construction with a corrugated roof but is almost completely covered with vegetation.

Dilapidated shed

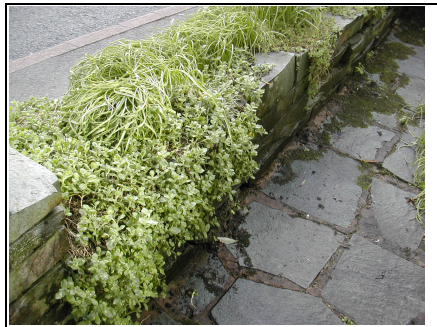
Stone wall covered in vegetation
