RESIDENTIAL BUILDING SURVEY

Shooters Hill,
SE18

FOR
Ms A

INDEPENDENT CHARTERED SURVEYORS

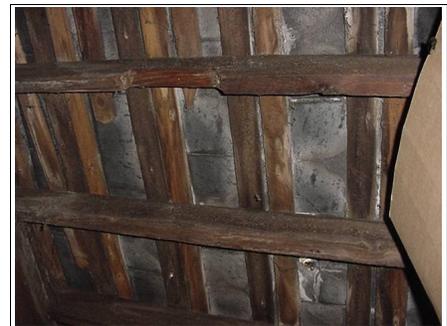
The slate roof is probably original as there is no protective underlayer beneath it. Without a protective underlayer it means that wind driven rain can get into the structure. We would add that we could also see light in some areas indicating that some slates are missing/moved/broken meaning the roof is leaking.

Slate Roof

ACTION REQUIRED: As a short term measure you can overhaul the entire roof. Particular attention needs to be paid to the valley gutter area. Again it should be noted that we weren't able to get a good view of the roof due to the mass of insulation which prevented us from accessing it properly. There may

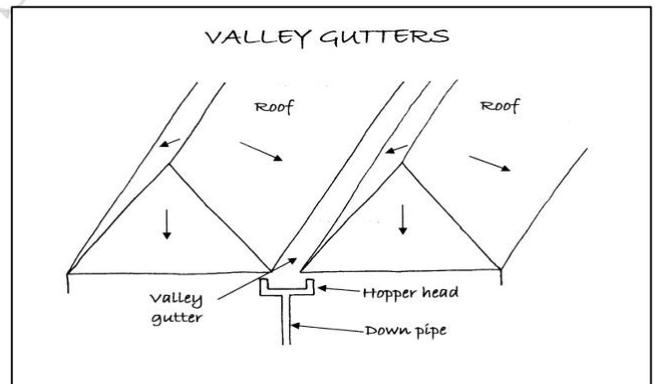
3.0) Valley Gutter

There is a valley gutter to the property that cannot be seen properly from the front but can be seen from the rear and in the roof space. These are generally considered problematic areas and we think that dampness is getting in which will lead to rot on the roof structure.

ACTION REQUIRED: We recommend that a roof light or access panel of some sort is put into the pitch of the roof so that the valley gutter can be seen, accessed and cleaned. Please note we did

not gain access to the valley gutter and our view within the roof was limited due to the mass of insulation. Please note you may need local authority approval to add a roof light/access panel.

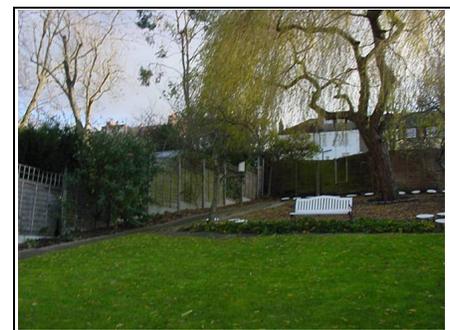
There is a Willow tree in the garden at the top of the sloping site. We would add that this can help hold the ground together although Willows are renowned for having a very long root system that can ultimately affect the foundations of the property.

Willow tree on slope

ACTION REQUIRED: Get an arboricultural report.

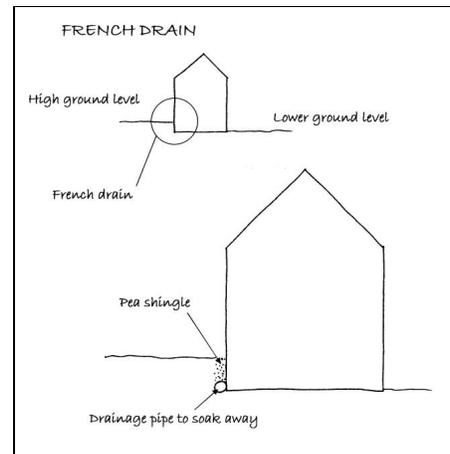
Dampness was found particularly to the rear of the property. We noted the high ground levels.

Dampness found in dining room due to the ground levels

ACTION REQUIRED: We would recommend lowering the ground level and ideally adding a French drain.

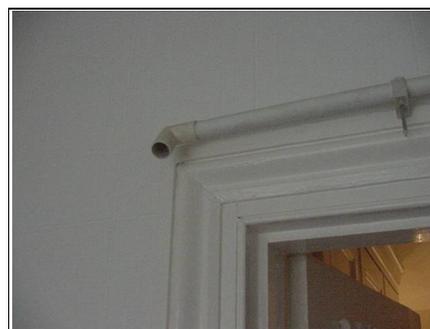
We spoke to the owner about both these items and she advised that the pipe work is redundant and there is an old boiler system in the master bedroom.

Redundant pipe work

ACTION REQUIRED: Open up area to check its condition and see if the boiler and pipe work needs removing.

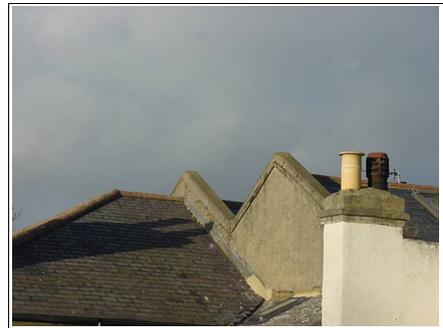
Rear left hand parapet wall

In this case there is a substantial parapet wall to the rear left hand side and also one to the front. We think we can see vegetation growing out of this parapet wall which as mentioned previously concerns us as this means that dampness is getting in.

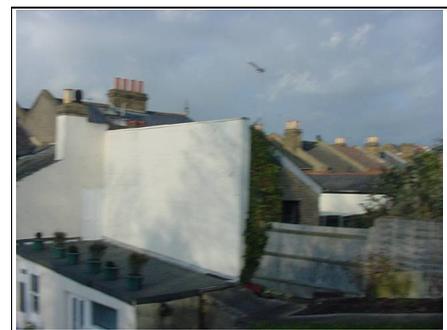
This photo (sorry it's blurred) shows the substantial painted parapet wall to the rear and adjacent to the kitchen. You can see the next door neighbour has extending against this pitch roof construction. You will have a responsibility/liability to keep it watertight.

Rear substantial parapet wall

We can see that there is strapping in this wall which indicates there has been retaining work.

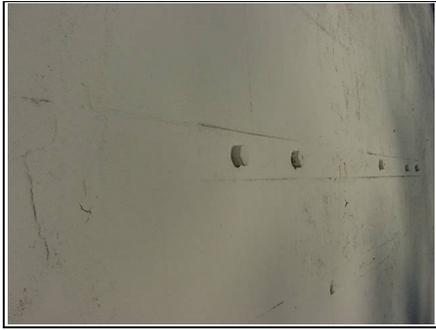
Strapping to rear parapet wall

ACTION REQUIRED: This should be inspected at the same time as the chimneys and no later than the summer of 2013.

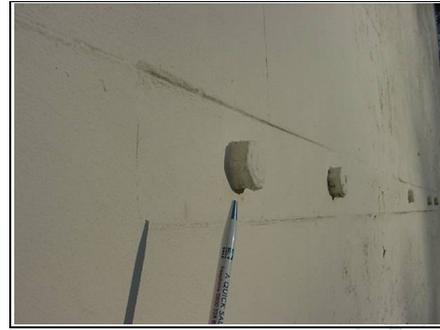
Strapping to parapet close up

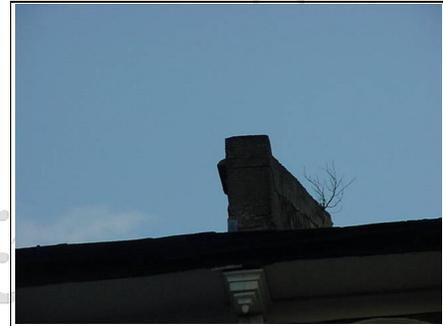
Front parapet wall

Finally, we were only able to see approximately sixty percent of the parapet wall, although the view was restricted. Therefore we have made our best assumptions based upon what we could see. A closer inspection may reveal more.

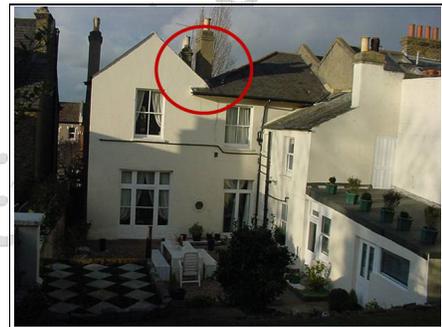
Circle shows where roofs meet and form valley gutter.

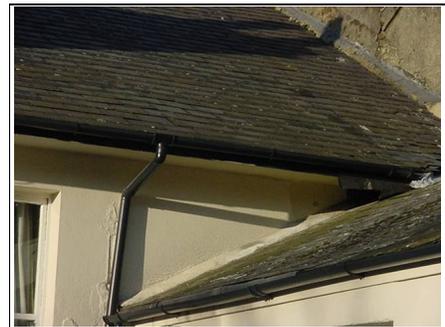
These are original slate coverings and from our view within the roof we can see that there is light coming through and therefore dampness will be getting in.

Main slate roof joining rear roof

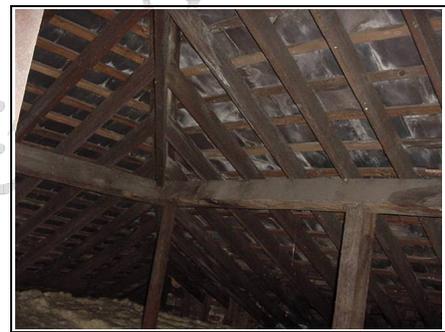
Most importantly we can see that dampness is getting in.

No protective underlayer and dampness getting in

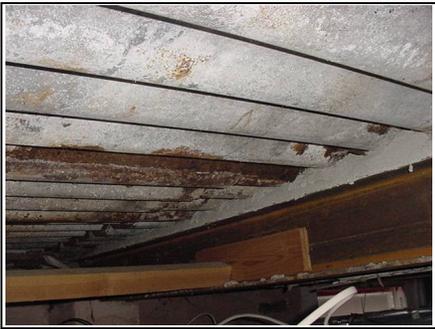
We spoke at some length about this within the Executive Summary but we want to re-emphasize that it has not been possible to identify what this roof decking is formed of. We have removed the ceiling tiles in the kitchen and found what looks to be a concrete finish but also found rusting which indicates it may be a reinforced concrete which makes sense for this size of roof.

Possible concrete roof

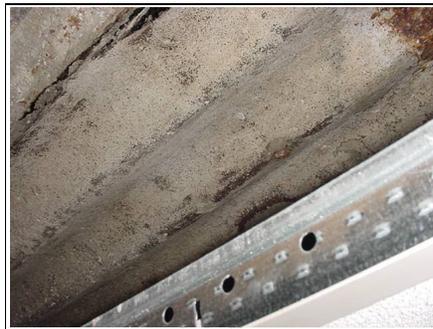
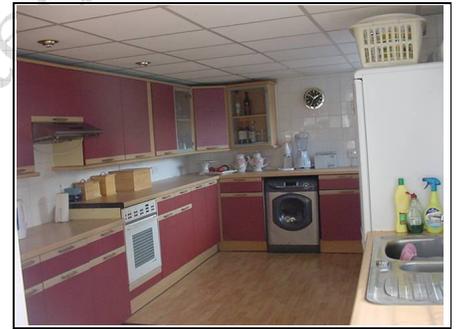
Tiles on kitchen ceiling

We can also see what looks like a tar under the roof which looks like it was an attempt at making it waterproof.

Finally there is an outside chance that asbestos is in the cement ceiling. Asbestos anywhere in the property increases the costs considerably when it needs removing.

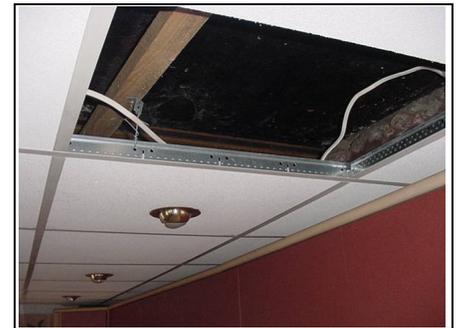
Tiles removed to see into roof

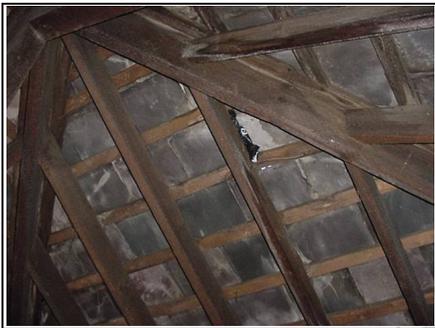
Front Left hand side roof showing dampness getting in.

1. Rain is getting through and this is visible in the damp timber.
2. The amount of insulation is starting to cause mould to the timbers due to lack of air circulation.

ACTION REQUIRED: A lot of work is required to these roofs. We would ultimately recommend re-roofing. Due to our limited view we would also recommend that the roofs are cleared and we will re-inspect. The only way to be 100 per cent certain is to have the roof cleared and checked.

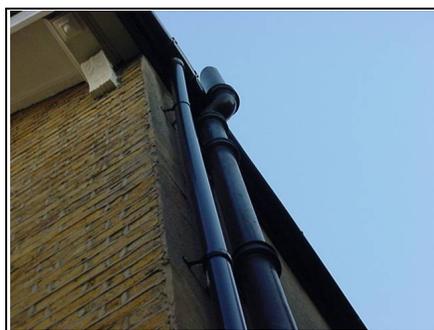
These are plastic and are located to the left hand side and rear of the property. There have been a lot of additions to the soil and vent pipes including very long runs of down pipe that look to have no fall on them at all.

Soil and vent pipe

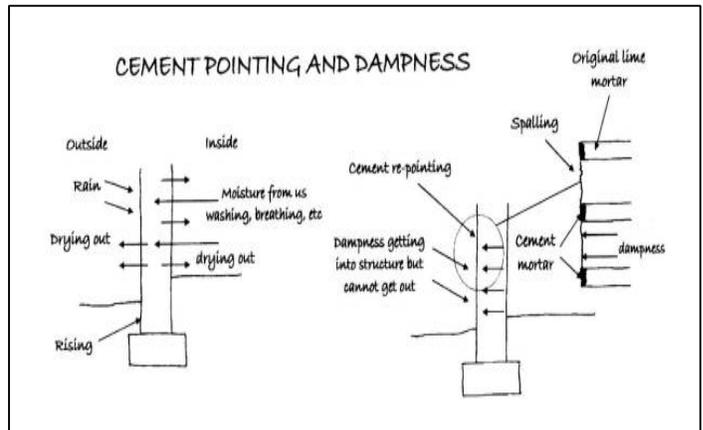
Lime every time

We would draw your attention to the cement mortar re-pointing that has been carried out on the exterior of the property that we feel is not appropriate to this building. Originally it will have been built with a lime-based mortar and this is what should be used for any re-pointing in the future.

The use of cement mortar causes deterioration to brickwork and does lead to the face of the bricks deteriorating, which in turn leads to dampness. This is a very important point

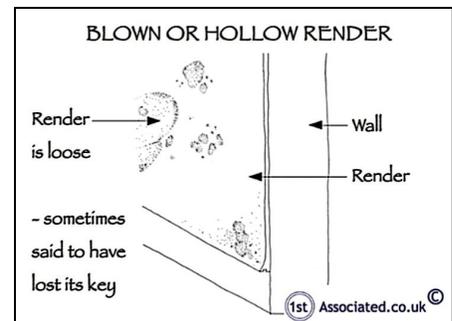
We can see some cracking in the render and these need to be sealed as soon as possible. We would remind you that any hairline cracks that appear, which tends to be the case with render, need to be sealed as soon as possible to stop dampness and water getting in and causing blisters and hollow areas.

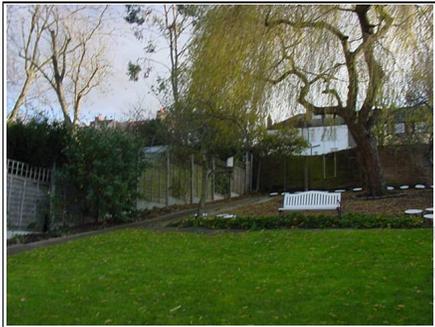
Often within this age and style of property there are significant trees present in the garden. We can see some of these still remain and they are what we would term within influencing distance, therefore you do need to maintain them. We were pleased to see the Willow at the rear from the point of view that it will hold the sloping site earth together and looks to be far enough away. However the tree at the front of the property, although we believe it has a small root ball, will affect it.

Willow Tree to the rear of the property

ACTION REQUIRED: You need to consult an arboriculturalist in the summer of 2012. We are not tree surgeons.

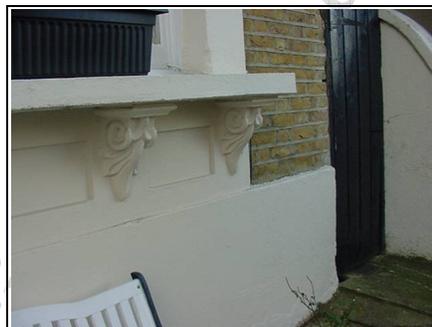
All modern properties should incorporate a damp proof course (DPC) and good building practice dictates that a differential of 150mm (6 inches) should be maintained between the damp proof course and ground levels. In this case, the render detail went right down to the ground both to the front, side and rear of the property. We would much prefer to see a bell mouth detail to the base this would then reduce the chances of dampness.

Render down to the ground

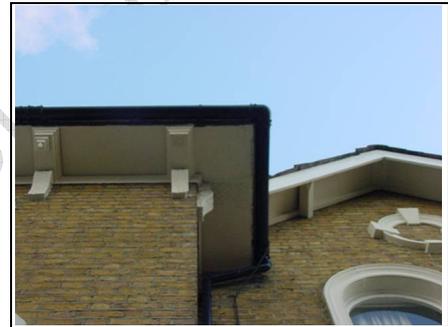
Decorative fascias and soffits to the front

ACTION REQUIRED: We recommend work in the summer of 2013 in the form of repair and redecoration. Make sure gutters and downpipes are watertight before carrying out any work on fascias and soffits.

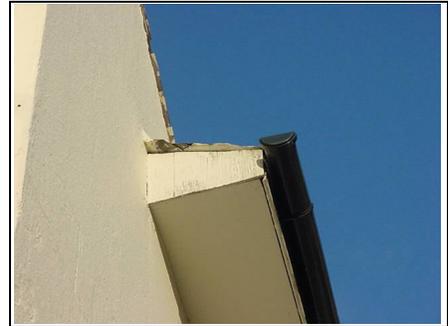
Plain Fascias and soffits to the rear

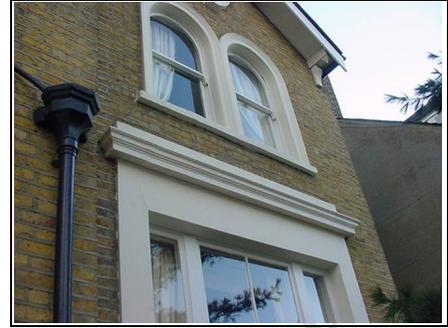
The property has some magnificent large single glazed timber sliding sash windows and doors. We would comment that the sliding sash window was a revelation in its day. We also find that some of these stick when we try to open them as was the case in this instance.

Sash windows

ACTION REQUIRED: We would refer you to our comments in the Executive Summary about rotten windows and also the lintels.

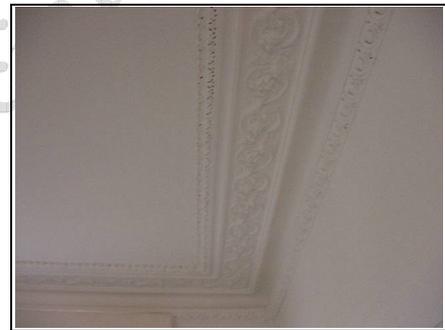
Unfortunately the cornicing has been painted rather than lime washed. This does mean that the detail of the cornicing has been lost over the years. Extensive repair work will be required to make the features fully visible

Painted Cornicing

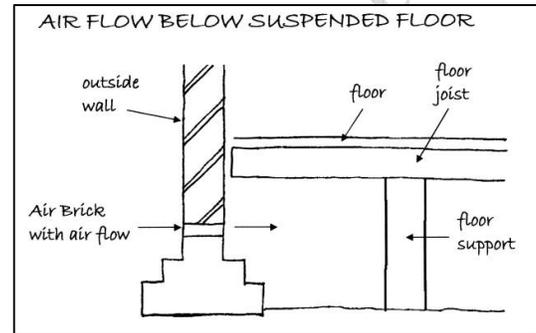
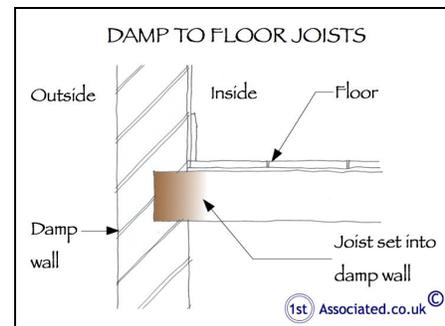
The floors of the property are suspended timber floors with embedded timbers. The danger with this type of floor is the embedded timber starts to rot. Whilst repairs can be carried out they are awkward. In this instance we have not been able to view these properly as we have not been able to gain access into the cellar area properly.

Stored items in cellar

ACTION REQUIRED: the whole cellar area needs clearing out to give us proper access before you legally commit to purchase the property.

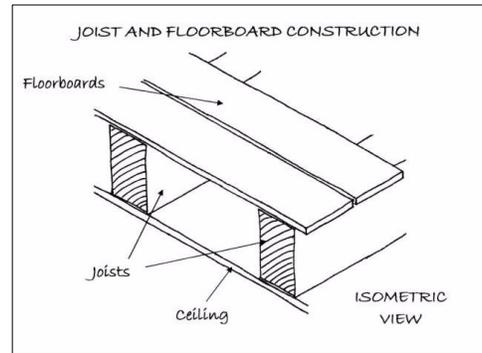
We have assumed that the first floor construction is joist and floorboards with embedded timbers, as this is typical in this age of property. We would expect some damage and deterioration to the floors. We noted woodworm patterns within the floors. There are also exposed timbers which could cause deterioration to the floor itself.

ACTION REQUIRED: Ideally the floor needs opening up to have an examination carried out.

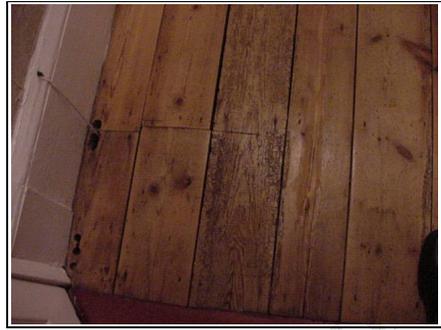
In this instance there is a mass of insulation within the roof that limits our view. We did notice to some of the exposed floor boards that there were signs of old woodworm. It is most important to establish whether woodworm is active or not. Many good old properties will have non-active woodworm. In this case we think there is a possibility of woodworm activity although we did not note any that was 'structurally significant'. In many properties there is an element of woodworm that is not active. Our inspection was restricted by insulation covering some of the timbers in the roof, as it is restricted throughout the property by general fixtures and fittings.

Woodworm

ACTION REQUIRED: If you wish to be 100 per cent certain that there is no woodworm the only way would be to check the property when is emptied of fixtures and fittings etc.

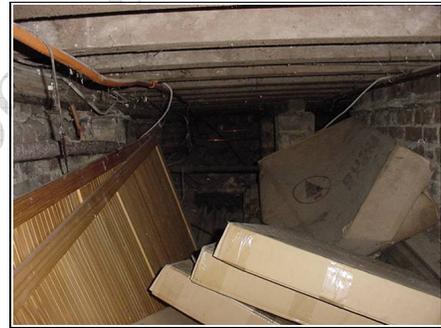
The cellar is accessed via the flaps as you enter the property. We could not access the cellar properly because of the amount of stored items.

Large amount of stored items in cellar

ACTION REQUIRED: We are more than happy to return to view the cellar once it has been cleared.

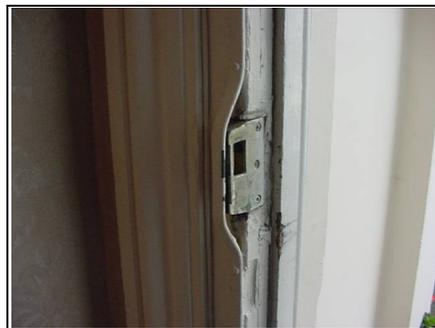
We noted a security box externally but we are advised that it is no longer in working order. This can still act as a deterrent. We also noted a London bar on the front door. Other than that there are very limited security features. A good alarm system should not only help reduce break-ins but also your insurance. We are not experts in this field and therefore cannot comment further.

London Bar on front door

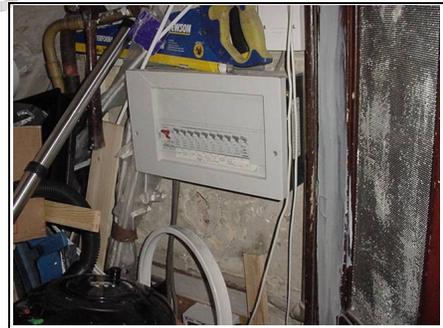
The electric fuses and consumer units were located under the stairs. The fuse board is from the 1980's/1990's and looked dated and better are now available.

1980's/1990's Electric fuse board

ACTION REQUIRED: Enquire about upgrading it.

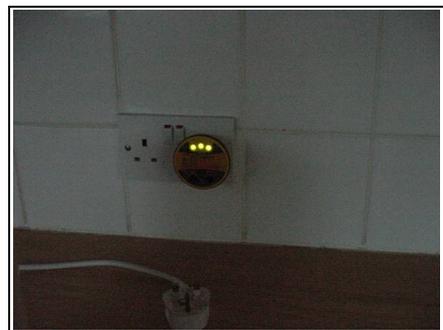
Earth Test

We carried out an earth test in the kitchen area to the socket point that is normally used for the kettle, this proved satisfactory. However we are concerned about the condensation that may be occurring in the kitchen area which is not ideal.

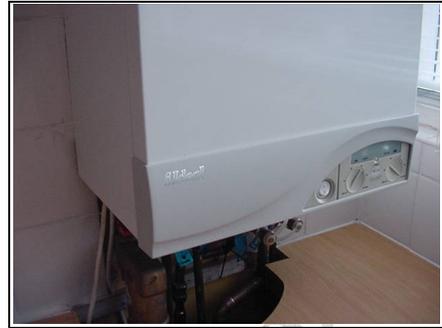
Boiler in Kitchen

The boiler was located in the kitchen and it is manufactured by Ideal and the model type is Cibi HE.

Our limited inspection of the hot water and central heating system revealed no evidence to suggest any serious defects but we would nevertheless recommend that the system be tested and overhauled before exchange of contracts and that a regular maintenance contract be placed with an approved heating engineer.

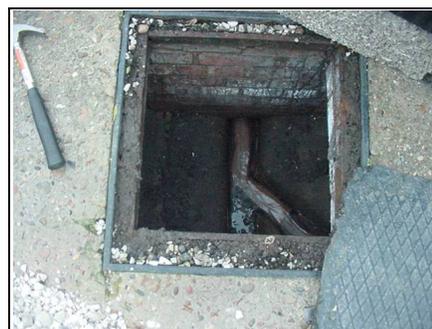
Rear Middle Manhole

We duly lifted the cover and found it to be free flowing at the time of our inspection.

From what we could see it is brick built.

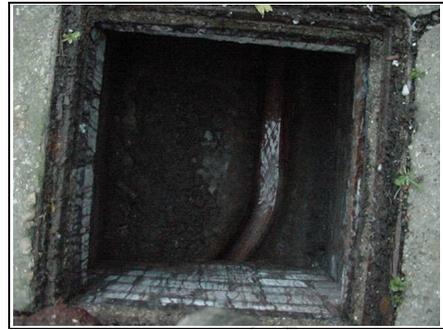
Rear Right hand side

We duly lifted the cover and found it to be free flowing at the time of our inspection.

From what we could see it is brick built.

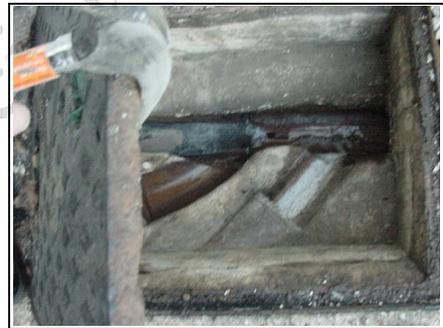
Manhole three

Inspection Chamber / Manhole Three -left hand side near the Kitchen

We duly lifted the cover and found it to be free flowing at the time of our inspection.

From what we could see it is finished in concrete.

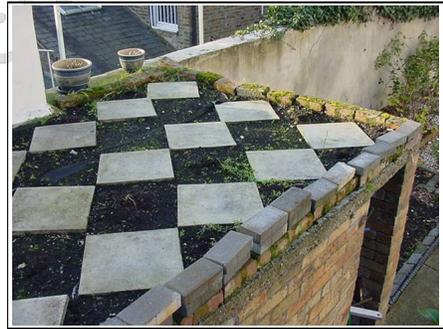
Outbuilding roof

There is an outbuilding to the right hand side of the property which has this unusual checkerboard roof. We cannot imagine it is waterproof and it should be considered a very basic construction.

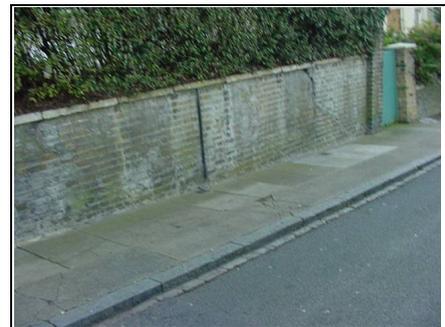
Retaining wall to the front

As the property sits on a sloping site we would much prefer to see the front retaining wall with weep holes but we couldn't see them in this instance. You can see from the whitiness how water is getting through it.

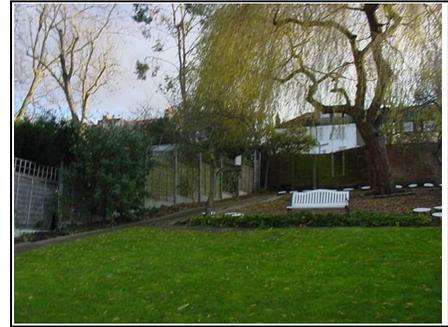
Rear Garden

The rear garden is a considerable sloping site and you therefore need to expect that rainwater will discharge to the bottom section whenever it rains.

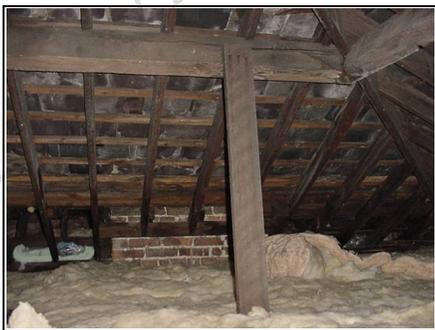
Dampness and condensation in the timbers

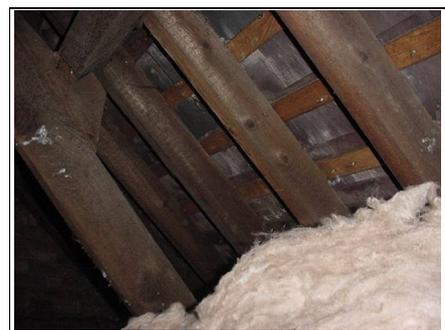
Unfortunately in this instance our inspection has been very limited due to the mass of insulation and we did not have access to the cellar.

Mass of insulation
