RESIDENTIAL BUILDING SURVEY

Surrey,
KT4 xxxx.

INDEPENDENT CHARTERED SURVEYORS

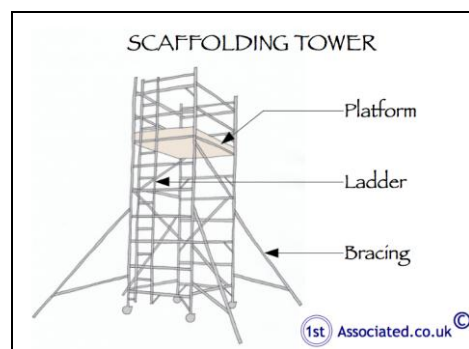
The chimneys need re-pointing ideally as soon as possible but at the latest the summer of 2014. The photographs below taken during our inspection show leaning to the chimney and the pointing required to them. There may also be rebuilding necessary although this looks unlikely at the moment. The longer you wait to carry out repairs the more likely this becomes.

Right chimney also needs the flashings repaired

ACTION REQUIRED: Re-point as soon as possible.

ANTICIPATED COST: This will require scaffolding and is likely to be in the region of £1,000-£3,000 (one thousand to three thousand pounds); please obtain quotations.

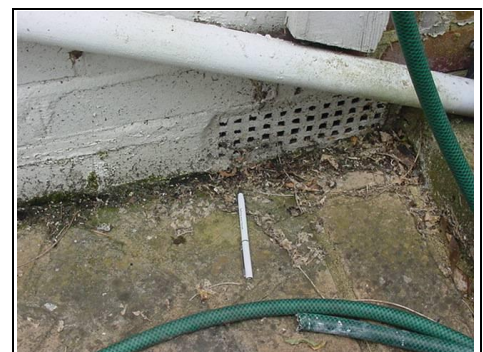
The airbricks need to be protected as some of them are acting as gutters and some of them are close to acting as gutters!

Air brick acting as a gutter

ACTION REQUIRED: Add protection to the air bricks as shown in the sketch below.

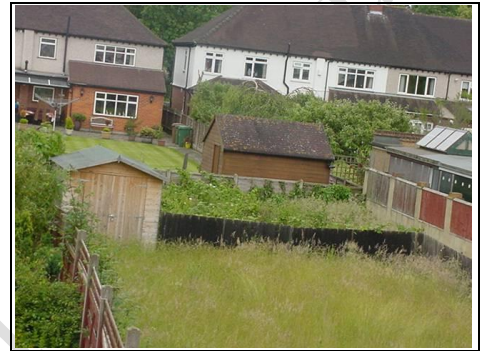
As you are aware we did not manage to speak to or check with the right hand neighbours about their overgrown garden. We were advised by other neighbours that they are busy doctors. We would personally check as they will be your direct neighbour and as this is a semi-detached house you will share the party wall with them.

Neighbours overgrown garden

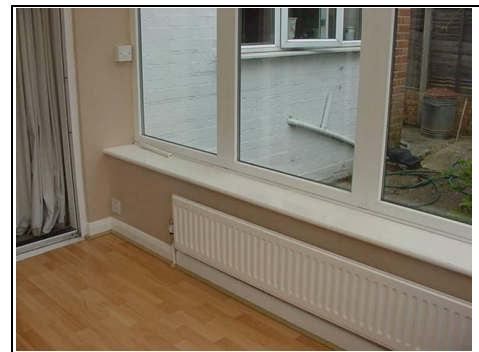
This property has a lot of single panel radiators. These may not warm the property as most people would wish. With specific reference to the conservatory we feel you are likely to suffer from heat gain in the summer and heat loss during the winter. This can be a problem particularly where the heat fills the rest of the house. You can shut off this area.

Single panel radiator

ACTION REQUIRED: You may wish to add double panel convection radiators.

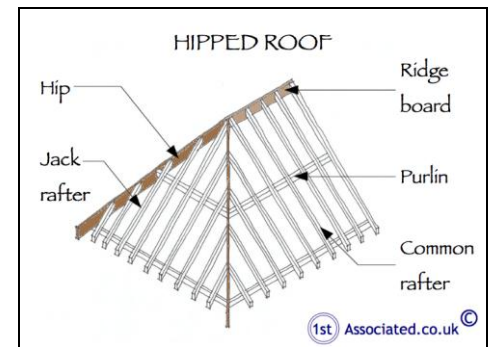
The property has a pitched hipped roof that has no protective underlayer which would be included if it was constructed today. As such rainwater can get in; typically this will be wind driven rain and also snow. Over the years this has caused the nibs on the tiles to deteriorate which ultimately will mean a new roof is required.

Closer still this shows dampness coming through

ACTION REQUIRED: We would recommend re-roofing in the next few years. It is difficult to give an exact time scale as to when as our weather is unpredictable and we seem to be getting highs and lows. For example, we have had a very dry spell followed by a very wet spell.

ANTICIPATED COST: New roofs are expensive as full scaffolding will be needed and will be in the region of £8,000 - £12,000 (eight thousand to twelve thousand pounds). If you look in the adjoining sketch you will see that the protective underlayer is a sheet that goes between the tiles and the roof.

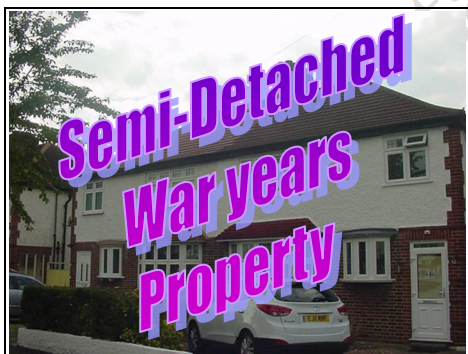
You can see this property has been re-roofed

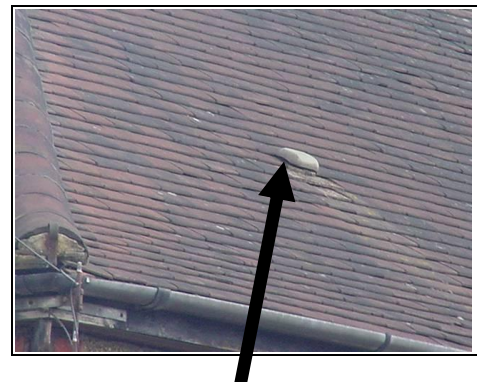
A close up of this roof shows a mushroom vent indicating a new roof probably from the 1980's

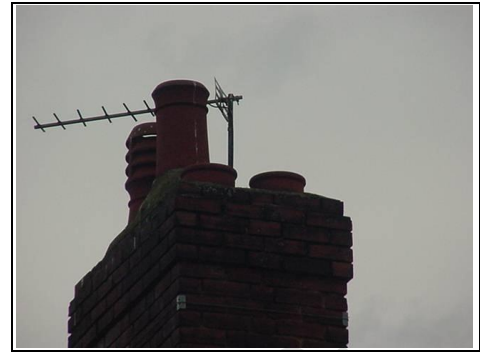
Our comments are very similar to the first chimney with the addition that the lead flashing does not look to be working and needs inspecting.

Top of right chimney

ACTION REQUIRED: Please see our comments within the Executive Summary and periodically inspect the chimney.

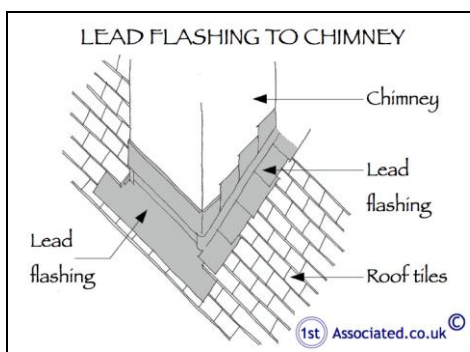
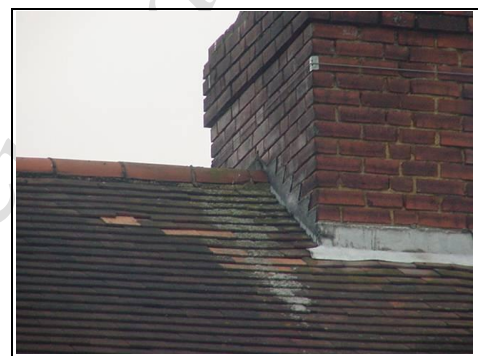
Base of right chimney

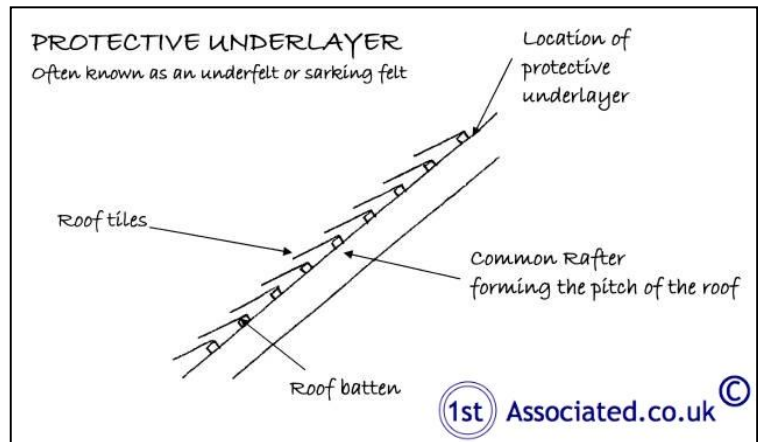
The tiles are nibbed tiles with no protective under layer. This means that wind driven rain can get underneath the tiles and indeed we can see that this is happening from the staining within the roof. We are always in a Catch- 22 with regard to this type of roof as although it is letting in some rain water it is not letting in that much.

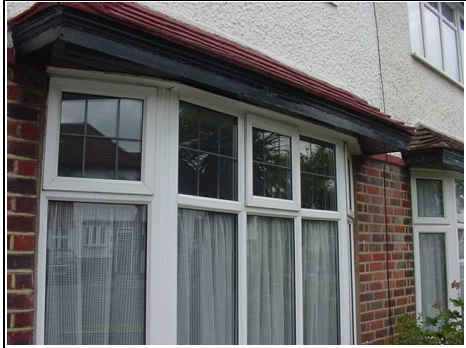
We could not see any visual signs internally of any dampness getting through.

Bay window roof

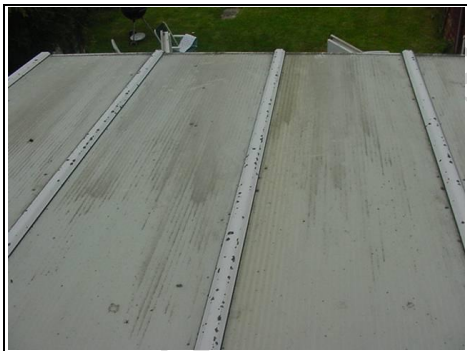
This is a polycarbonate roof and is in need of a clean. The roof is fairly shallow and we would much prefer to see a roof with a bigger pitch than this.

Conservatory roof

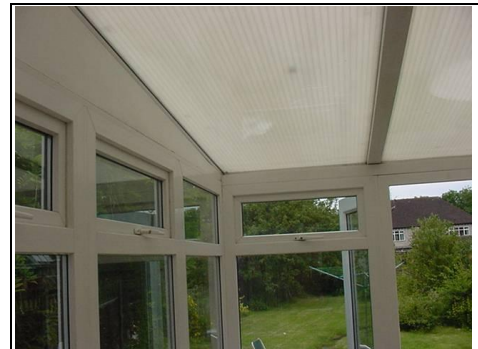
Polycarbonate roof

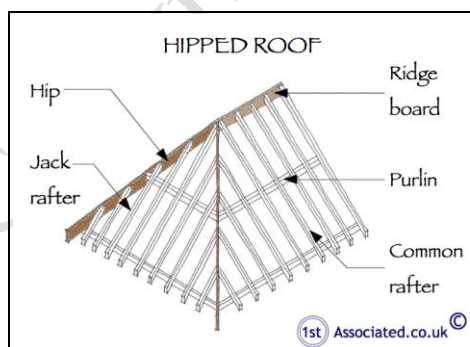
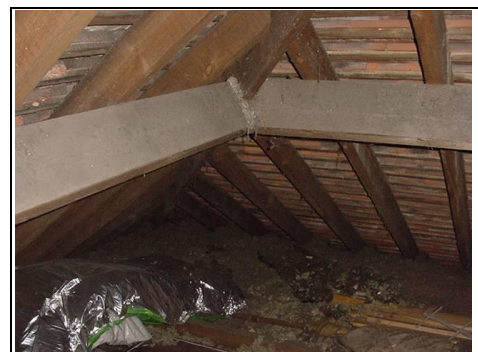
This type of roof structure has what is known as a hipped cut timber roof. This is a roof that is purpose made and hand built on site. Without the original design details we cannot categorically confirm that there are no defects; however it is in line with what we typically see. A weak area is the junction of the hip but this looked in reasonable condition where we could see it.

Hip of the roof

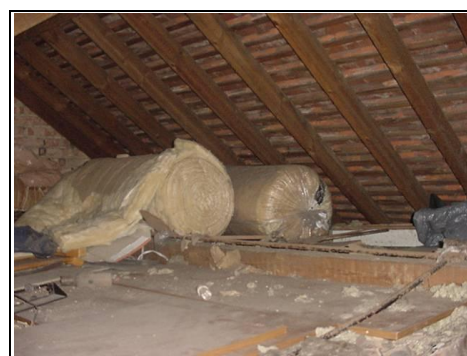
General view of the roof

Our examination was limited by the general configuration of the roof, the insulation (and insulation rolls), boards and stored items. What we could see was generally found to be in average condition for its age, type and style. It is, however, feasible that there are problems in the roof that are hidden.

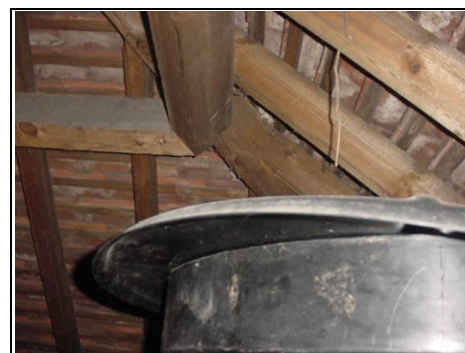
There is a plastic water tank within the roof.

Plastic water tank

We would always recommend that water tanks be drained down and cleared of any debris etc. (we have seen dead birds and other unmentionable things in these tanks). As you are often cleaning your teeth with this water it is best that it is as clean as possible!

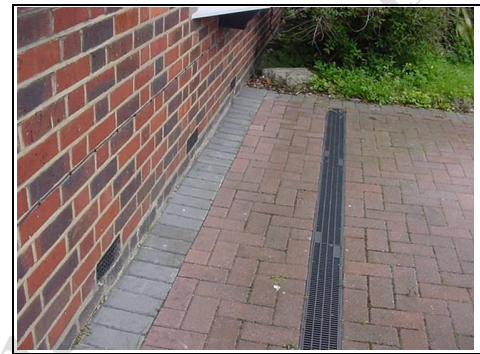
Generally Flemish Bond brickwork is liable to penetrating dampness internally, dependent upon the condition of the brickwork and the exposure to the weather. In this case it is essential that external faces be kept in good condition.

Flemish bond brickwork

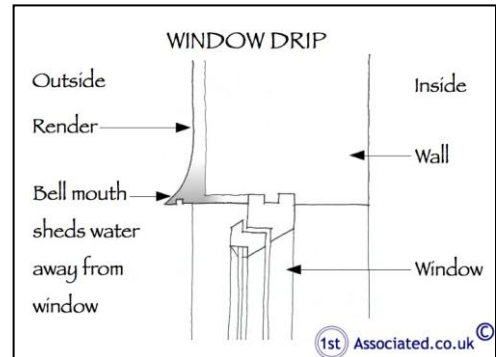
Bell mouth detail

The render stops at the brick band with a slight bell mouth.

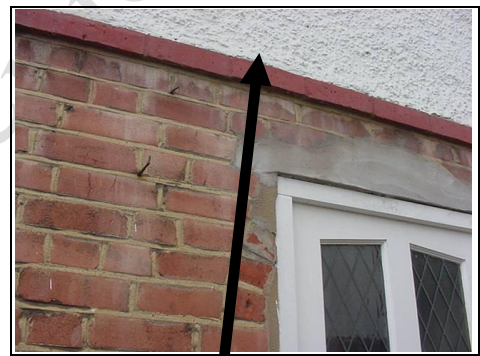
Slight bell mouth

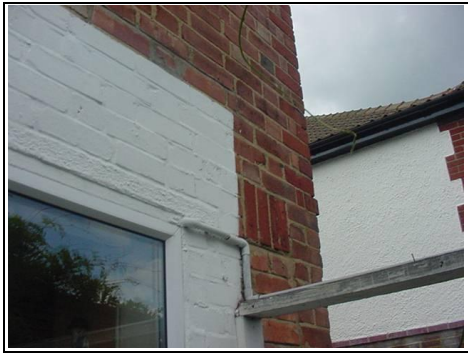
Lintel altered to rear

There may be cold bridging in this property because of the concrete lintels. This is a common problem and there looks to have been problems in the past which is why the lintels have been replaced. There does not seem to be any other reason for this other than possibly minor settlement.

ACTION REQUIRED: To be on the safe side regarding the settlement we would recommend a closed circuit TV report or as mentioned previously that you get the owners to submit an insurance claim.

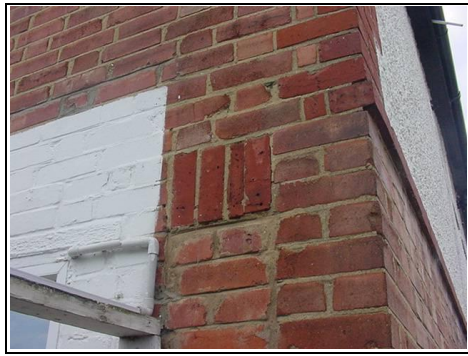
Lintel altered to the rear

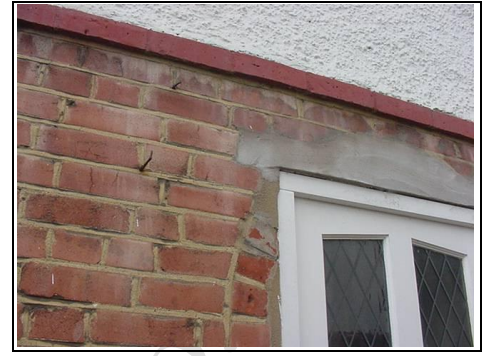
Lintel altered to the left hand side

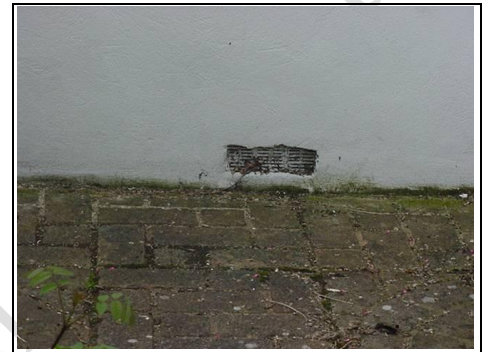
All modern properties should incorporate a damp proof course (DPC) and good building practice dictates that a differential of 150mm (6 inches) should be maintained between the damp proof course and ground levels. In this case, we could not see a DPC because of the render plinth but in some areas we could see a thickening of the joint indicating a DPC.

We could not see a DPC in some areas because of the render plinth

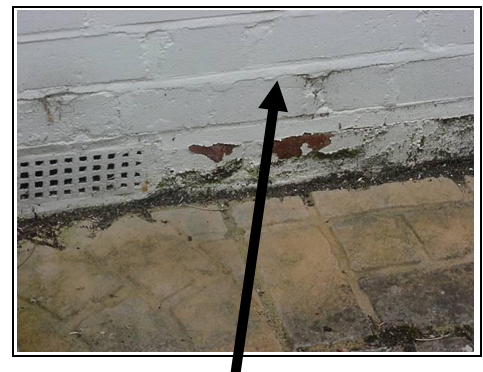
Thickening of the joints indicate a possible DPC

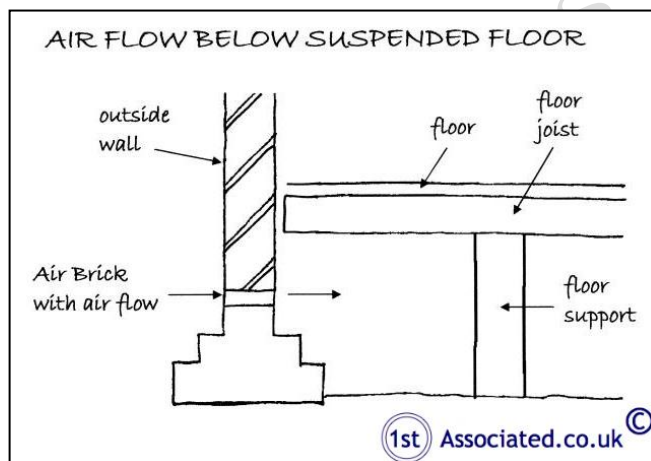
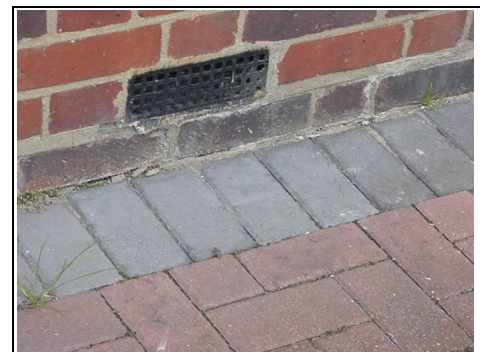
Air brick

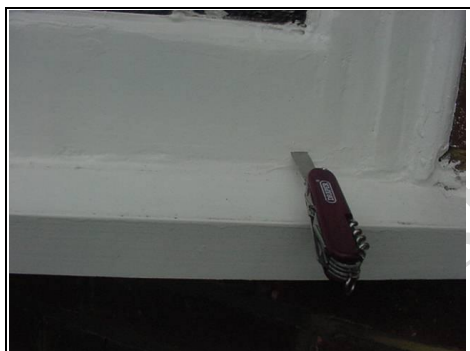
Knife test on windows

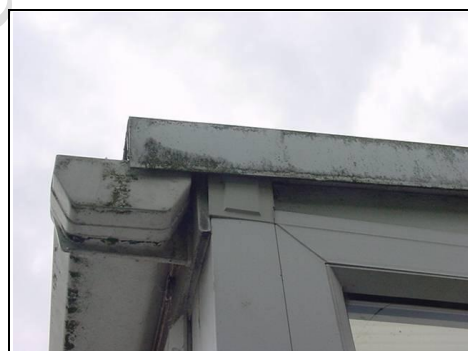
Discoloured plastic on conservatory needs cleaning

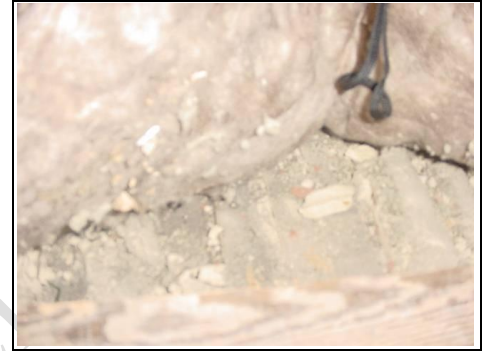
Lath and plaster

The area of concern is that the dampness coming through from the roof will cause dampness in the lath and plaster. Please see our earlier comments about putting down floor boards with insulation in the roof space as soon as possible to protect the ceiling as well as identify where the damp is coming from in the roof.

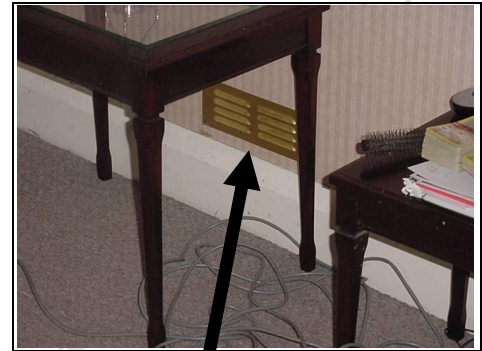
Venting to chimney breast

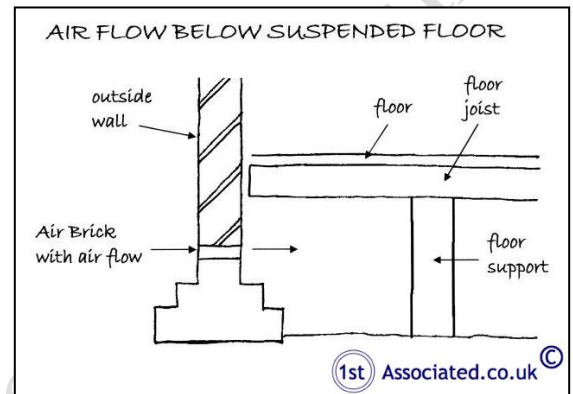
Where extensions are added, they can often block the air movement. In this instance we believe it does. In this case we can see airbricks indicating a timber floor although it did not feel like it under foot apart from that it was laminated. It may also be a concrete floor with vents, we simply do not know without opening it up. The laminate restricts us from doing this and also restricts us from viewing the floor.

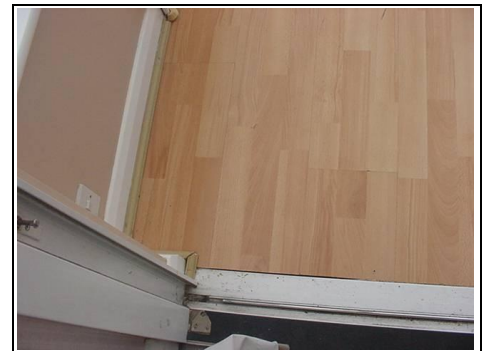
Poor quality laminate flooring with quadrant bead.

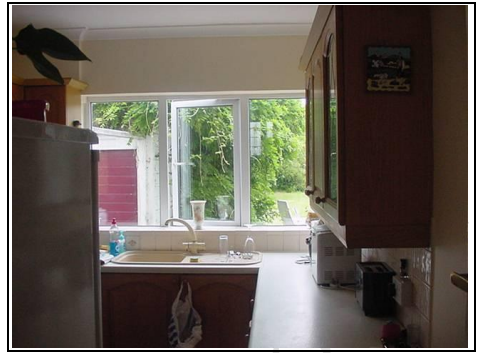
Please note our comments with regard to the chimney being removed in this area. There may be a support system needed although there are no obvious tell-tale signs of problems in the structure such as cracking and undulations in the walls.

Kitchen

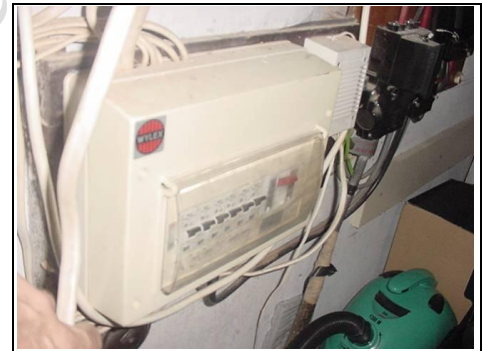
The electric fuses and consumer units were located under the stairs. The fuse board looked dated and better are now available.

Fuse Board

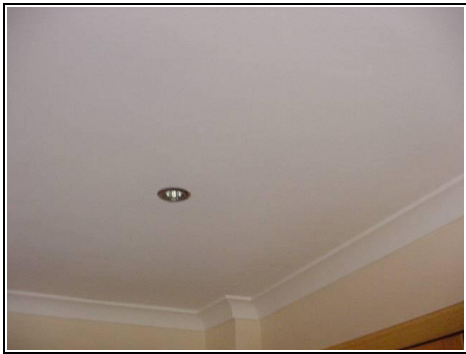
Ceiling light in the kitchen

ACTION REQUIRED: These do need to be checked when you have the IEE test and report carried out.

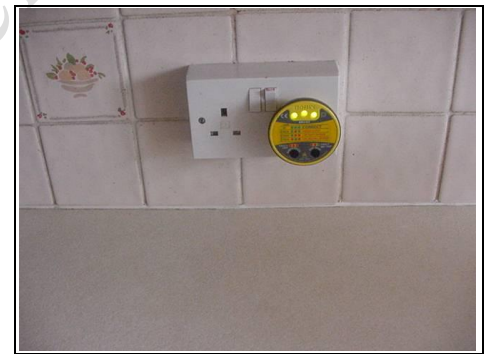
Earth Test

We carried out an earth test in the kitchen area to the socket point that is normally used for the kettle, this proved satisfactory.

ACTION REQUIRED: Please see our comments within the Executive Summary. As the property is changing occupancy an Institute of Electrical Engineers (IEE) test and report should be carried out by a NICEIC registered and approved electrical contractor or equivalent.

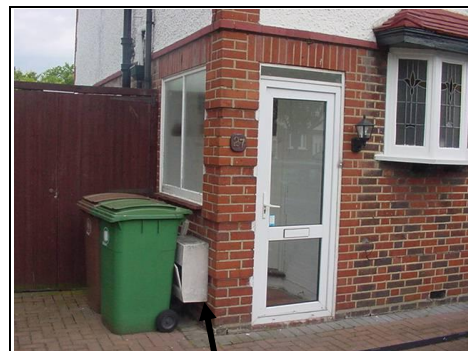
Gas unit

We believe that the property has mains gas. The consumer unit is, we think, located to the left hand side of the property hidden behind the bins.

All gas appliances, pipework and flues should be the subject of an annual service by a competent engineer, i.e., a member of Gas Safe; works to gas appliances etc., by unqualified personnel is illegal. Unless evidence can be provided to confirm that there has been annual servicing we would recommend that you commission such a service prior to use to ensure safe and efficient operation.

ACTION REQUIRED: As a matter of course it is recommended that the entire gas installation is inspected and made good, as necessary, by a Gas Safe registered contractor. Thereafter the installation should be serviced annually.

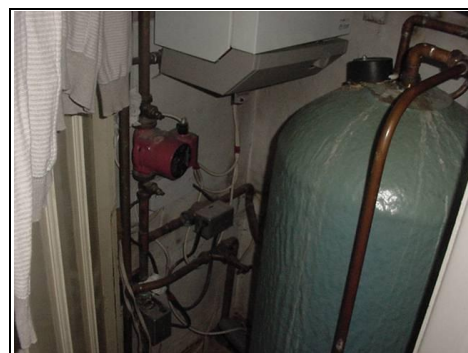
Hot water cylinder

There is a factory insulated hot water cylinder located within the airing cupboard. This cylinder will therefore have a good thermal efficiency, although not as good as the more modern hot water cylinders.

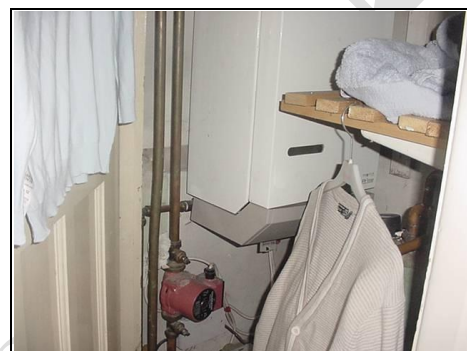
Boiler

The wall mounted older style boiler was located in the airing cupboard. It is manufactured by Potterton and the model type is Prima.

Our limited inspection of the hot water and central heating system revealed no evidence to suggest any serious defects but we would nevertheless recommend that the system be tested and overhauled before exchange of contracts and that a regular maintenance contract be placed with an approved heating engineer.

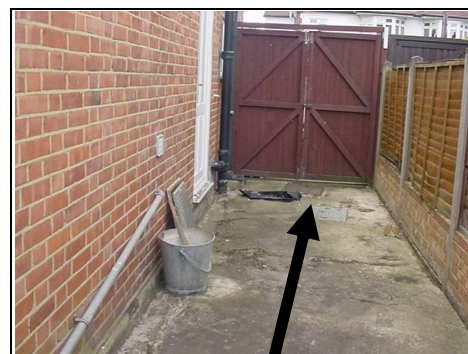
Manhole

We noted in our photos that we had missed a manhole in the garden. We do not anticipate any problems from this. However we would be happy to return at a later date to inspect the manhole if necessary.

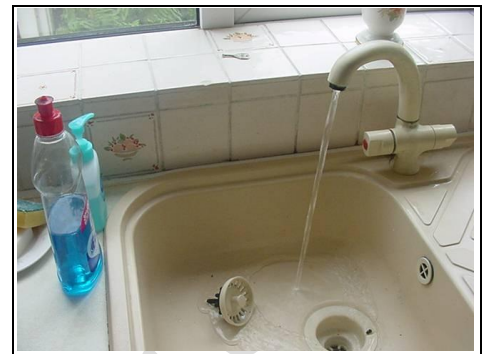
Running the taps

The taps have been run for approximately quarter of an hour. No build up or back up was noted.

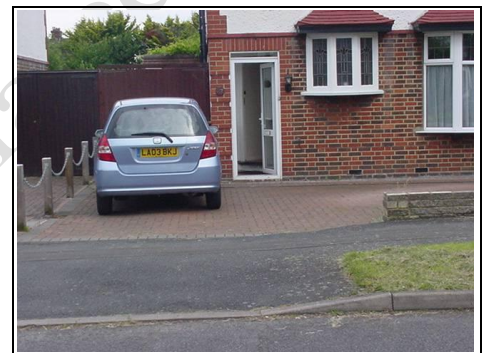
Parking

There is parking on an average quality brick paved area to the front of the property.

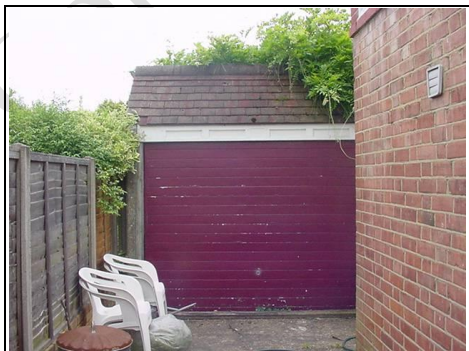
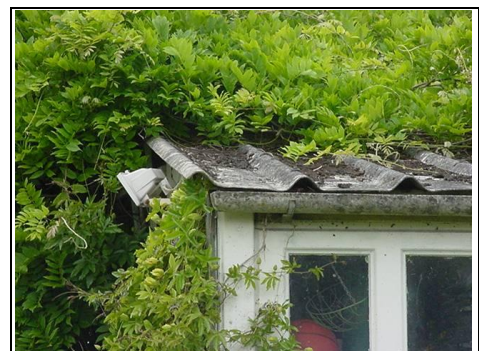
In this case we have noted asbestos to the garage roof.

There is a garage to the left hand side of the property. This has an asbestos roof. There may also be hidden asbestos, for example, to the service ducts and other such areas.

Asbestos roof

ACTION REQUIRED: Please see our comments within the Executive Summary.

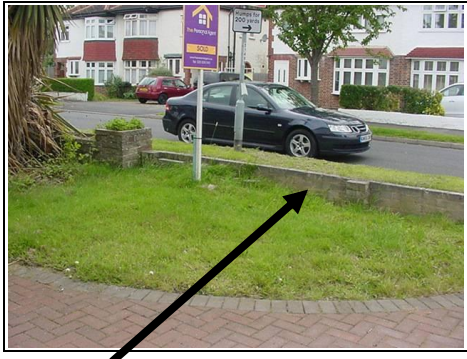
The front garden has mainly been given over to parking. The front boundary wall is quite low for some reason. However we did notice a number of other low ones nearby.

Front garden with low boundary wall

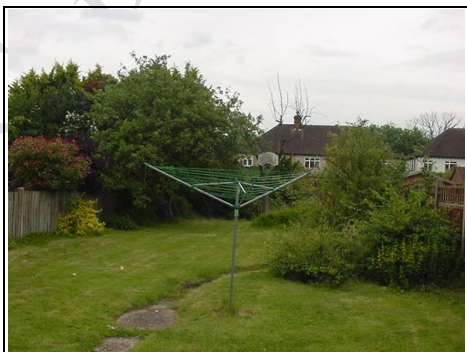
Rear Garden

There is a large garden to the rear of the property mainly laid to lawn with a paved patio area. Note the condition of the right garden fence which is usually the responsibility of your neighbour (all directions given as you face the front of the property) with your fence being the left hand side.

As you are aware we queried the condition/state of the garden. We knocked on several neighbours doors to establish this further. We were told that they are busy doctors and have not had chance to do the garden. We do feel you need to be one hundred per cent that you are happy with this situation as they will be your immediate neighbours.
