RESIDENTIAL BUILDING SURVEY

Wormley, Surrey,
GU8

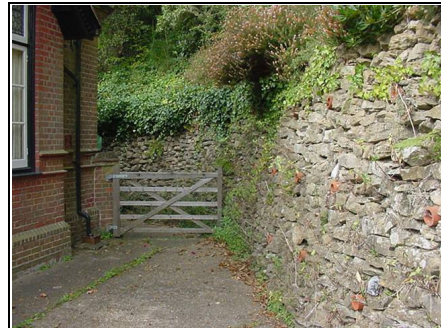
You have a retaining wall surrounding the property which from the number of weep holes in it looks like there is a substantial amount of water coming down through it when it rains heavily. As you are probably aware the woodland area surrounding the retaining wall will in part hold it in place.

Red terracotta weep holes

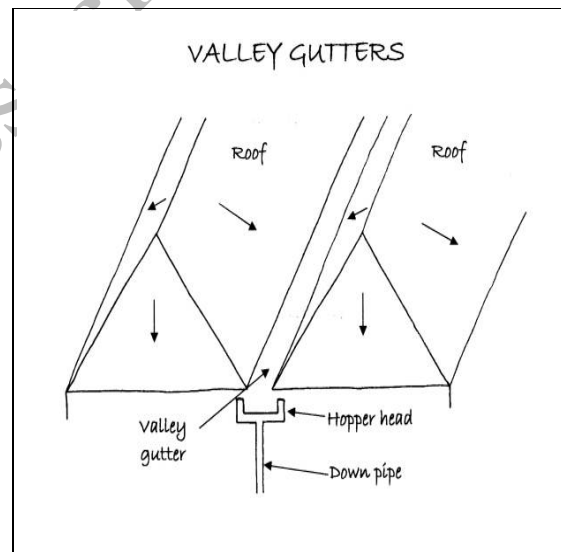
Valley gutter

From what we have seen the main problem area will be the valley gutters although the gutters themselves will be a continual maintenance task.

Whilst this area can be accessed via a ladder (as we did as part of the survey) it is slightly tricky and there may well come a time when health and safety requirements mean that builders won't be able to/want to (for insurance reasons) access the roof without scaffolding.

ACTION REQUIRED: We therefore recommend you buy your own tower

scaffold for easier access to higher areas. It can then literally be wheeled around to clear the gutters and the valley gutters. We are sure trades people will much prefer safer access. You will have to carry out very regular maintenance with regard to clearing leaves and other debris from the trees or else you will get water into this property. We would also advise that if the hopper heads, gutters and valley gutters aren't cleaned regularly then dampness will get into the property.

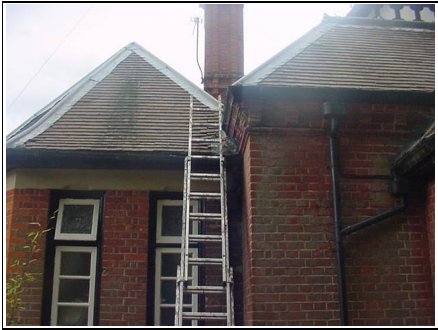
Access to valley gutter

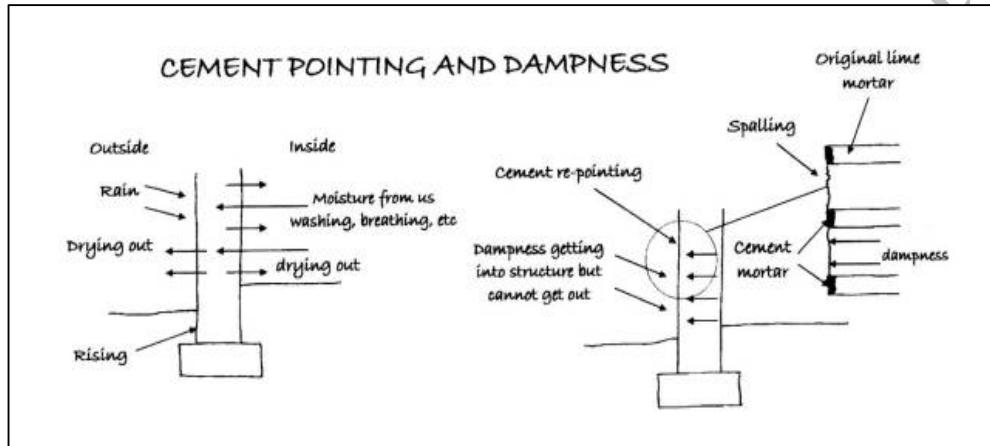
Chimneys and repairs

We would draw your attention to the main chimneys which will benefit from re-pointing where the mortar has been worn away. If they are not re-pointed then dampness will get into the property.

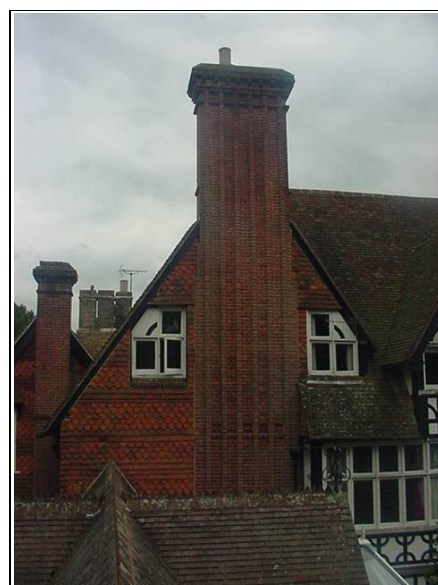
We suspect there is a lot of history between the owner of this property and the adjoining neighbours, particularly in relation to the extension and blocked up windows which have been blocked up in a different colour brick. You should be aware that the adjoining owners could be waiting for a change of occupant to put a window in. We also noticed the high level chimney to next door which has not been maintained for some time. We recommend you mention this to them.

Next doors chimney

ACTION REQUIRED: We would recommend a cup of tea meeting with the neighbours before you commit to legally purchase the property to ensure you are not buying into any problems and ask your legal advisor to check that there isn't a long running dispute between these two properties.

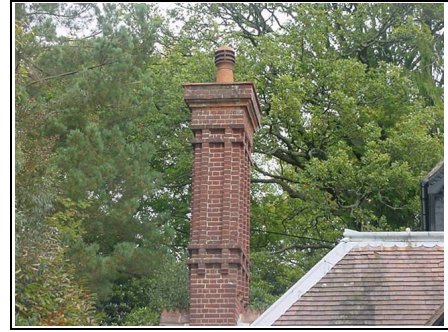
Chimney two

This chimney was built in a similar manner to the first chimney with one chimney pot. From what we could see from ground level it looked in slightly below average condition considering its age, type and style.

ACTION REQUIRED: You will need to double check the pointing when the middle chimney is being re-pointed. We would reiterate it needs to be re-pointed in appropriate lime mortar.

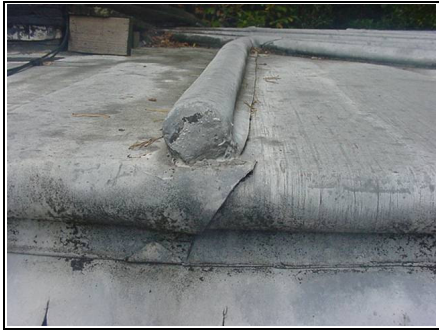
Lead work –roll joint

The property has an excellent flat lead roof on it. Lead for us is the Rolls Royce material for flat roofs. However this has suffered over time with some what we would term as sticking plaster repairs using the produce known as Flashband which is effectively we feel a temporary repair.

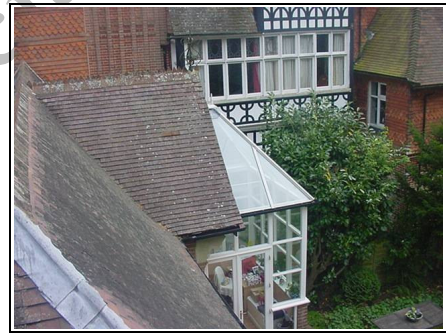
Conservatory roof

We were pleased to see the conservatory has a glass roof. It is frosted/opaque to the neighbours side. You would normally only find this where there has been some planning requirement needed.

ACTION REQUIRED: This is why we believe that it would be best to go and have a cup of tea meeting with the neighbours before you legally commit to purchase this property and just to make absolutely sure that what has gone on in the past with regard to planning permission, building regulations and local authority approvals doesn't lead to you having disputes.

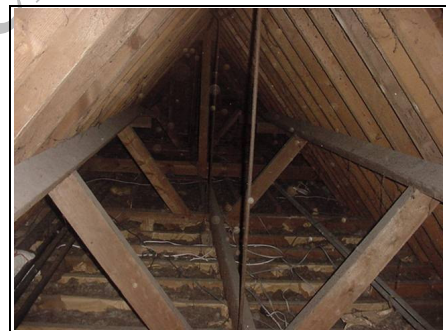
Left hand side of roof (hard to get in)

Our examination was limited by the general configuration of the roof and the insulation. What we could see was generally found to be in average condition (although we would have preferred to have seen some venting at the gables). With modern day heating requirements this type of roof can suffer from condensation which in turn can lead to it being a very pleasant environment for woodworm.

ACTION REQUIRED: The only way to be 100 per cent certain is to have the roof cleared and checked.

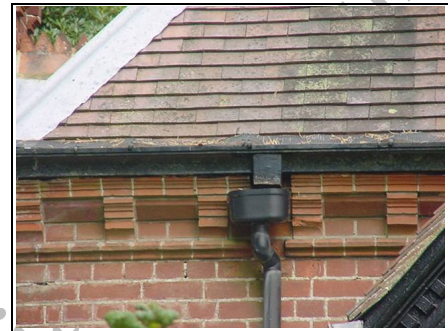
There are leaf guards in the gutter which indicate to us that this gets a lot of leaf and tree debris.

There are bound to be some minor leaks but most people would be happy to live with these.

Metal gutter and plastic downpipe

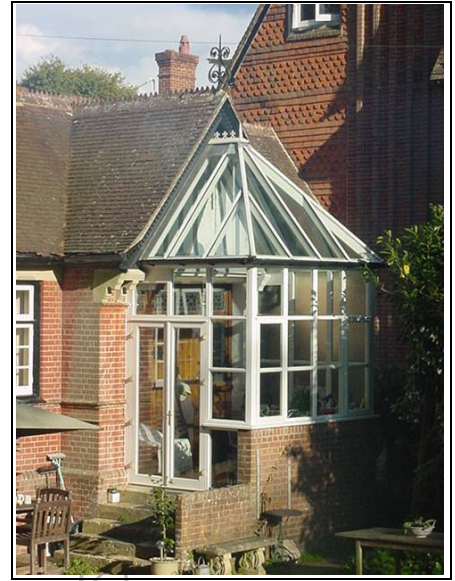
Conservatory

Being a glass built conservatory extension to the rear of the property will mean it can get very warm.

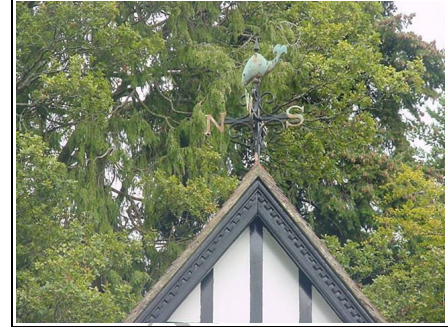
Trees nearby

As explained at the time you came to meet us we found tree roots within the drains. Please see our comments in the executive summary.

The owner advised that they had found tree roots in the rainwater drains previously. These will need removing before they block the drain.

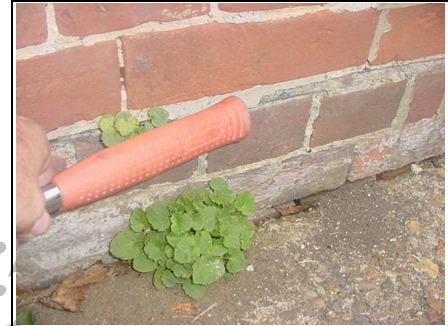
Damp proof course

In this case we could see a thickening of the mortar indicating a slate damp proof course.

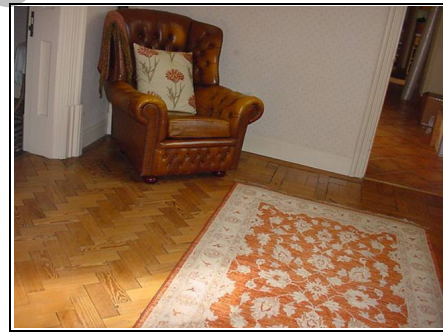
Wood block flooring over suspended timber floor

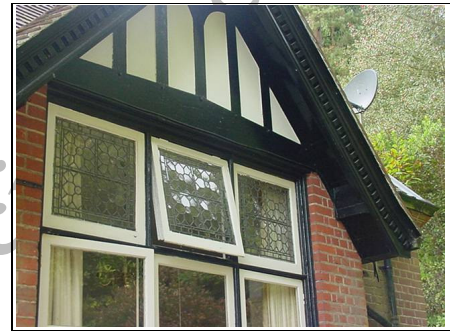
The property has decorative fascias and soffits which are painted black. We would comment they are in reasonable condition for their age, type and style. We would however comment that black painted timber does tend to deteriorate fairly quickly as it absorbs the heat.

Fascias and soffits painted black

ACTION REQUIRED: Double check the fascia and soffits when carrying out work to the gutters, hopper heads and downpipes.

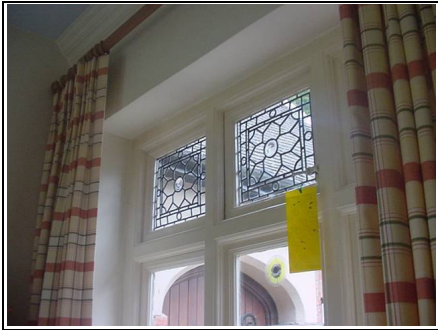
The property has painted single glazed timber casement windows. They have beautiful leaded lights to the upper section in some cases. They also add a terrific amount of natural daylight to the property.

Leaded light window

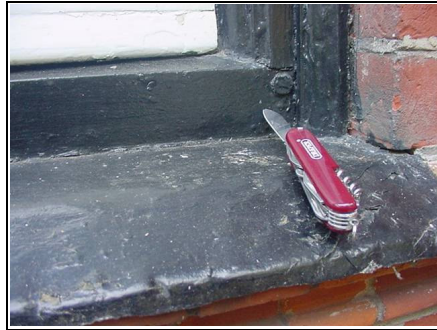
We carried out a knife test and they are in reasonable condition. We note that the lead has been used to form window sills in many cases. This we assume is to stop the deterioration of the soft red brick.

Knife test

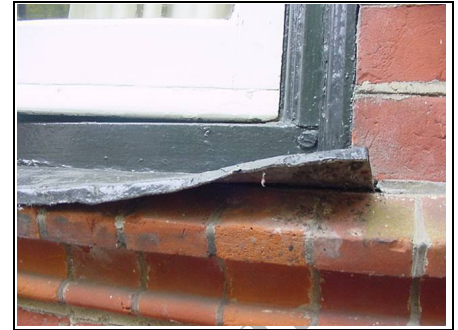
Lead window sill

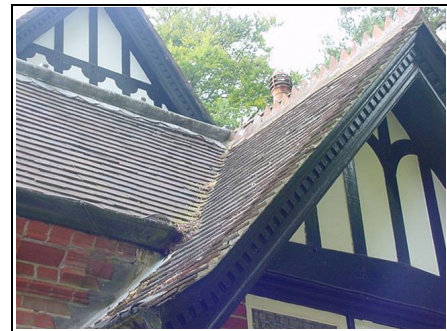
Decorative woodwork

There is a fair amount of external decoration with the decorative woodwork. It looks in average condition at the moment but you should expect it to need redecorating. Check in the summer of 2012 to redecorate in the summer of 2013 depending upon condition.

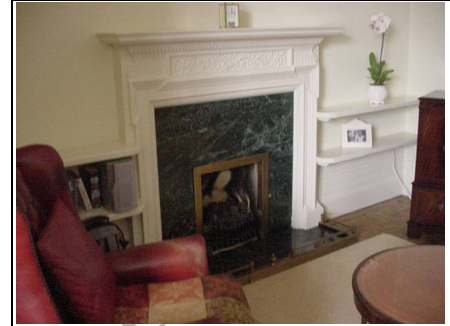
There is a chimney breast to either side of the lounge. One has been partly closed up, as you can see in the photo, and one is being used for the flue of the gas boiler.

Fire in lounge partly closed

Incidentally we need to remind you (we believe you have already been advised) that the gas boiler isn't strictly to standard as it's not vented to external air.

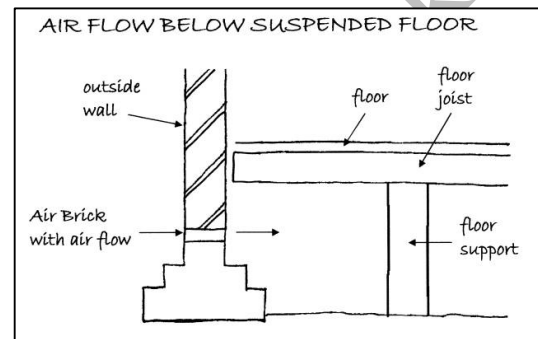
The ground floor we believe is a mixture of solid and suspended timber floors. We were unable to see the suspended timber floor due to the blocks.

Flooring blocks covering the floor were opening up slightly

Please see our comments in the Executive Summary about looking at part of the floor. It may be the case that it is all solid we cannot be certain until you try to open up a section of it.

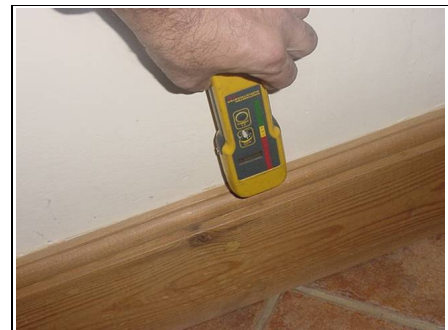
A random visual inspection and tests with a moisture meter have been taken to the perimeter walls and some internal walls. In this particular case we have found no rising damp.

Testing for rising damp

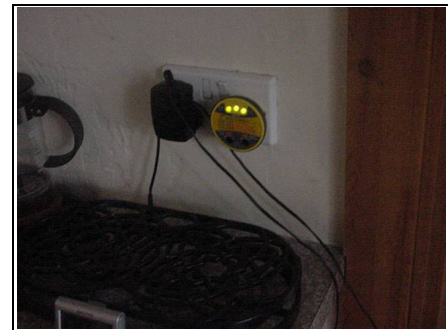
Earth Test

We carried out an earth test in the kitchen area to the socket point that is normally used for the kettle, this proved satisfactory

ACTION REQUIRED: As the property is changing occupancy an IEE report should be carried out by a NICEIC registered and approved electrical contractor.

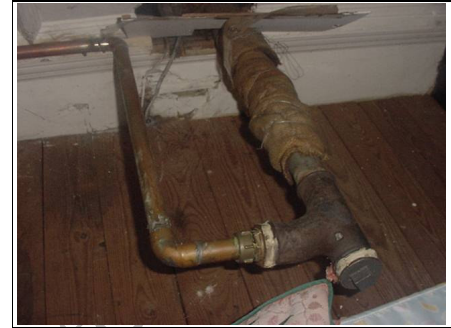
Gas Pipe

The thing we would bring to your attention in regards to the gas is the size of the pipes we can see coming into the lantern roof.

ACTION REQUIRED: As a matter of course it is recommended that the entire gas installation is inspected and made good, as necessary, by a Gas Safe registered contractor. Thereafter the installation should be serviced annually.

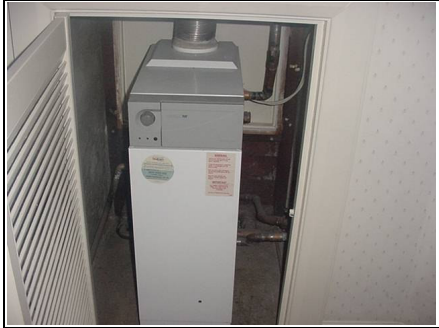
Potterton boiler

The boiler was located adjacent to the entrance hallway, it is manufactured by Potterton.

Our limited inspection of the hot water and central heating system revealed no evidence to suggest any serious defects but we would nevertheless recommend that the system be tested and overhauled before exchange of contracts and that a regular maintenance contract be placed with an approved heating engineer.

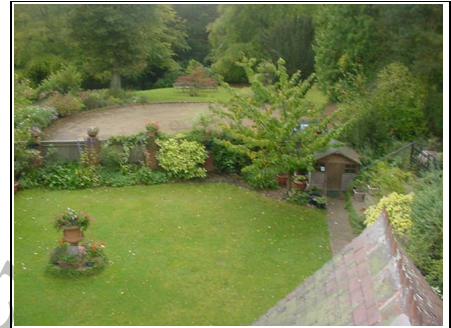
Parking to the front of the property but we also noted what looked to be parking to the rear of your garden. You need to check that you are happy with this layout.

Garden with parking behind

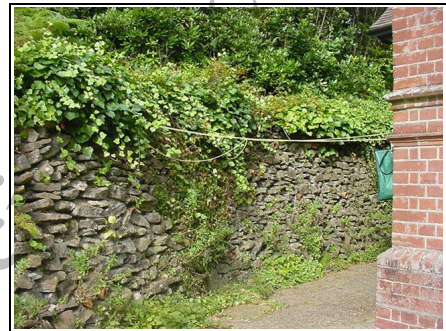
Retaining Wall

There is an area to some extent around the whole of the property. This is mainly bound by a large retaining wall with more terracotta weep holes than we've ever seen. This does seem to indicate that a lot of water does come out of this when it rains.
