RESIDENTIAL BUILDING SURVEY

Wrexham LL14

This is a new building which is a two storey detached property with integral single garage. There are gardens to the front and rear, the front garden is predominantly given over to parking. At the time of our inspection the property was approximately four weeks from being completed. There was an established building to the left hand side and a new building on the right hand side which is currently coming out of the ground (at foundation level) with an adjacent church (all directions given as you face the front of the property).

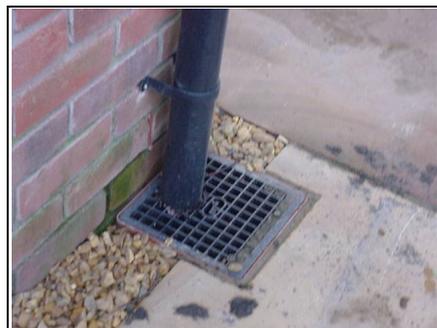
Downpipe not working, note moss to brickwork

ACTION REQUIRED: You need assurance from the builder that they will come back and amend any areas where the gutter is not working properly. We find that only by living in the property can you fully understand whether gutters and downpipes are working! Even with new gutters and downpipes we would always recommend that they are cleared out periodically, the joints are checked and the alignment checked to ensure that the gutters fall towards the downpipes.

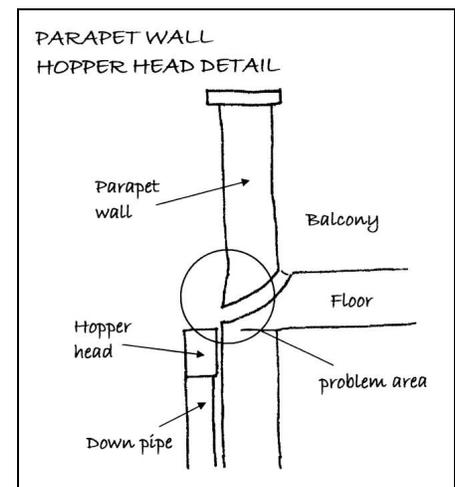
Gutters and downpipes on front left hand side – we think valley gutter may overflow and will ultimately require a hopper head

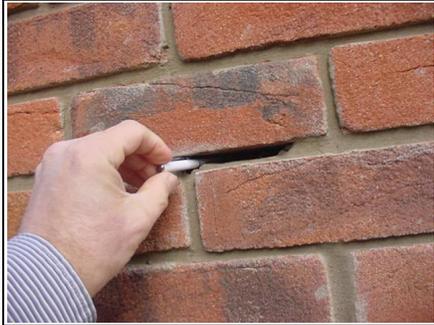
The mortar has not been cleaned off the brickwork (commonly known as 'snots'). Also there are a number of joints, etc where the mortar has not been bedded properly which needs repointing, for example to the rear right and left hand corners.

Mortar needs repointing

ACTION REQUIRED: Repoint in a suitable mortar.

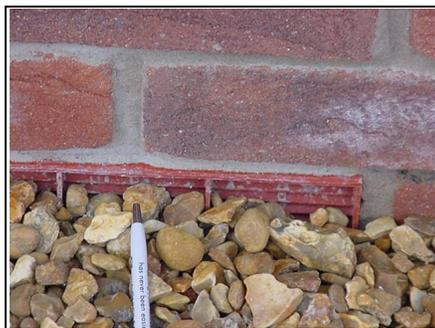
The airbricks are covered in some areas.

Blocked air vent

ACTION REQUIRED: Your solicitor needs to specifically ask the builder why this has happened and where the ground level should be. We would also comment that we were unable to note a damp proof course (which is sometimes the case). It needs to be established where this is to ensure there are two courses of brickwork of approximately 150mm before the ground level.

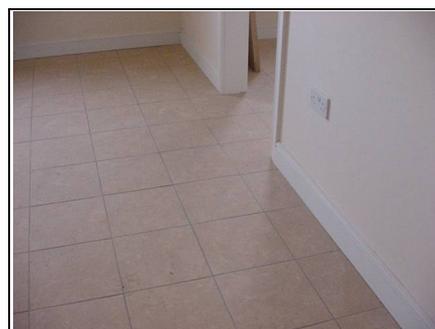
No expansion joints can be seen on tiled floors

Your solicitor to specifically ask the builder if expansion joints have been added as where a hard surface such as a tile is put onto a flexible surface such as the first floor flooring differential movement can occur.

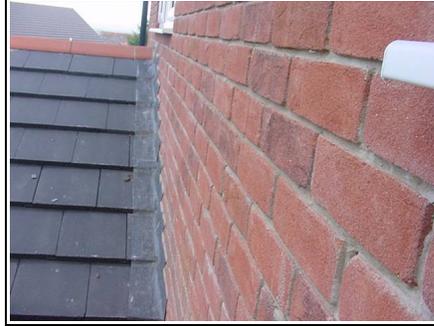
Both roofs are pitched and clad in a concrete tile as previously described. Where they meet the main building we are concerned that the flashing may not have been bedded properly and deterioration of this bedding joint may occur. This is a problem that we see too often on modern properties.

Close up of flashings to conservatory

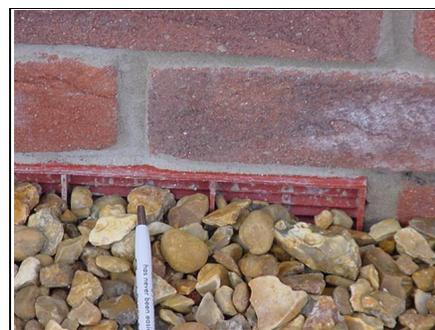
There are problems in relation to the airbricks as these are being blocked by the shingle.

Blocked air vent

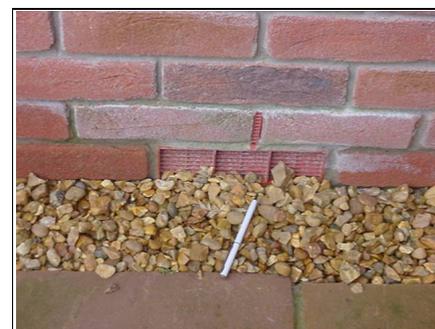
Partially blocked air vent

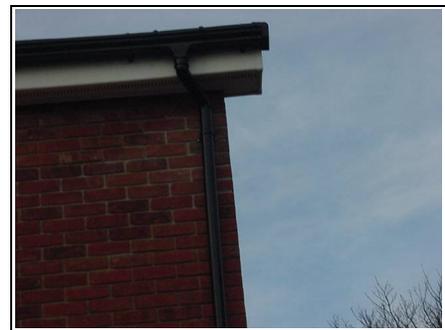
The property has plastic fascias and soffits which are in average condition. We were pleased to see that there is a vent in the soffit that will, providing it is not blocked, allow ventilation to the loft space to reduce condensation.

Plastic fascias and soffits

ACTION REQUIRED: Your solicitor needs to specifically ask if pre-formers have been used to ensure that the air vents around the soffits don't get blocked.

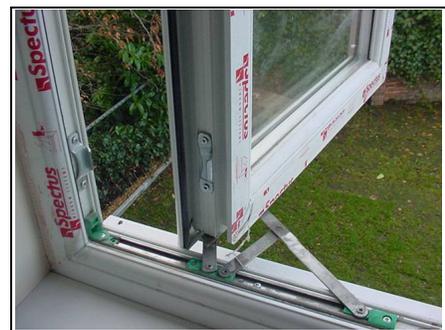
The property has plastic, double glazed windows, which generally look to be of an average quality. A guarantee needs to be offered.

Window

ACTION REQUIRED: Guarantees should be obtained. Generally it is considered that double glazed units have a life of about ten years.

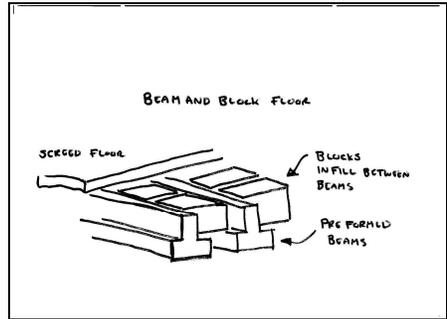
Based on the airbricks, the age of the property and the area, we believe that the ground floor construction is predominantly a suspended concrete floor, often known as a beam and block floor. This type of floor needs air circulation under it.

ACTION REQUIRED: Please see our comments in the executive summary with regards to differential movement.

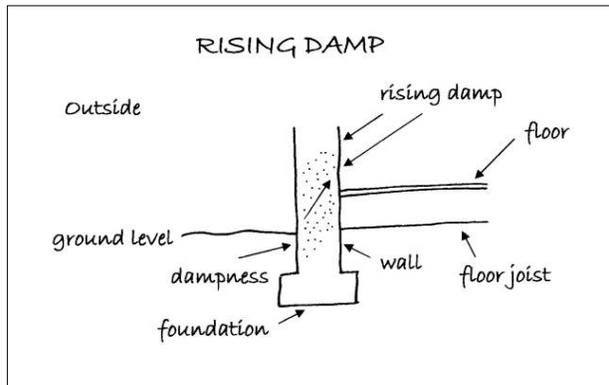
We were not able to take electric damp meter readings due to the dry lining in most areas.

ACTION REQUIRED: Please see our comments with regards to the apparent high ground level externally.

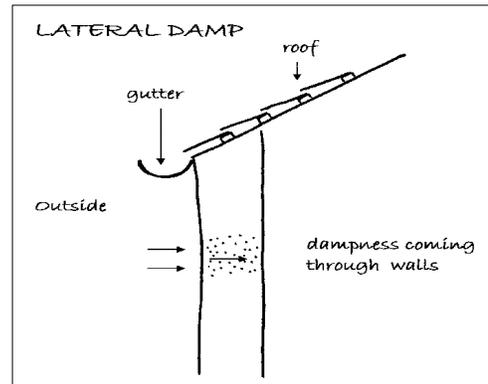
Trying to check dampness and getting readings between 15 and 30 which indicates plasterboard finish

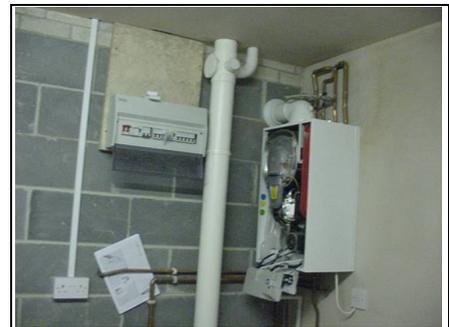
Fuse board

The electric fuses and consumer units were located in the garage. The fuse board is new. We would expect an Institute of Electrical Engineers (IEE) test and report. We can see it has been carried out to the new IEE requirements due to the high electrical points for example, even though the electricity wasn't working at the time of our inspection.

ACTION REQUIRED: In view of our findings it is recommended that a competent electrical contractor, preferably registered with the NICEIC, be engaged to carry out a thorough inspection and test together with an assessment of the cost of works required to ensure compliance with current IEE standards. You are strongly advised to implement any recommended works.

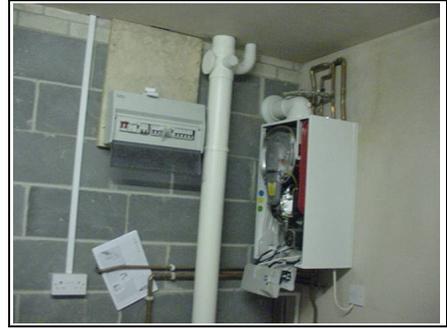
Boiler

The boiler was located in the garage; its make was not identifiable. Our limited inspection of the hot water and central heating system revealed no evidence to suggest any serious defects.

A new boiler has been fitted and a guarantee should be available. Typically we are finding that the wall mounted boilers, often known as combination boilers or 'combi' boilers, are lasting up to 15 years from new, assuming regularly serviced. To ensure it runs efficiently the boiler needs to be regularly serviced and run at its optimum temperature.

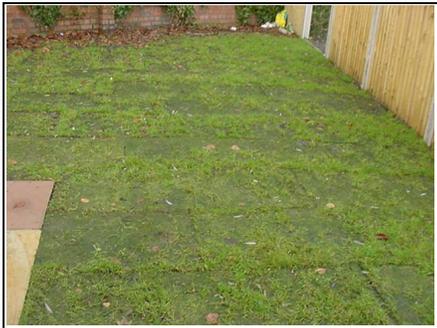
We believe you have made an agreement with regards to the turf and replacement of it
