SPECIFIC DEFECTS REPORT

Relating to Dampness

London N6

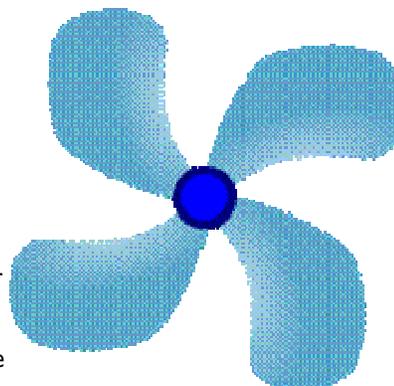
An example of condensation that we are coming across more and more is where an extractor fan is installed to the bathroom to take away the excess moisture, but unfortunately where ceiling extractor fans are fitted and these are very popular where a light is fitted, and if they are fitted directly over the shower it makes sense to have one fitted, then the extract flue is left to discharge into the roof space or attic, rather than taking it to a vent to outside air.

The reason this is the case is because it is much harder to get it vented to outside air. We have been into a roof where literally it was like a rain forest. You could tap the underside of the felt in the roof and get covered with water. Fortunately, we only see this once every five to ten years but we can only imagine it is going to become more common with the general increase in thermal efficiency of houses. Whilst we feel thought has been given to the air change in properties there is a big human factor in having to use the extract fans in the bathroom and kitchen and having to maintain them once they are broken.

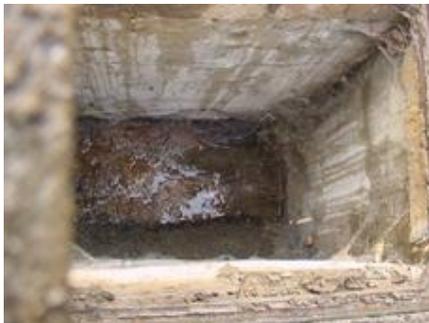
Checking a manhole

The first thing we would always do is to try and establish where the drains are running. By this we mean identifying the manholes and the drainage runs from the house and trying to establish where they run. It is relatively easy if there are manholes present as it is literally manhole to manhole and water can be run from the taps to check this. We have even used dye in the test just to establish which drains come from which section of the house.
