SPECIFIC DEFECTS REPORT

Relating to identified Dampness

XXXX London. E17 XXX

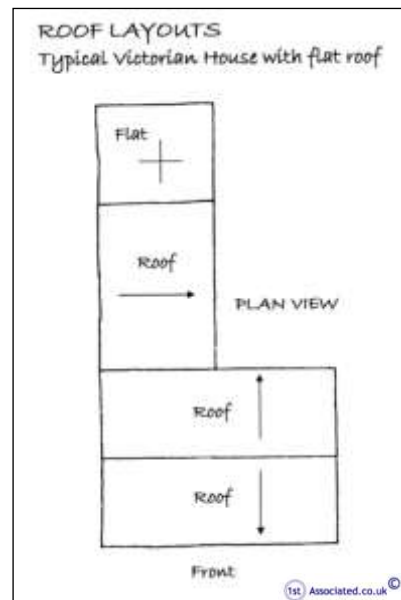
Dampness within main bedroom left hand wall

- iii. Condensation on the water supply pipe
- iv. Possibly a poor joint between the main roof and the rear roof
- v. A parapet wall that is allowing dampness in, please see answers to point 1.

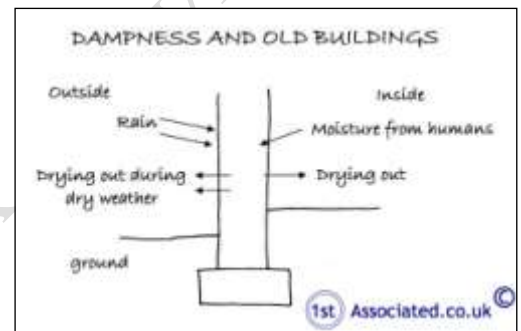
what is typical with a damp proofing company which is what is known as a renovating plaster or a waterproof plaster which is much harder, their argument being that this protects the property from rising damp. We would refer to the research that has been carried out by Jeff Howell, see the book *The Damp Proof Myth*, available on Amazon, we much prefer a wall that breathes rather than one that uses this raincoat type principle.
