# **SPECIFIC DEFECTS REPORT**

**Relating to dampness and noise transfer within  
the ground floor flat  
XXXX Plaistow, London E13 XXX**

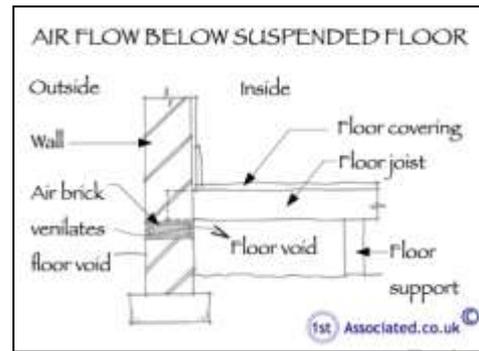
There is rising damp in the property which is common in many properties of this age however this can be reduced by ensuring there is airflow underneath the floor via the airbricks. This property has a suspended timber floor (which you can see in the first sketch) so you need to ensure there is an airflow from the front to the rear of the property (as you can see in the second sketch).

Air flow below suspended floor

Given the condition the property is now in you will need to replace timbers particularly embedded timbers that have rotted over the years the repair and replacement of the timbers should only be carried out once an air flow has been established from the front to the rear of the property.

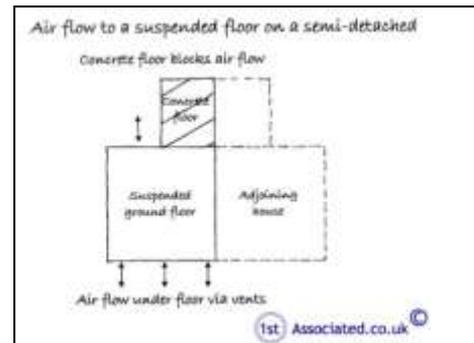
Air flow to a suspended floor on a semi detached

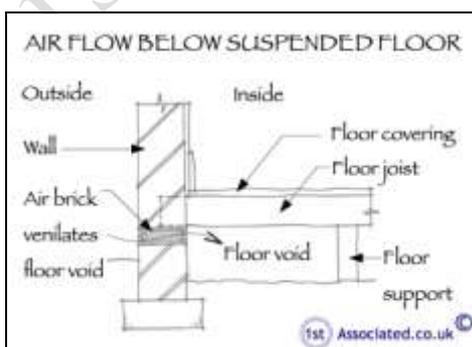
We believe problems relate due to a lack of ventilation under the floor of the property and lack of air movement in the property in general which has resulted in dampness getting into the floor timbers (this is not just within the hallway but it is throughout the entirety of the ground floor of the property).

As is shown in the sketches below with this age of property it is likely to be a suspended timber floor with embedded floor timbers.

Air flow beneath suspended floor

**TION REQUIRED:** You will need to clear and open up the air vents to the outside of the property and ensure there is no air flow underneath the whole of the floor of the property. Once this has been carried out you will then need to replace the deteriorated timbers and we would also recommend that the plaster is removed and replastered as it will be contaminated with hygroscopic salts (salts that attract moisture) and ideally it should be replastered in a lime based plaster (we are aware that many builders will not want to do this because it is hard) but lime based plasters will dissipate any dampness in the structure.
