# **SPECIFIC DEFECTS REPORT**

## **Harrow HA3 Relating to Problems with Suspended Timber Floor near Bay Window**

FOR  
**Mr S**

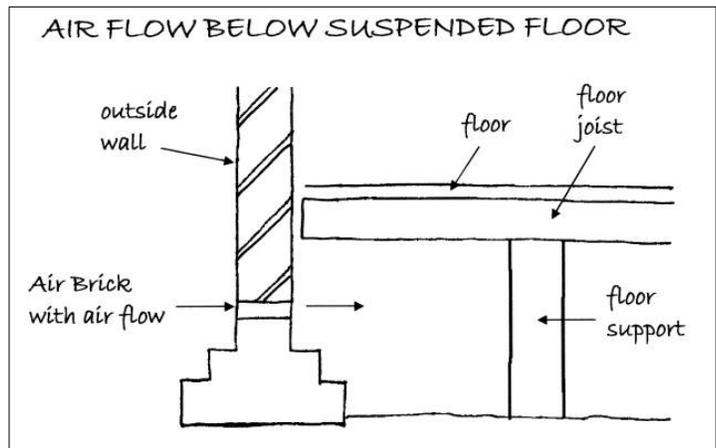
### Suspended Timber Floor Construction Defined

A suspended timber floor usually consists of timbers spanning the ground floor, supported on piers (usually brickwork), vented via air bricks within the walls.

As you are aware we have taken up the floorboards and found woodworm. We believe this to be "active", based upon the amount of "frass" (the chewed up wood), that we can see.

There needs to be a through flow of air underneath the suspended timber floor to dry out the environment and make it less suitable for woodworm and in turn stop their activity.

**ACTION REQUIRED:** We would recommend that you strip back the defective timber floor boards and dispose of them promptly (ensuring that you don't leave them somewhere where the woodworm could transfer, although upon reading on this subject it appears that they do not transfer from timber to timber that readily).

Once you have removed the damaged floorboards we recommend that you check the airbricks are open to give an adequate air flow.
