SPECIFIC DEFECTS REPORT

Relating to Dampness

xxxxxxxxxx,
Luton,
Bedfordshire,
LU3 xxx

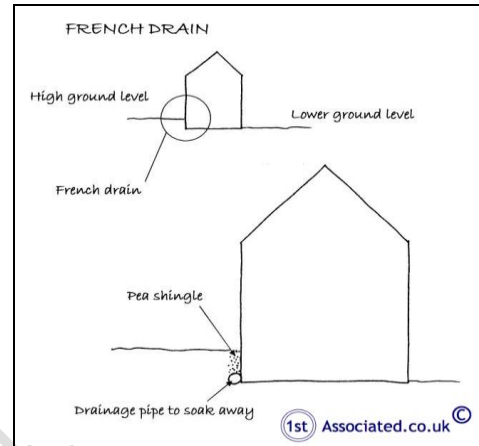
The property sits on a sloping site where we believe rainwater and surface water travels down to the property and sits against/ is absorbed by the concrete foundations and is drawn in to the house. Of course with the recent spell of wet weather the area will have had more rainwater/ ground water than usual.

Real French Drain

ACTION REQUIRED: Add a real French Drain around the property. There are wires/cable currently buried in the area so care should be taken when work is carried out.

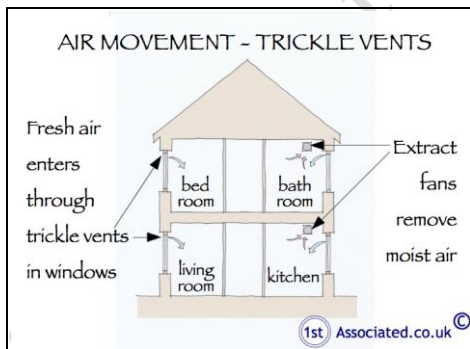
From what we can see of the property as a whole there appears to be a lack of air movement caused by a variety of issues including:-

1. Lack of trickle vents to windows
2. Lack of mechanical extraction to humidity creating areas
3. Positioning of radiators

Air movement with trickle vents

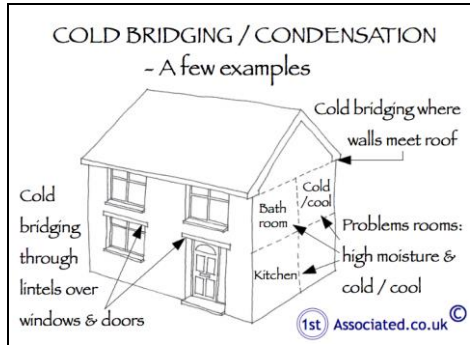
Cold bridging is caused by a colder element in the structure allowing coldness to pass through the structure much quicker when warm moist air is present in the property. Cold bridging is often caused by things like having a shower or a bath, cooking or washing, particularly if you are drying washing on the radiators. This is also caused by the general climate which results in condensation on the element.

Cold bridging

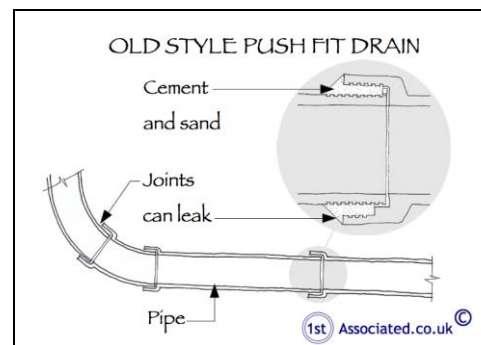
You explained how your neighbour had high pressure cleaned the drains. We do find in older drains that this can damage the joints.

Push fit drains

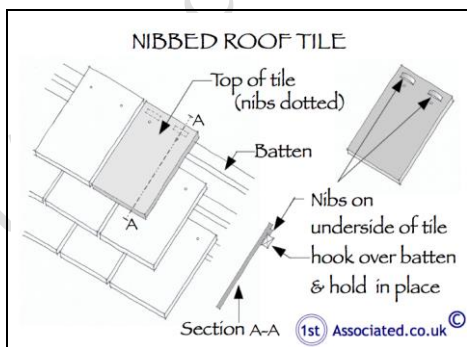
The roof is clad in a concrete tile which we believe to be nibbed and is sitting on the battens.

Nibbed tile

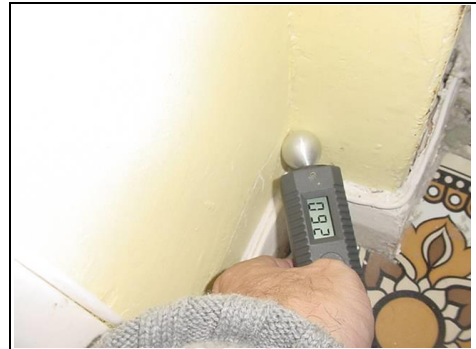
Dampness resistance meter readings using a Gann Meter have been taken.

Damp meter reading

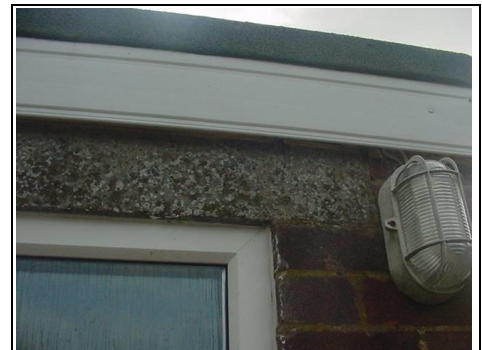
A close up view showing there is a concrete lintel over the door and window. This is where the cold bridging occurs causing condensation inside

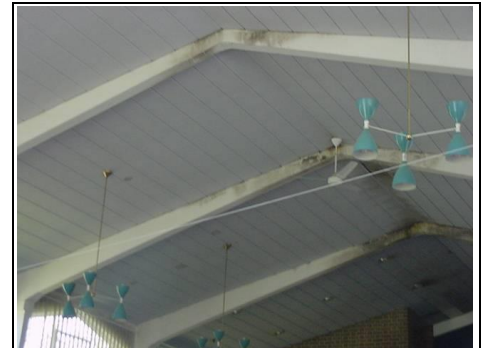
Commercial buildings are often built using structural frames. These frames are usually constructed of concrete or metal or sometimes both. The structural frame forms the skeleton of the building as you can see in the adjoining photo. Sometimes the structural frames, particularly, the concrete ones can suffer from Cold Bridging which causes blackening of the

Cold Bridging in a commercial property with a concrete frame.

concrete frame. This can look like the roof has leaked and can lead to wrongly diagnosing a problem as being a roof leak. This can result in great time and expense being wasted repairing a roof that was not leaking and indeed in some cases has led to a new roof being fitted which has costs tens of thousands of pounds. This happened because it wasn't understood what the problem was.

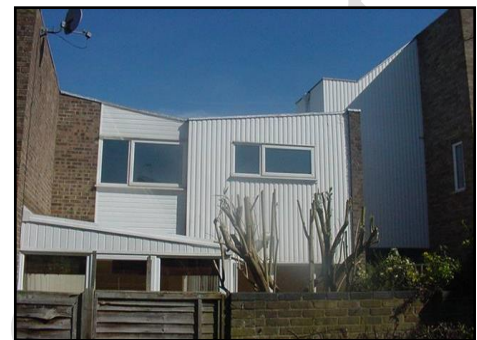
1970's property with cold bridging to the roof beams and the lintels

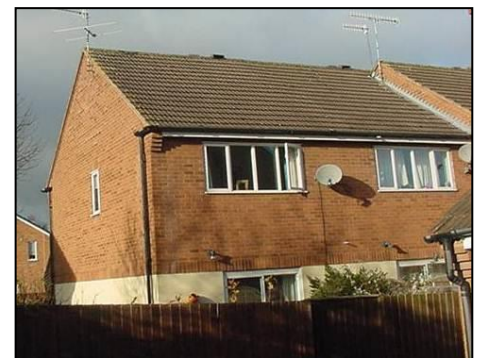
1980's property, cold bridging was found in the lintels
