SPECIFIC DEFECTS REPORT

Relating to the condition of
all external windows and doors at:-

Poulton-le-Fylde Lancashire FY6 XXX

Specific Defects Report

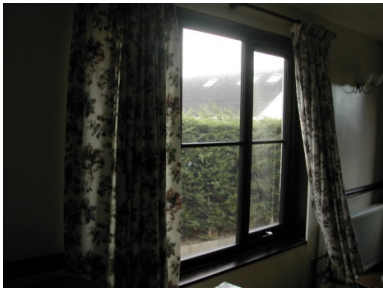
Photo Number	Photo	Observations
9417

- 3.0) Window 3 – Lounge. Being on the side elevation and therefore in a more exposed position. There is evidence of re-sealing with silicone. There are small gaps and cracks in the sealant. The finish of the sealant is untidy. There are gaps around the reveal and beneath the cill. The rubber seal around the inner faces of the casements appeared in-tact but the frame appeared to bow along its sides, the casement being top hinged. It was possible to slot a 10p coin without force into the gap between the right hand opening casement and frame and the gap on the left hand opening casement and frame was equally visible.

Window 3. General view.
9418

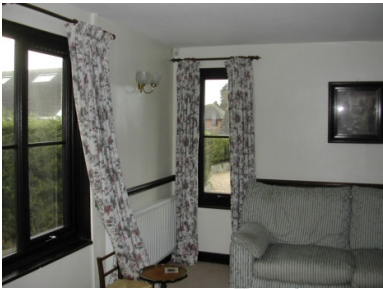
Window 2. General view.
9419

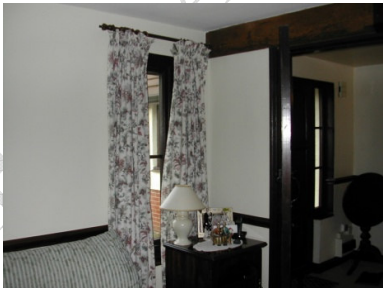
- 1.0) Window 1- Lounge. There is evidence of re-sealing with silicone. There are small gaps in the seal. The sealant finish is untidy. The rubber seal around the inner face of the casement appeared in-tact but the frame appeared to bow along its sides, the casement being top hinged. There is a vertical crack in the wall running from the left hand corner of the cill.

Window 1. General view.
9420

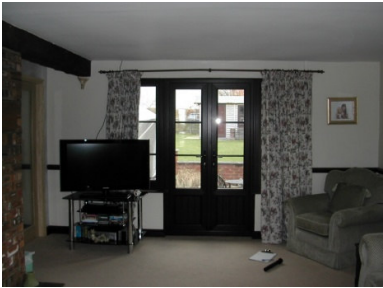
- 4.0) Window 4 –Lounge. Being patio doors facing the rear of the property. There is a gap between the timber reveal and the wall behind, and beneath the cill, above the wall. The right hand opening door has a different construction to the left hand opening door, with an inner rubber seal surrounding the lower glazed panel in one but not the other. The side opening casements again appeared to bow along their side edges. There was evidence of water ingress due to staining on the timber threshold. The top hinge stays to the opening patio doors 'grate' on the doors and are not adjusted correctly.

Outside. There are gaps between the frame and brickwork. Additional sealant has been applied to the frame. Sealant has been applied between the cill and the tiled cill. There is a gap at the end of the cill attached to the frame where the end piece does not match the profile required. There is evidence of water standing on the threshold of the door. Damaged brickwork has been repaired with mortar beneath the tiled cill

Window 4. General view.
