SPECIFIC DEFECTS REPORT

Relating to main roof problems,
xxxxxxxxxxx,
Islington, N7 xxx

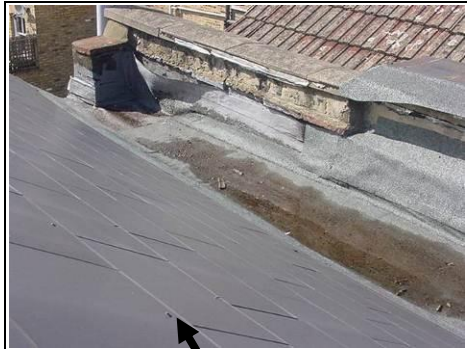
We do not believe the main problem is due to the slates being wrongly put on the roof but we do believe in the long term that they will become unsecured. This will allow rainwater in.

How the slates should be fixed with a nail(or tingle) as they are to the front.

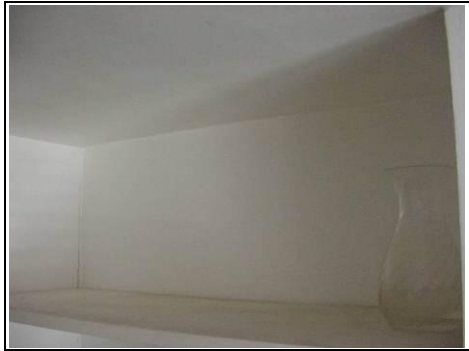
Right hand wall

Staining to the right hand wall

Internally we obtained damp meter readings over and above those we would typically find. Once the cause has been resolved, please see the roof section, you then need to deal with the effect which is the dampness and the staining. At present we believe this will just involve re-painting. If the staining gets worse then deterioration of the plaster may also occur.

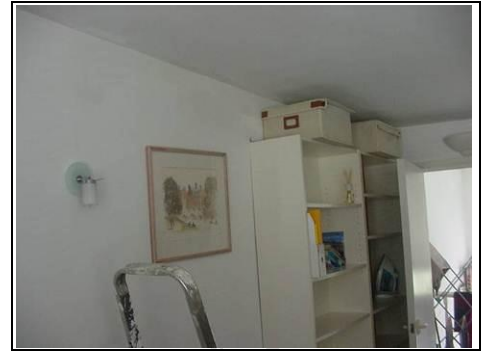
Left hand wall

Staining to the left hand side

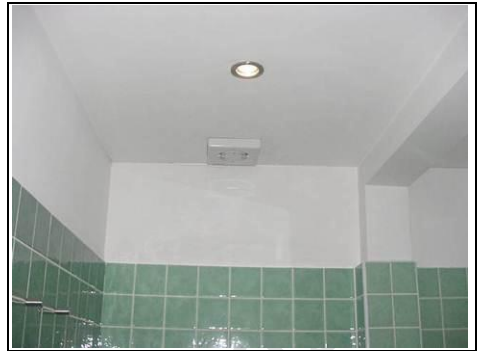
No problems at high level

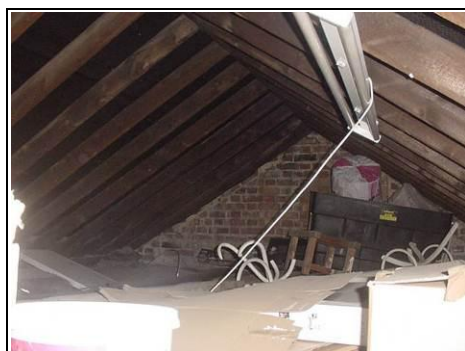
General view of the roof

4. From our visual inspection within the roof we noted staining to the rafter feet within the property indicating that dampness is coming in through the valley gutters. Our view was limited by being carried out by torchlight.
