SPECIFIC DEFECTS REPORT
Relating to roof work and associated elements
London, SW12
(visual inspection)

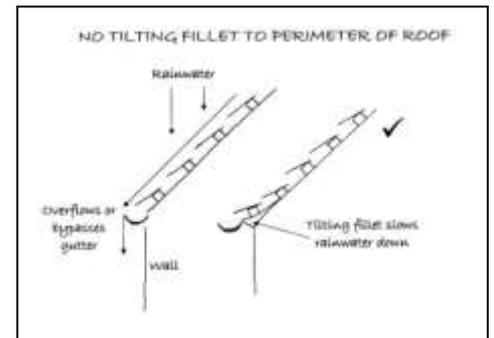
The property has a mixture of cast iron and plastic gutters and downpipes. We can see that these have corroded and are in need of repair/replacement.

Hopper head and cast iron downpipe

ACTION REQUIRED: Repair or replacement. If you do replace the gutters in cast iron be prepared to carry out regular maintenance/re-decoration which is difficult because of the height of this property, then this is the best alternative with the longest life. We would avoid plastic if at all possible, we do appreciate it has a cheaper capital cost. We would look at a modern metal guttering/downpipes as an alternative.

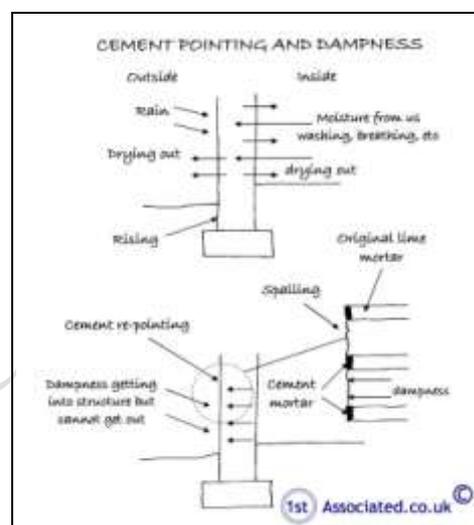
The brickwork would have originally been bedded in a lime mortar. The cement mortar has effectively smothered the building. We believe the scaffolding gives an ideal opportunity to check the brickwork and the pointing and we would recommend that as much cement mortar pointing as possible is removed and repointed in a lime mortar to allow the building to breathe and reduce future spalling of the brickwork.

Spalling starting to occur to brickwork

In our experience this type of work is best carried out with a soft brush to remove any loose cement and repoint.

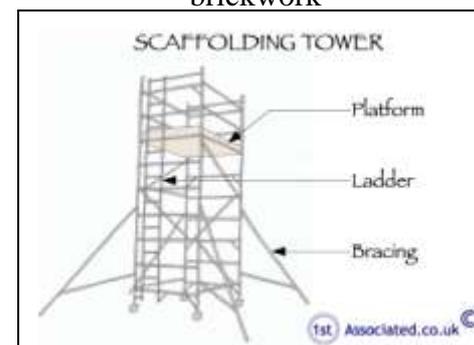
Tower scaffold

We have recommended the purchase of a tower scaffold to carry out future work to the brickwork and other areas.

ACTION RREQUIRED: Purchase good high level tower scaffold.

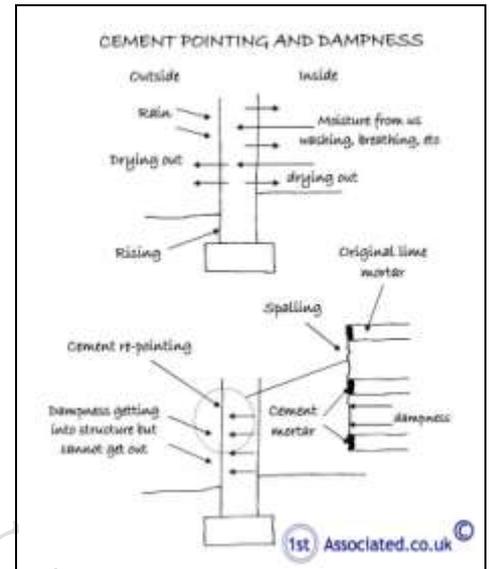
In this age of property the walls are kept dry by breathing and taking on board rainwater and then dissipating it during the dry weather as in the adjoining sketch. Unfortunately this is reduced considerably when the walls are wrongly repointed in cement mortar. It is very difficult to remove cement mortar; however you do have the perfect opportunity to carry out repointing when you have the scaffolding in place. Dampness can be seen to be coming into the top floor apartment.

ACTION REQUIRED: You do need to carry out repointing where the mortar joints are weathered such as to the chimneys and some areas of the walls. We would recommend this is carried out in an appropriate lime based mortar. You need to ensure that the builders really do use this as even where specified we have found builders are not using it. The advantages are that the softer lime based mortar doesn't cause deterioration the same way as cement mortar does to the walls.

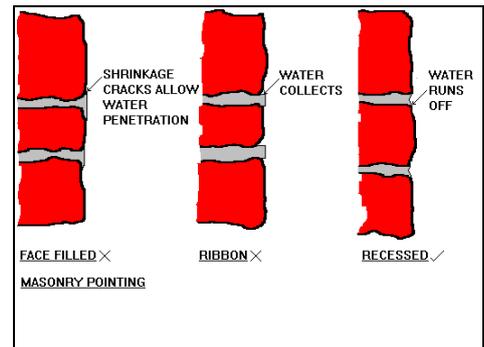
Range of different pointing to brickwork

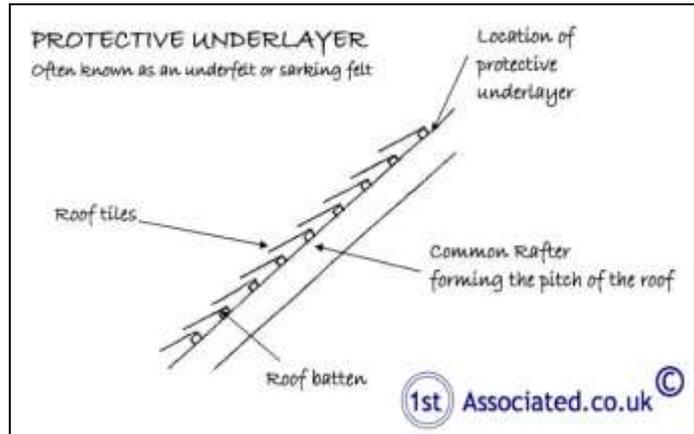
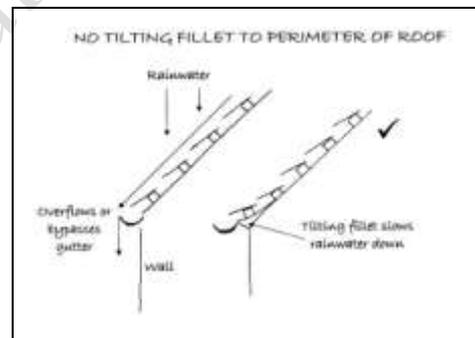
The roof originally would have been slate; it has been re-roofed in a concrete tile. This adds extra weight to the roof. We cannot see any additional support that has been added but having said that the majority of older style roofs were over-engineered with large timbers that would adequately support roofs. However a lot of problems have been caused with roof spread which has resulted in building regulations now requiring you to have specific structural calculations where concrete tiles have been used.

We would draw your attention to this and also advise that the tilting fillets have not been added at the base of the roof which could mean that water is discharging down the walls. The easiest way to check this is when it is next raining see if the rainwater is hitting the gutters or not. Nevertheless we would recommend that when the scaffolding is in place a further check is carried out and tilting fillets added if so required.

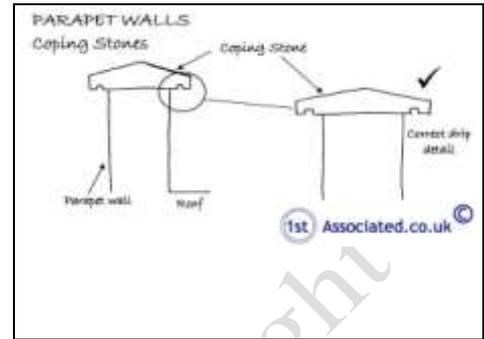
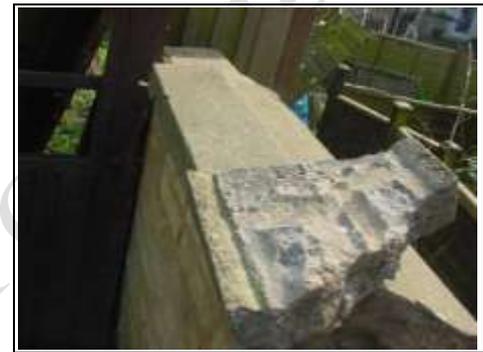
Something that will need checking close up when you are actually at high level is the parapet walls. Coping stones can often be the cause of damage to the walls beneath. As discussed the coping stones look to have been cast in place. The ones that we could see on the rear garden wall had a drip in place although not the V shaped drip as shown in the sketch but more of a triangular finish to the coping stone which we rarely come across but we don't see any reason why it wouldn't work. Nevertheless the parapet walls need to be checked to ensure the coping stones are secured properly.

Moulded coping stone with drips taken from garden wall
