SPECIFIC DEFECTS REPORT

Relating to mould within the front first floor bedroom

Surrey

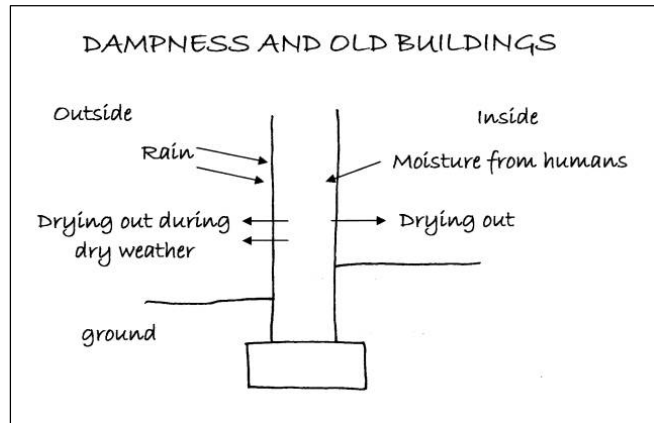
In this older style of property there is a need for it to be breathable very much like the material Gortex which allows water vapour in and out as in the sketch example adjacent. The various alterations to this property have unfortunately reduced the breathability of the property.
