SPECIFIC DEFECTS REPORT

Relating to front and rear
extension work

We have been asked to provide an independent report with regard to front and rear single storey extensions that have been built at XXXX Surrey XXX

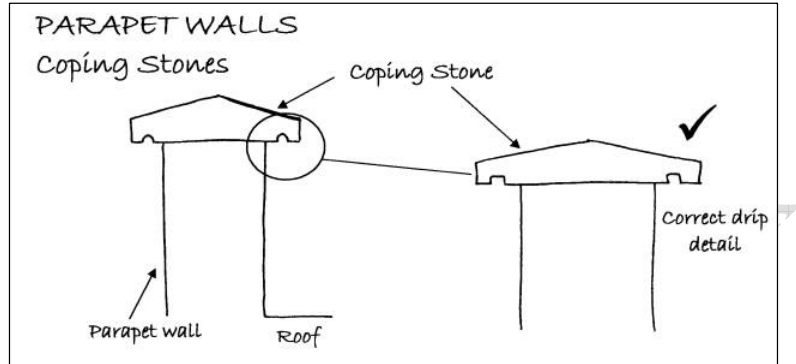
1.2.4) The coping stones do not have a drip detail and we are advised do not have a DPC (damp proof course) detail (the latter would only be a hundred per cent confirmed

with the lifting of the coping stone).

No drip detail to the front of the coping stone allowing water ingress into the property

No DPC to coping stone a way around this would be capping the coping stone or removing it and adding a DPC and replacing it with a suitable coping stone.

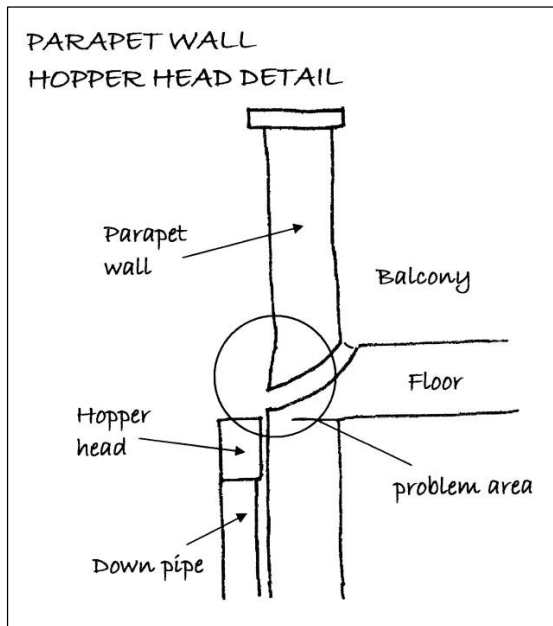
Junction detail to the hopper head not finished correctly

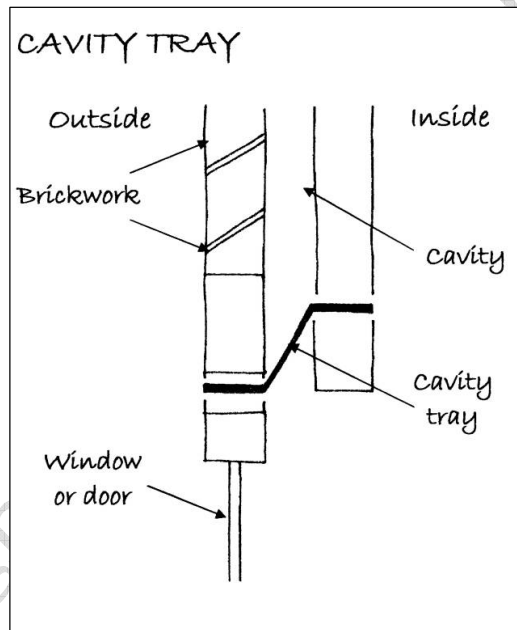
It is unknown if there is a cavity tray or a DPC (damp proof course) in the parapet wall and opening up into the main structure.
