SPECIFIC DEFECTS REPORT

**Relating to Dampness and Structural
Alterations
At a Residential Property in West Sussex**

**Specific Defects Report
of a residential property in West Sussex**

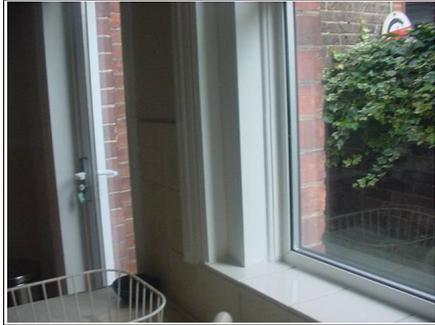
To the front bay window the timber surround with the double glazing within it rot was found.

Typical window detail with traditional wider brickwork

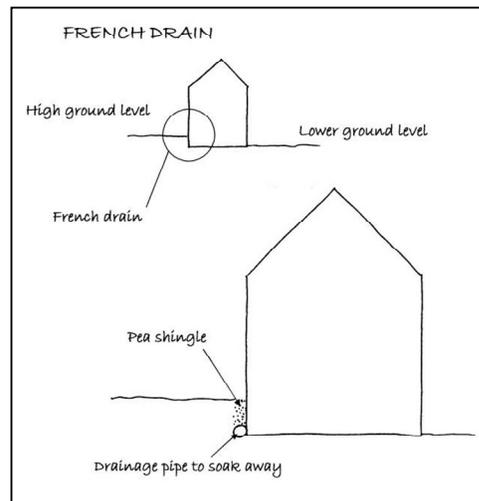
A French drain is a trench, the width of approximately six inches or 300 millimetres wide, or the width of your spade, and is approximately twice the depth, i.e. 12 inches or 300 millimetres. In most cases this will suffice, however, where there is a great deal of ground water you may wish to make the trench wider and deeper.

The French drain acts as an area where water soaks away quickly. We often recommend them close to building, but not next to the building, as this helps reduce the ground level and/or take any water that is directed at that area away. For example, where a patio has been put in place which aims any rainwater at part of the wall. As mentioned, whilst a French drain is a D.I.Y. job, it does need some understanding of how it works.
