SCHEDULE OF CONDITION

Public House Surrey

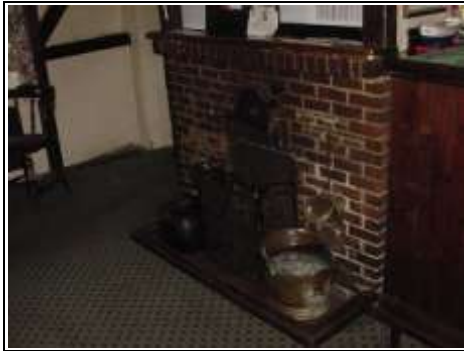
Bar right hand side near toilets

Dated.	Repair, prepare and redecorate
<p>Walls:</p> <p>Painted render</p>	Dated. Dampness found.	Resolve dampness. Repair, prepare and redecorate
<p>Floors:</p> <p>Carpet</p>	Worn	Clean or replace.

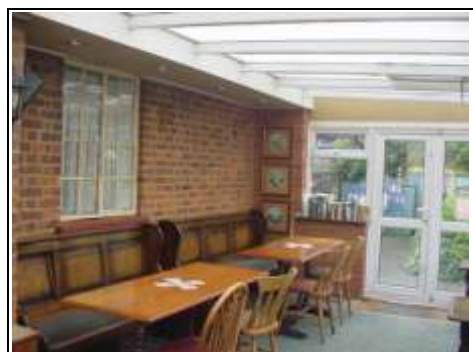
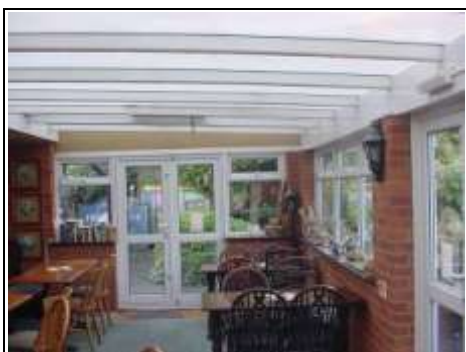
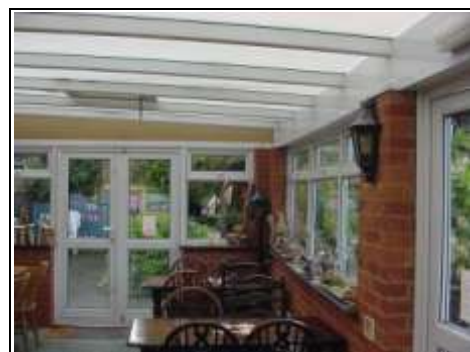
Conservatory

Polycarbonate roof	Clean
<p>Walls: Exposed brickwork Our inspection was limited by bench seating</p>		Resolve dampness.
<p>Floors: Carpet</p>	Worn	Clean or replace.
<p>Joinery: Windows Plastic double glazed</p> <p>Doors: Plastic double glazed</p>		Clean Clean
<p>Services: See Services section</p>

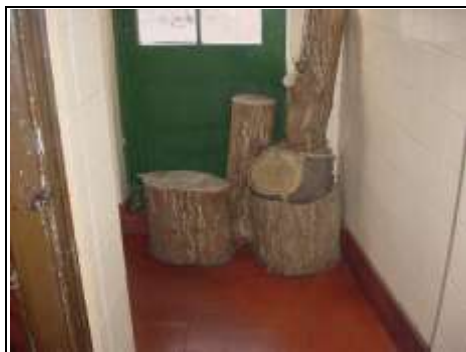
Lobby to Gents Toilets

DESCRIPTION	CONDITION	ACTION REQUIRED
Ceiling: Painted	Dated. Hairline cracking following plasterboard lines.	Repair, prepare and redecorate.
Walls: Floor to ceiling tiles	Fixing holes. Dampness to walls	Re-grout. Fix holes.
Floors: Red quarry tiles		Deep clean.
Detailing: Entrance door: Glazed panels, locked.	Dated.	Repair, prepare and redecorate. Glazed panels should be amended for security
Door to pub:	Dated.	Repair, prepare and redecorate.

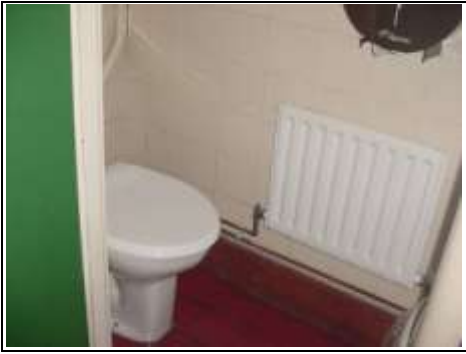
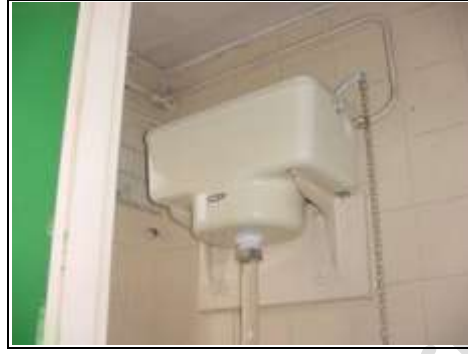
Ladies Toilets

DESCRIPTION	CONDITION	ACTION REQUIRED
Ceiling: Painted	Dated.	Repair, prepare and redecorate
Walls: Floor to ceiling tiles	Dampness to walls. Old fixing holes	Resolve damp problems and then re-tile.
Floors: Vinyl

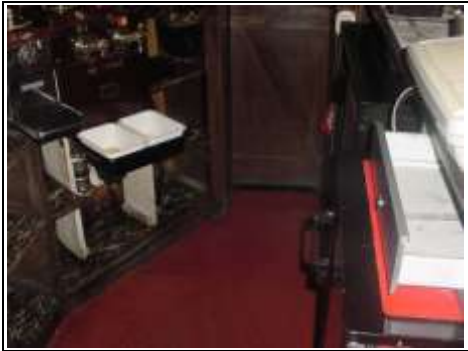
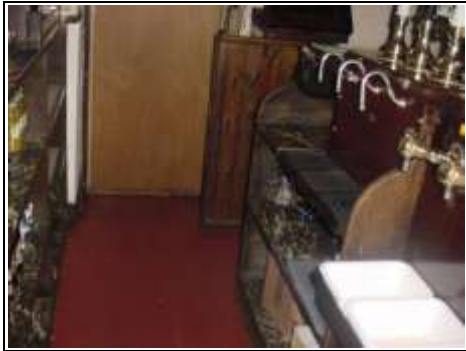
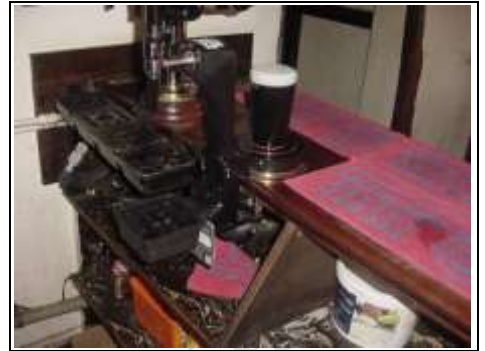
Bar Servery Area

DESCRIPTION	CONDITION	ACTION REQUIRED
<p>Ceiling:</p> <p>Old sign with embossed paper behind</p>		Clean sign and redecorate ceiling.
<p>Walls:</p> <p>Painted</p>	Dated	Repair, prepare and redecorate.
<p>Floors:</p> <p>Altro style flooring</p>	  Worn	Replace or repair.
<p>Detailing:</p> <p>Formica bar worn to right hand side</p>	  Shelving to bar worn	Replace shelving
<p>Services:</p> <p>See Services Section.</p>

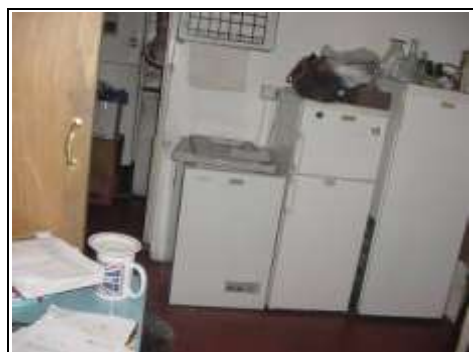
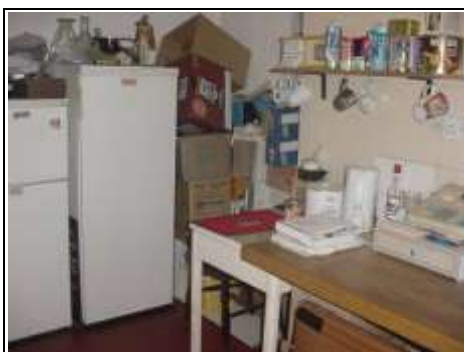
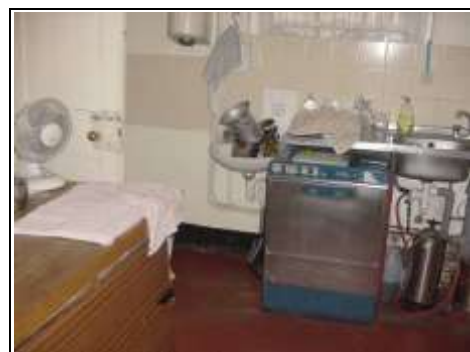
Preparation area behind bar (accessed from bar area)

DESCRIPTION	CONDITION	ACTION REQUIRED
Ceilings: Painted plaster	Dated.	Repair, prepare and redecorate
Walls: Painted	Dated.	Repair, prepare and redecorate
Floors: Altro style flooring	Worn in areas.	Repair and deep clean. Replace as necessary.
Joinery: Windows Doors: Two veneer doors Painted door leading to python store		Repair, prepare and redecorate Repair, prepare and redecorate
Kitchen Equipment: Wash hand basin Stainless steel sink with notice 'Designated for washing up' The catering equipment has not been inspected, you should seek expert advice. We have assumed that the catering equipment meets Local Authority approval and is appropriate for use. We would recommend a meeting with the Local Authority prior to taking over the lease.

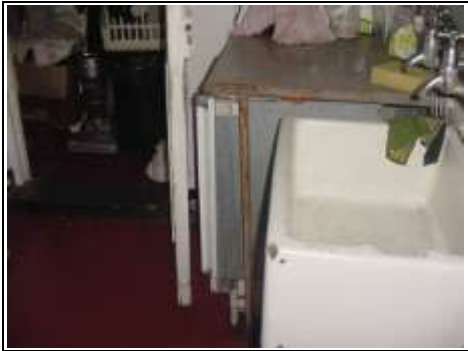
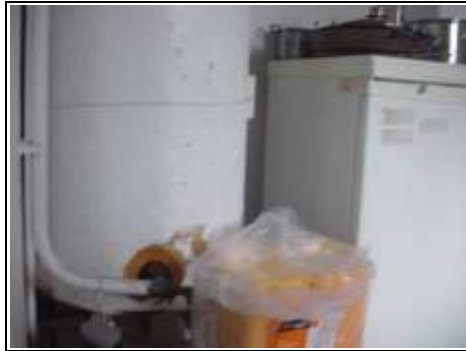
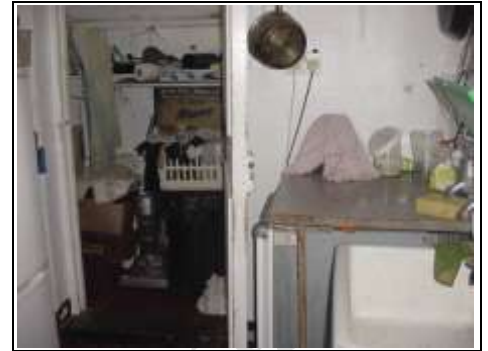
Food Store – fridges and hot water cylinder

DESCRIPTION	CONDITION	ACTION REQUIRED
Ceilings: Painted Exposed light	Stained, hairline cracking	Repair, prepare and redecorate
Walls: Painted Could not access	Dampness Hairline cracking	Resolve dampness. Repair, prepare and redecorate
Floors: Altro style flooring	Ingrained dirt	Clean and/or replace
Joinery: Windows: One metal window Doors		Repair, prepare and redecorate Repair, prepare and redecorate
Kitchen Equipment: Belfast sink		
Services: See Services section

Hot water cylinder - Obtain Service Records

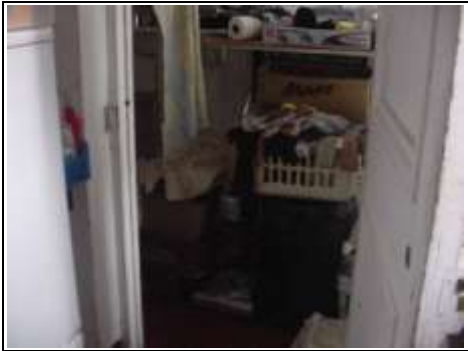
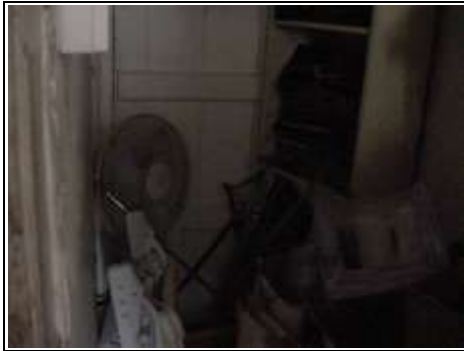
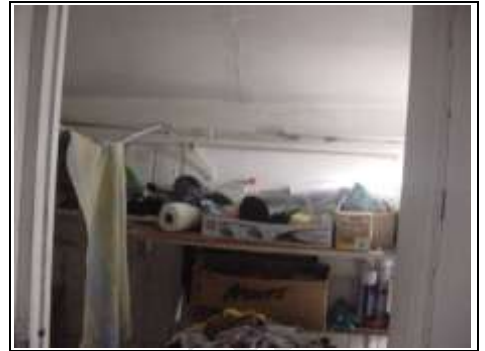
Laundry Room in lean-to

DESCRIPTION	CONDITION	ACTION REQUIRED
Ceilings: Painted	Dated	Repair, prepare and redecorate
Walls: One brick thickness Boarded walls to left, rear and front Painted brickwork to right hand side	Dampness Flaking	Resolve dampness. Repair, prepare and redecorate
Floors: Altro style flooring Tiled	Dated and damaged	Clean and/or replace Clean
Joinery: Windows: One timber window with Georgian wire polish plate glass Doors: Timber panel door		Repair, prepare and redecorate Repair, prepare and redecorate
Services: See Services section

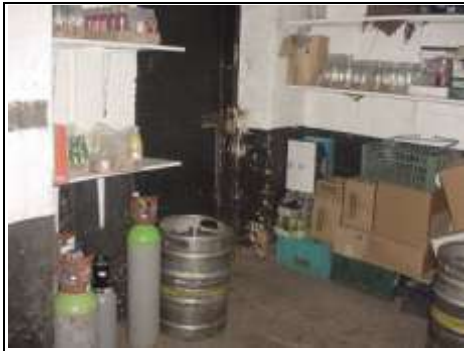
Cellar

DESCRIPTION	CONDITION	ACTION REQUIRED
<p>Ceilings:</p> <p>Painted fibreboard</p>

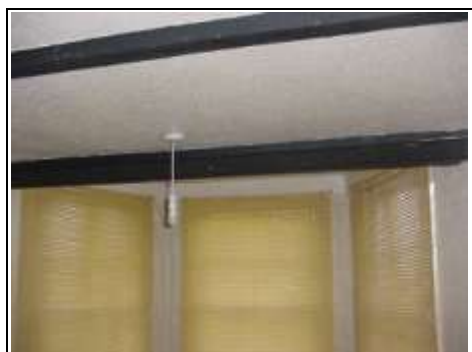
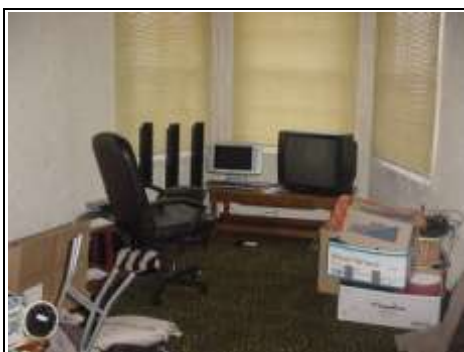
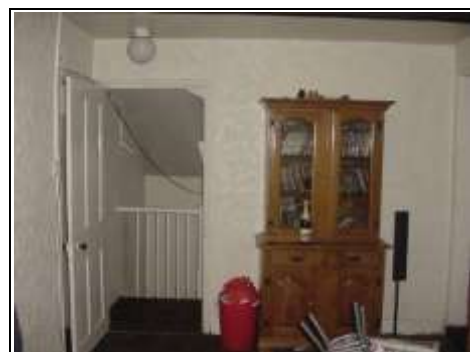
Lounge area

DESCRIPTION	CONDITION	ACTION REQUIRED
Ceilings: Timber feature beams, painted panels between	Dated.	Repair, prepare and redecorate.
Walls: Chipboard embossed paper	Dampness coming in via side of brick chimney	Repair, prepare and redecorate.
Floors: Carpet	Worn	Clean or replace.
Detailing: Windows: Bay window Doors:	Dated	Repair, prepare and redecorate.
Services: Brick exposed fireplace

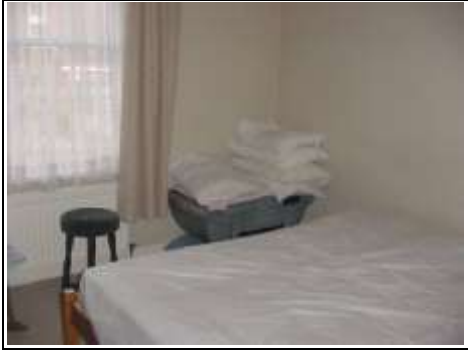
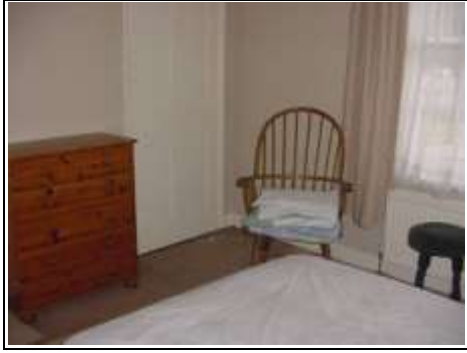
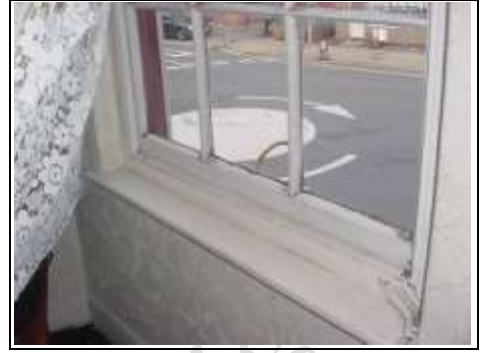
DESCRIPTION	CONDITION	ACTION REQUIRED
Ceilings: Papered cathedral ceiling	Average	
Walls: Papered	Average Crack around rear window approximately at flashing line, so assume flashing is leaking	Repair, prepare and redecorate.
Floors: Carpet	Areas of exposed floor boards which indicate joists go from front to back of property in this section	Clean or replace.
Detailing: Windows: Doors: Painted panel doors	One glass pane cracked Mould to window Dated.	Replace broken pane, repair, prepare and redecorate. Repair, prepare and redecorate and replace ironmongery
Services: Internal radiator with microbore pipes

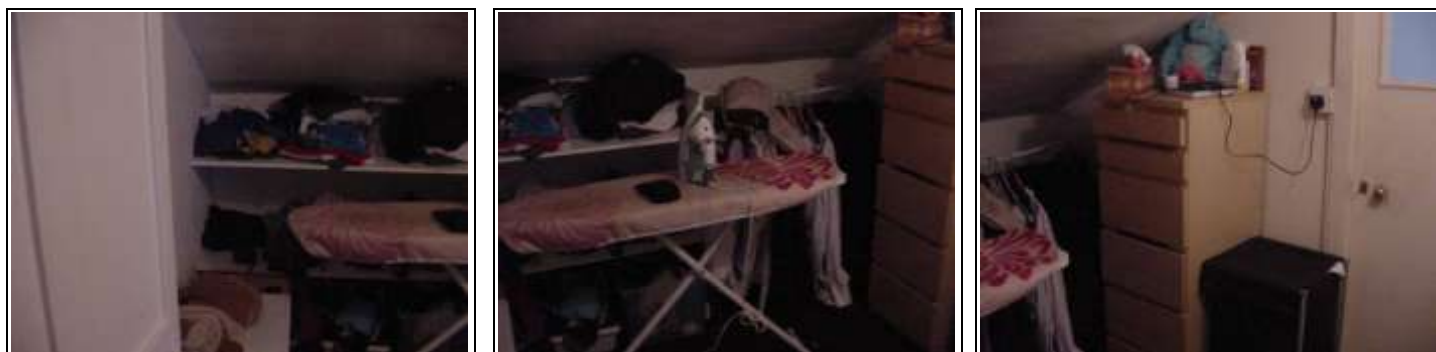
Ironing area

DESCRIPTION	CONDITION	ACTION REQUIRED
Ceilings: Cathedral ceiling	Dated.	Repair, prepare and redecorate
Walls: Painted	Dated.	Repair, prepare and redecorate
Floors: Carpet	Worn	Clean or replace.
Detailing: Doors: Painted panel door	Dated	Repair, prepare and redecorate.
Services: See Services Section.

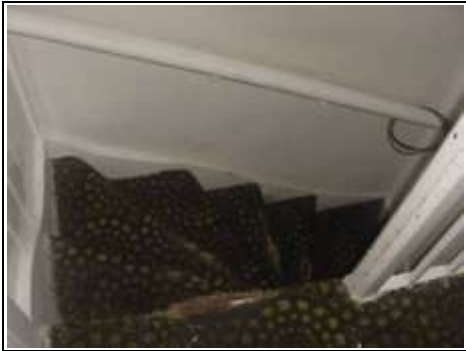
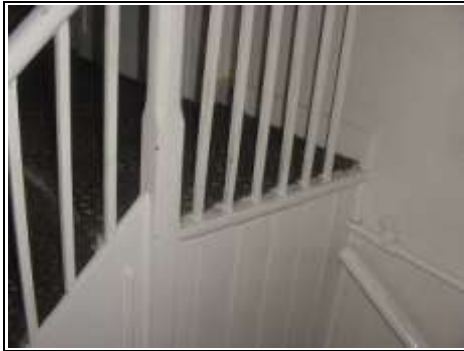
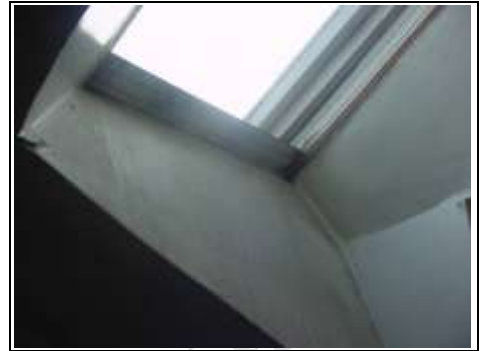
Stairs

DESCRIPTION	CONDITION	ACTION REQUIRED
Ceilings: Painted Roof window at top	Dated Average	Repair, prepare and redecorate
Walls: Wood chip wallpaper	Dated.	Repair, prepare and redecorate
Floors: Carpet	Worn	Clean or replace

<p>Detailing:</p> <p>Stairs: Curving staircase, half landing, three more steps</p> <p>Banisters and Balustrades:</p>	<p>Dated</p> <p>Dated</p>
