SCHEDULE OF CONDITION

Swimming Pool

London

We have been instructed to provide a Schedule of Condition with regard to XXXX Swimming Pool to establish its condition at the time that XXXX took occupation of the premises. We have been briefed on the project and walked around the premises with XXXXXXXX.

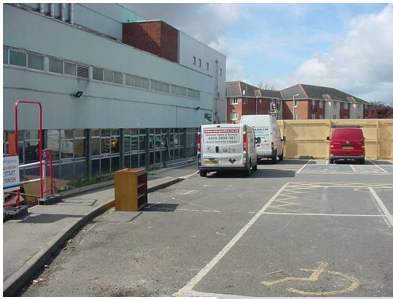
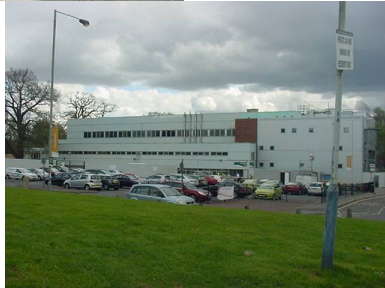
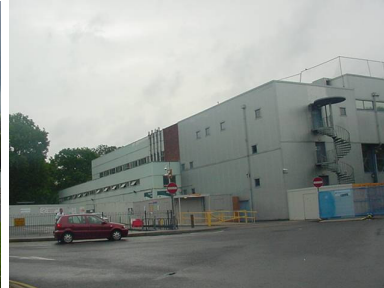
FRONT EXTERNAL ELEVATION

DESCRIPTION	CONDITION	ACTION REQUIRED
<p>Roofs:</p> <p>Main roof:</p> <p>Flat roof: Felt roof with roof lights viewed from half landing internally. Note: awkward valley gutter detail against the main building window.</p>	<p>Advised no work taking place</p> <p>We were advised the front flat roof will be insulated and covered</p>

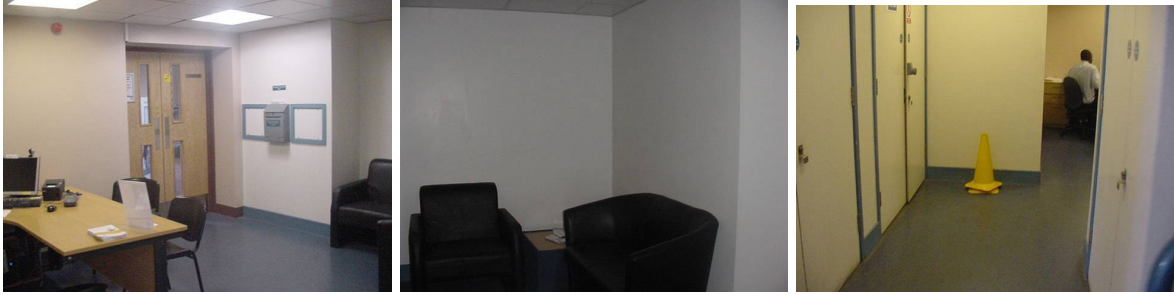
Admin/Subscription Area

DESCRIPTION	CONDITION	ACTION REQUIRED
Ceilings:		
Suspended ceiling tiles	Marked	
Walls:		
Painted

Marked and damaged particularly by chairs	Repair, prepare and redecorate
Floors:		
Poly vinyl type floor		Clean
Detailing:		
Double doors into gymnasium (gym not part of schedule)	Advised no work taking place	
Store doors:	Marked	Repair, prepare and redecorate

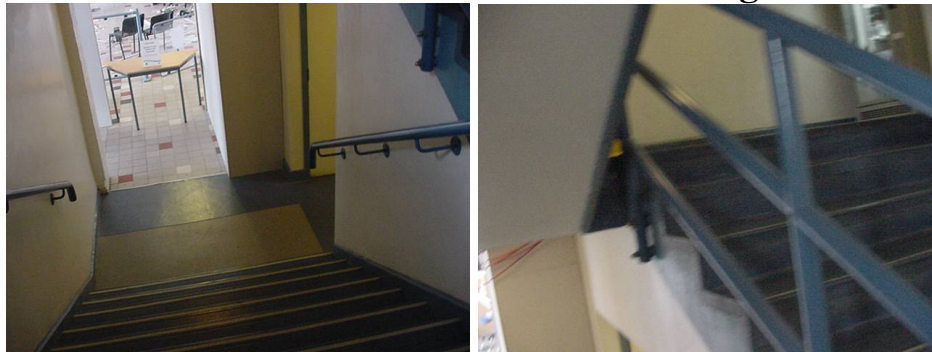
Main Stairs to right hand side
Ground floor to first half landing

DESCRIPTION	CONDITION	ACTION REQUIRED
<p>Ceilings:</p> <p>Painted</p> <p>Suspended ceiling system next to stores with an exposed grid</p>	Dated and stained	Repair, prepare and redecorate
<p>Walls:</p> <p>Painted</p>	Dated/marked	Repair, prepare and redecorate
<p>Hand rail:</p> <p>Proprietary finish</p>	Average	
<p>Floors:</p> <p>Altro style floor with replacement strip at base</p>	<p>Replace area at base of stairs</p>

Deep clean

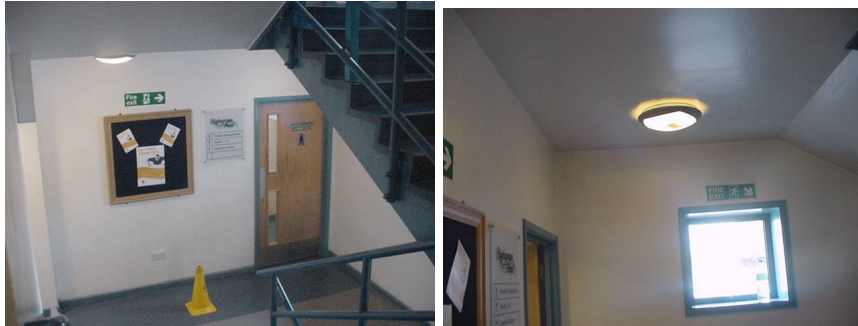
Half Landing (male changing room area)

DESCRIPTION	CONDITION	ACTION REQUIRED
<p>Ceilings:</p> <p>Part painted,</p>	Marked	Repair, prepare and redecorate
<p>Walls:</p> <p>Painted</p> <div style="display: flex; justify-content: space-around; align-items: flex-start;"> <div style="text-align: center;">   <p>Hairline cracking around door</p> </div> <div style="text-align: center;">   <p>Hairline crack next to gents changing rooms</p> </div> </div>	Marked	Repair, prepare and redecorate
<p>Floors:</p> <p>Altro style flooring</p>	Worn, part re-placed flooring	
<p>Detailing:</p> <p>Windows: Side window</p>

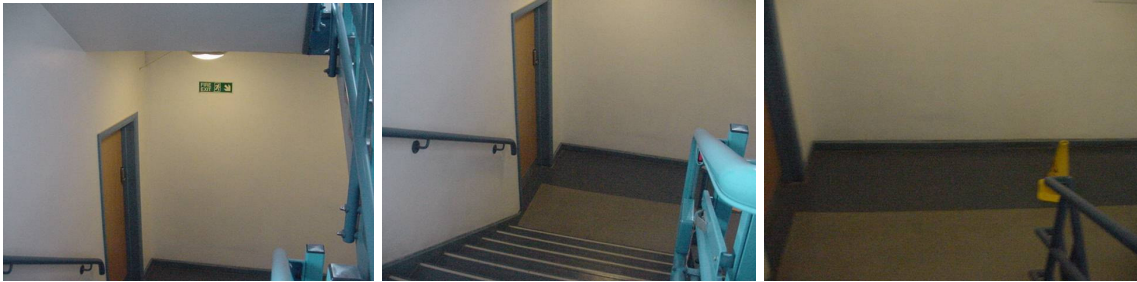
Half Landing to First floor
(Access to pool supervisors office/store, lift and swimming pool ground floor level)

DESCRIPTION	CONDITION	ACTION REQUIRED
Ceiling: Painted	Average	
Walls: Painted	Marked and dated.	Repair, prepare and redecorate
Floors: Altro style flooring	Worn	Deep clean

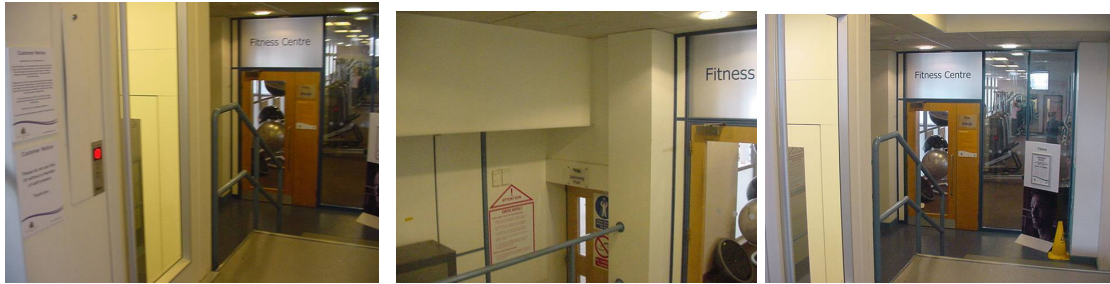
Stairs/Half Landing
with access to female changing rooms and first floor fitness centre

DESCRIPTION	CONDITION	ACTION REQUIRED
<p>Ceilings:</p> <p>Painted Part suspended ceiling (opposite lift)</p>

<p>Walls:</p>	<p>Hairline crack</p>	<p>Repair, prepare and redecorate.</p>
<p>Floors:</p> <p>Altro style flooring</p>	<p>Worn</p>	<p>Clean</p>
<p>Lift:</p> <p>Adjacent to stairs</p>

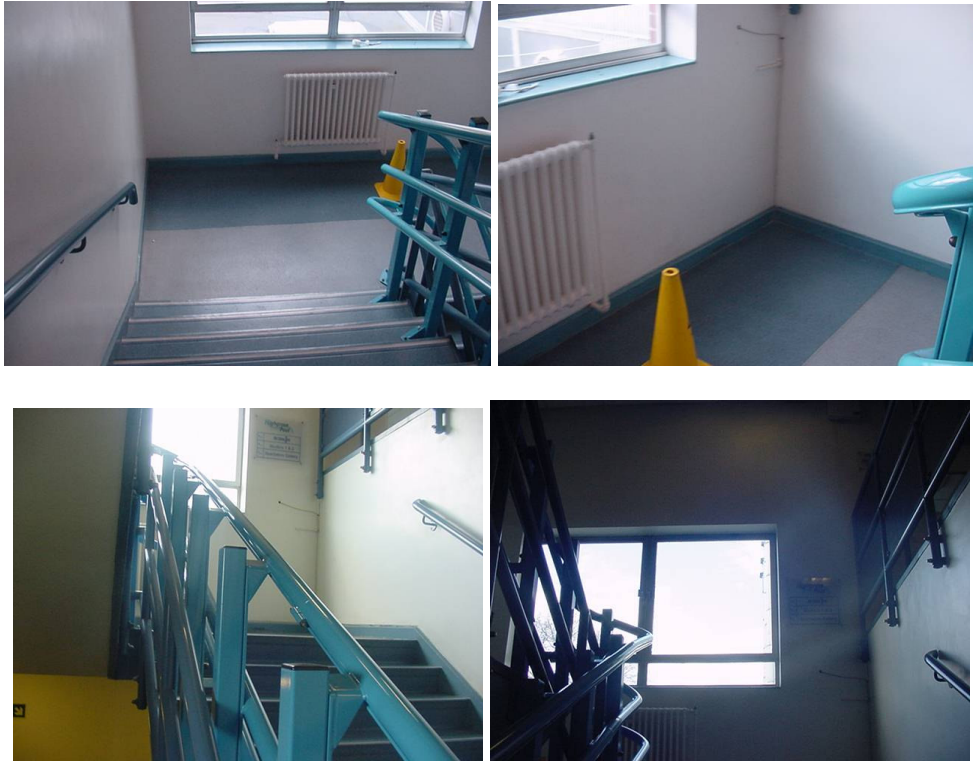
Half Landing/Stairs to Top Floor

DESCRIPTION	CONDITION	ACTION REQUIRED
<p>Ceiling:</p> <p>Painted</p>	<p>Water staining (see top floor)</p>	
<p>Walls:</p> <p>Painted</p>	<p>Marked, hairline cracks.</p> <div style="text-align: center;">

<p>Horizontal crack</p> </div>	<p>Repair, prepare and redecorate.</p> <div style="text-align: center;">

<p>Vertical hairline crack</p> </div>

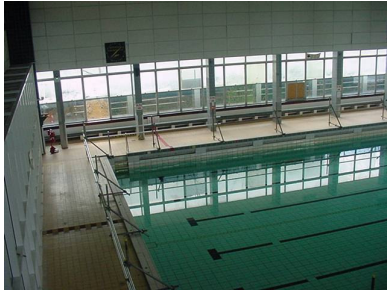
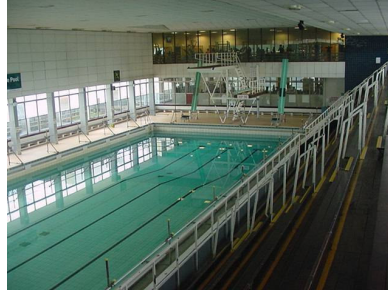
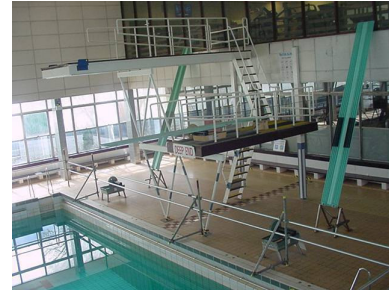
Swimming Pool Area

DESCRIPTION	CONDITION	ACTION REQUIRED
<p>Ceiling over diving board section: Old style rectangular ceiling tiles with bulk head lights and vents</p>	<p>Ceiling tiles dated and deteriorating, vents missing. Advised no work taking place</p>

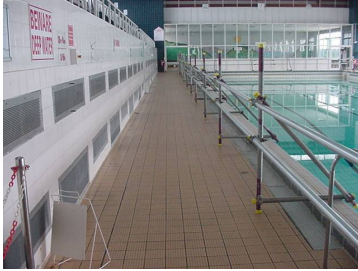
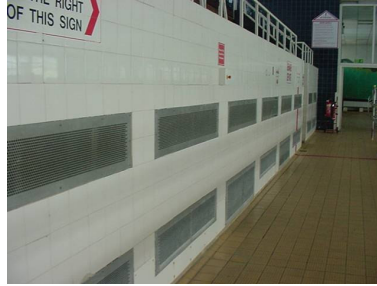
Tiled with signs, metal grills at low level and mid level

Corrosion to fixing screws around vents

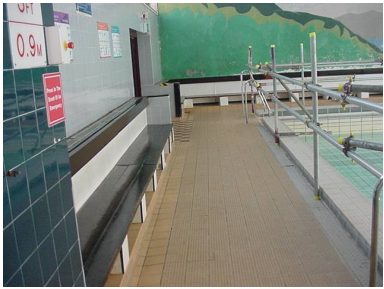
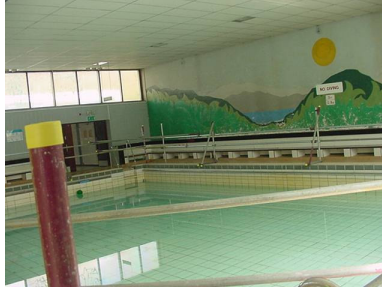
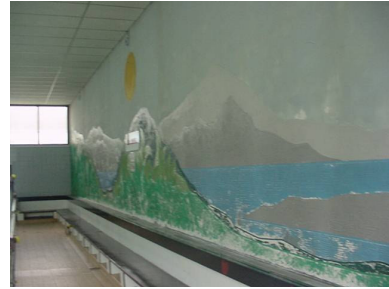
Learners Pool Area

DESCRIPTION	CONDITION	ACTION REQUIRED
<p>Ceilings:</p> <p>Old style rectangular suspended ceiling tiles between timber windows Bulk head lights and vents</p>

<p>Dated and deteriorating. Bulk head light missing</p>	
<p>External Wall:</p> <p>As main pool</p>

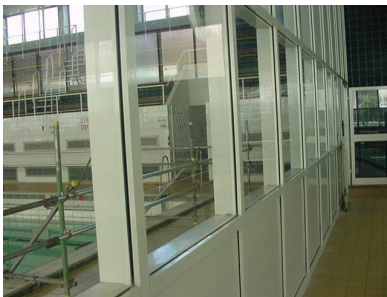
Division between main pool and learners pool

Glazed curtain wall between Learner pool and Main pool

Metal aluminium frame with proprietary finish

Flaking and deterioration is occurring to the proprietary finish to the transoms and mullions, particularly where they join.

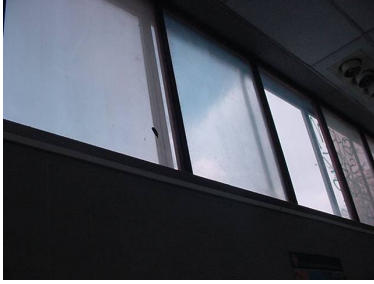
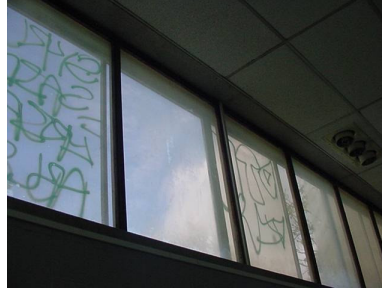
Glazed window at high level with secondary glazing

Remove graffiti.

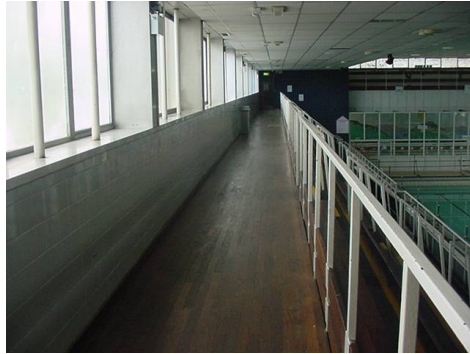
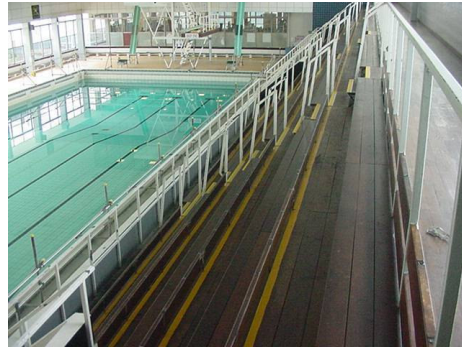
Swimming Pool Main Spectators Gallery

DESCRIPTION	CONDITION	ACTION REQUIRED
<p>Ceiling: Rectangular fibre suspended ceiling tiles</p>	<p>Dated and stained close to window</p> <div data-bbox="727 905 966 1081" data-label="Image"> </div> <p>Ceiling tiles in poor condition</p>

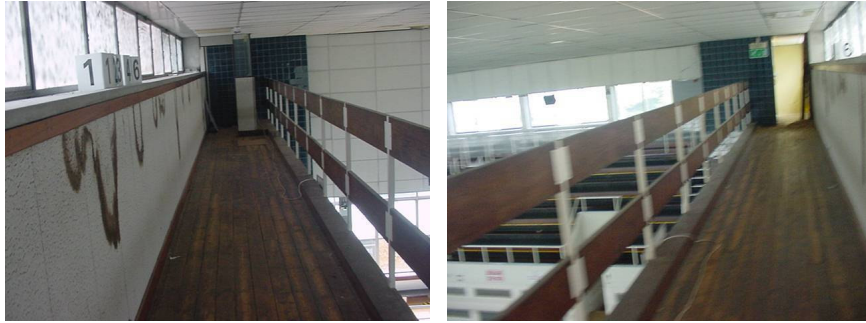
Left Hand Side Balcony

DESCRIPTION	CONDITION	ACTION REQUIRED
<p>Ceiling: Rectangular fibre suspended ceiling tiles with exposed grid Metal bulk head adjacent to window</p>	Deteriorating	
<p>Windows: Single glazed aluminium window and aluminium sill</p>

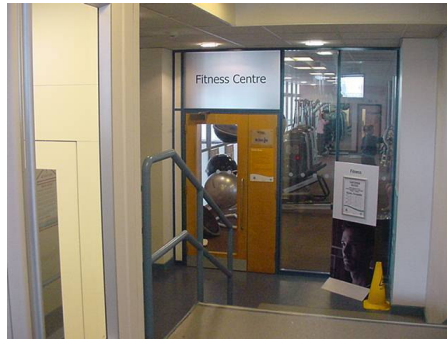
Fitness Centre

DESCRIPTION	CONDITION	ACTION REQUIRED
<p>Ceiling:</p> <p>Suspended ceiling</p>	<p>Advised no work taking place Marked</p>	
<p>Walls:</p> <p>Painted</p> <p>Locker space area, giving access to swimming pool</p>	<p>Advised no work taking place Marked</p>	
<p>Floors:</p> <p>Altro style flooring</p>	<p>Advised no work taking place Worn around stair area</p>

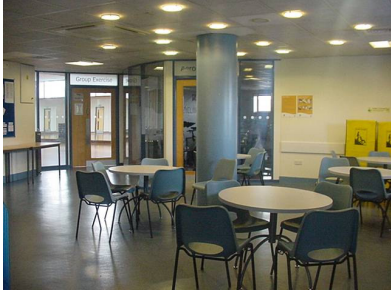
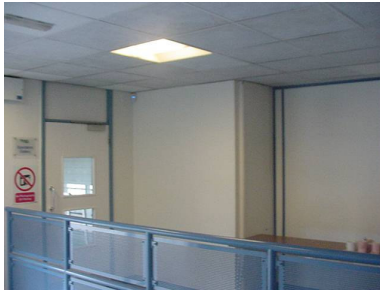
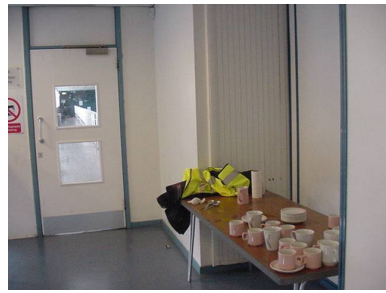
Landing on Top Floor with access to Aerobike Studio, Group Exercise Studio and Fitness Studio and Balcony overlooking swimming pool

DESCRIPTION	CONDITION	ACTION REQUIRED
<p>Ceiling:</p> <p>Suspended ceiling</p>	<p>Advised no work taking place Marked</p>

<p>Water staining to suspended ceiling</p>	<p>Replace tiles</p>

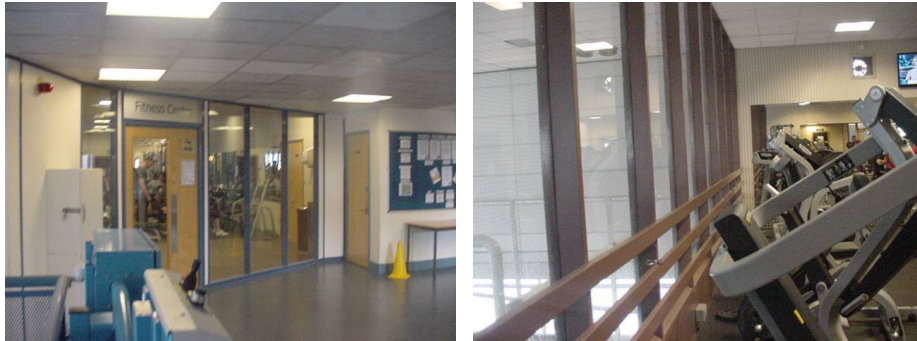
Fitness Room overlooking pool

DESCRIPTION	CONDITION	ACTION REQUIRED
<p>Ceiling:</p> <p>Rectangular fibre suspended ceiling tiles</p>	<p>Advised no work taking place</p> <p>Marked</p>	
<p>Walls:</p> <p>Timber curtain walling screen with Georgian wire plated glass between fitness centre and swimming pool</p>

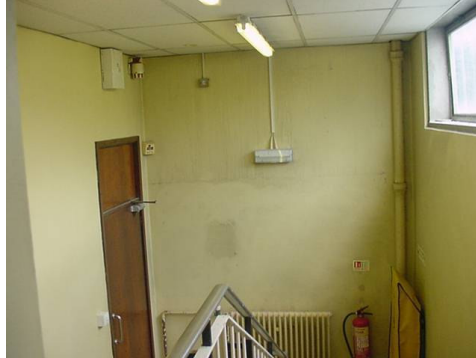
**Access from swimming pool viewing gallery
Top floor down to ground floor**

DESCRIPTION	CONDITION	ACTION REQUIRED
<p>Ceiling:</p> <p>Rectangular suspended ceiling tile Two fluorescent tiles</p>	<p>Advised no work taking place</p>	
<p>Windows:</p> <p>High level single glazed aluminium window</p>	<p>Deteriorating</p> <div style="text-align: center;">
