SCHEDULE OF CONDITION

Large Commercial Building, Berkshire

The Schedule of Condition offers a detailed description of the condition of the property at the time of our inspection on 16th December 2011.

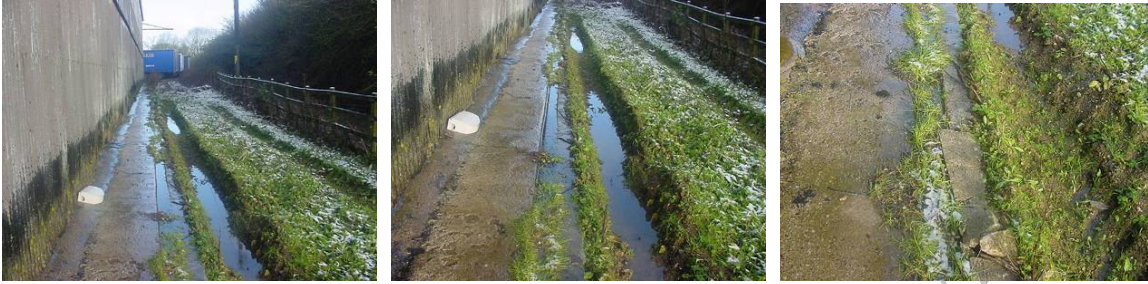
RIGHT HAND GRASSED AREA

Right hand side grass area:

To the side of concrete gully is a grassed area; approx three to four metres in width.

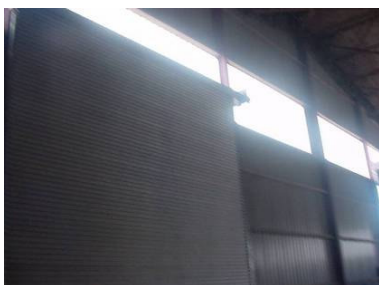
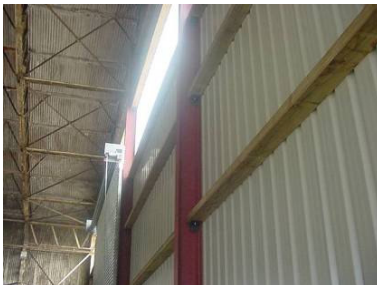
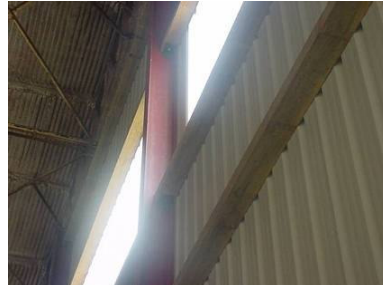
Front Internal Elevation

DESCRIPTION	CONDITION	ACTION REQUIRED
<p>Walls Structure:</p> <p>Vertical “T” beams with horizontal purlins fixed with angle irons and they in turn are fixed with anchor bolts to the profile metal sheet</p> <p>Top:</p> <p>Profile metal sheeting and plastic windows, following the profile pattern</p> <p>Middle:</p> <p>Profile metal sheeting</p> <p>Bottom:</p> <p>Profile metal sheeting.</p>	<p>As new</p> <p>

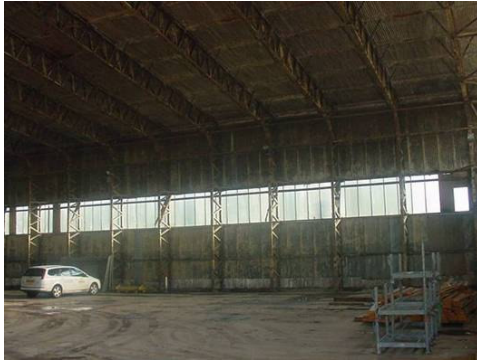
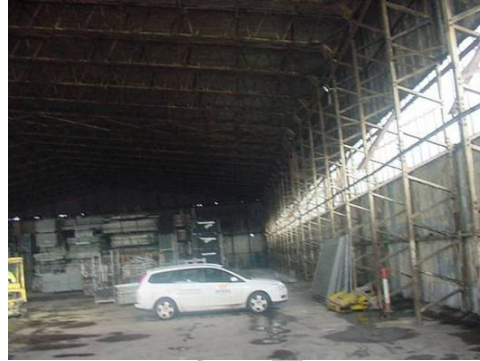
Right Hand Side Internal Elevation

DESCRIPTION	CONDITION	ACTION REQUIRED
Walls Structure: Lattice steel portal frame, divided into 23 number bays	First, middle and last bay have wind bracing.	
Walls Cladding: Concrete fillet to all bays Approx 300mm in height	Wind bracing Part of old grain shoot, which is the angled section, in timber All bases of bays replaced to bottom 300mm Can see metal sheeting where paint flaked off altogether.
