# SCHEDULE OF CONDITION

**Internal Only Inspection  
relating to insurance claim  
and reinstatement work  
carried out for  
Mr & Mrs X by  
XXXX  
at**

**XXXX  
Chadderton,  
Oldham,  
Lancashire.  
OL9 XXX**

## **Part of an Independent Report**

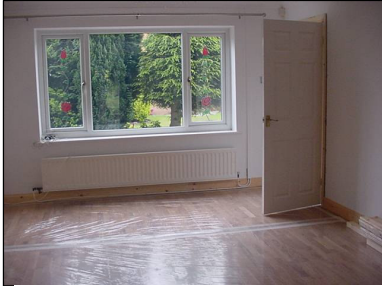
Lounge general view

DESCRIPTION	CONDITION	ACTION REQUIRED
<b>Ceilings:</b> Painted	Confirmation required as to whether preparation has been carried out and if a skim coat of plaster has been added.	XXXX to advise
<b>Walls:</b> Ready to paper and paint	Originally painted and papered. Painted and papered incorrectly to a poor standard.  Client advises that redecoration was agreed with XXXX at meeting on XXX  Paint bits are within the walls.	XXXX to advise
<b>Floors:</b> Laminate floorboards provided by Mr & Mrs Clayton to be fitted.  Skirtings: Fitted but unpainted	Laminate flooring re-laid with correct underlay.  The incorrect skirting had been added now a complete new skirting is in place. We would comment that some of the skirtings are heavily knotted indicating a poor quality skirting.	Confirmation required by XXXX that the skirting is of the required quality and has been knotted, primed and stopped.

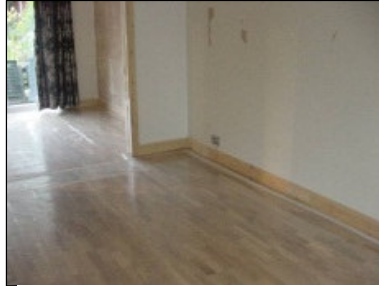
Lounge laminate flooring

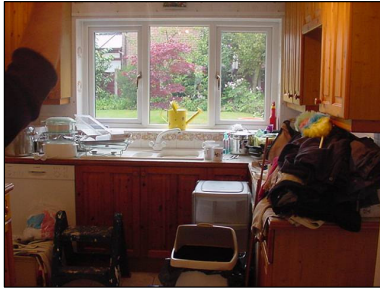
Kitchen units to right hand side and sink area

<b>Kitchen Units:</b> Kitchen units have suffered from general wear and tear but no specific water damage noted in the form of staining. However, please see our comments in relation to the Kitchen in general and Kitchen units.

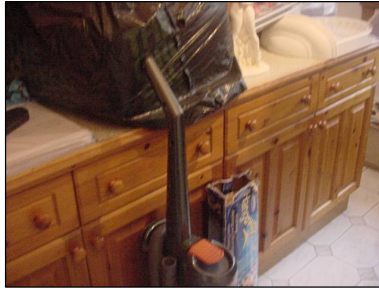
Kitchen floor units

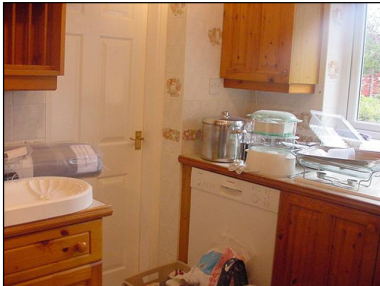
Work units looking towards the Utility Room

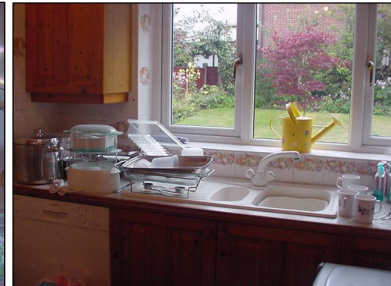
Kitchen units at the sink area

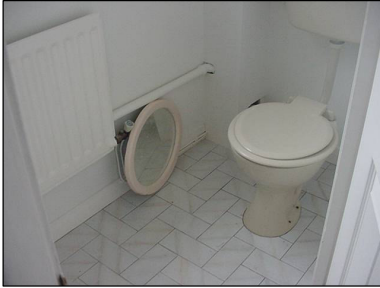
General view  
cloakroom/WC

DESCRIPTION	CONDITION	ACTION REQUIRED
<b>Ceilings:</b> Painted	Confirmation required as to whether preparation has been carried out and if a skim coat of plaster has been added.	XXXX to advise
<b>Walls:</b> Painted and tiled	Redecorated with a new tiles around the basin but the sill tile has not been changed which would be a common sense measure. You now have a modern tile and a dated tile to the window sill.	Remove old tiles, prepare and redecorate.
<b>Floors:</b> Tiled (assumed original)	Trim incorrect colour.	General clean, new trim in correct colour to be installed.

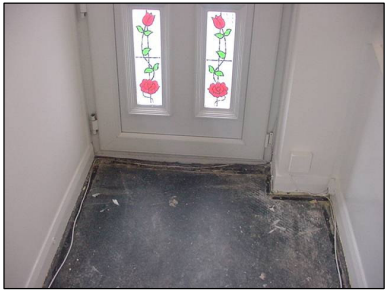
Entrance hallway

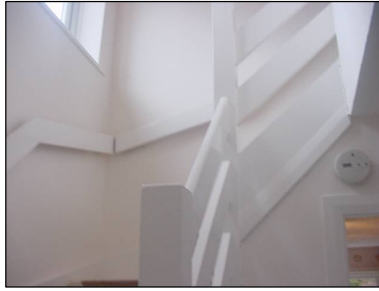
Stairs

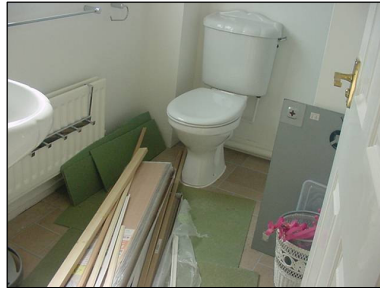
General view en suite  
shower room

<b>Ceilings:</b> Painted	Confirmation required as to whether preparation has been carried out and if a skim coat of plaster has been added.	XXXX to advise
<b>Walls:</b> Tiled	Trim the incorrect colour to match tiles.	XXXX to advise
<b>Floors:</b> Floorboards with laminate boarding provided by Mr & Mrs Clayton	Quadrant bead poorly fitted.	<p>Replace/refit quadrant beading.</p> <p>Aquaseal flooring or equivalent to be fitted.</p> <p>Confirmation that this area has dried out suitably and no future problems.</p> <p>Confirmation required from XXXX.</p>

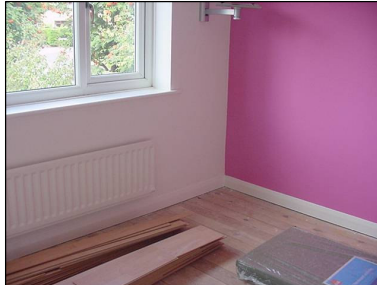
**Bedroom Two**  
**(rear right hand side)**

DESCRIPTION	CONDITION	ACTION REQUIRED
<b>Ceilings:</b> Painted	Advised skimmed and painted.	Confirmation required from XXXX.
<b>Walls:</b> Painted	Advised skimmed and painted.	Confirmation required from XXXX.
<b>Floors:</b> Floorboards	Felt to have a slight cupping which occurs often due to water damage.	Confirmation that this area has dried out suitably and no future problems.  Confirmation required from XXXX that the floor is satisfactory and there will be no latent defects.
<b>Joinery/Detailing:</b> Windows Plastic  Doors and Architraves	Architraves not painted to a standard they were previously painted to.	Re-paint architraves. Confirmation required that doors have been removed prior to redecoration and/or the ironmongery will be cleaned.
<b>Services:</b> Radiator	Requires redecoration	Prepare and redecorate. Agreed with XXXX

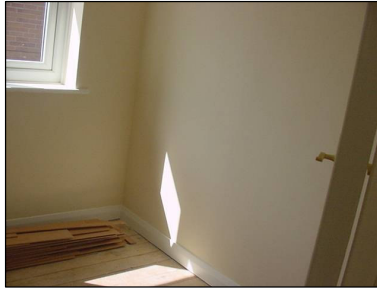
**Bedroom Four/Study**  
**(middle left hand side)**

DESCRIPTION	CONDITION	ACTION REQUIRED
<b>Ceilings:</b> Painted	Advised skimmed and painted.	Confirmation required from XXXX.
<b>Walls:</b> Painted	Advised skimmed and painted.	Confirmation required from XXXX.
<b>Floors:</b> Floorboard covering		Confirmation that this area has dried out suitably and no future problems.  Confirmation required from XXXX that the floorboards will not have any latent defects.
<b>Joinery/Detailing:</b> Windows Plastic  Doors and Architraves	Architraves not painted to a standard they were previously painted to.	Re-paint architraves. Confirmation required that doors have been removed prior to redecoration and/or the ironmongery will be cleaned.

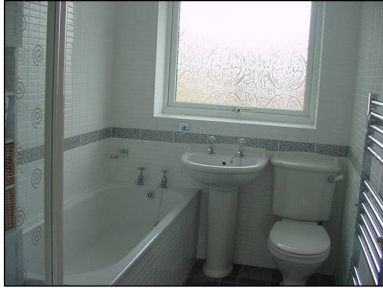
Bathroom general view

DESCRIPTION	CONDITION	ACTION REQUIRED
<b>Ceilings:</b> Painted	Advised skimmed and painted.  The ceiling runs out on the right hand side/or the wall tiling.	Confirmation required of by XXXX that this is unacceptable and will be replaced.
