Example Pages taken from a Commercial Building Survey

A three storey mid-terraced property

COMMERCIAL BUILDING SURVEY OF Address of Property

FOR
Mr M

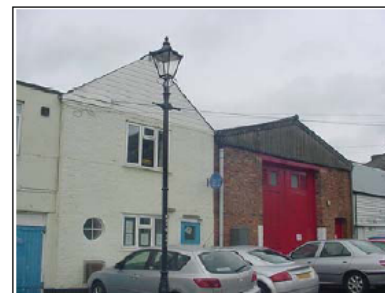
A considerable amount of water is getting into this storage facility and office area, particularly down the right hand back wall (all directions given as you face the property from the front). This is affecting both your property and the adjoining CAB (Citizens Advice Bureau).

The only long term solution is to redesign the valley gutter. We would recommend a wider valley gutter. The roof problems could in turn, we believe, have affected the roof structure. Please note we have not gained access to the high level areas within the store.

ACTION REQUIRED: We would recommend the only long term solution to the valley gutter problems that you have is to change the design of them. We would recommend a wider valley gutter, which allows access, i.e. to be a width of approximately half a metre to one metre. This, unfortunately, would involve reconfiguring part of the roof. Also, the question is do you replace the asbestos now, or encapsulate it, which of course depends how long a term your long term plans are!

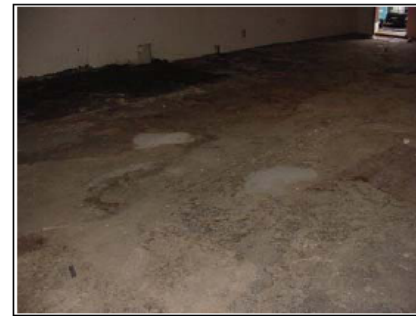
The uneven floor needs repairing and how this is repaired, again depends upon how long term your long term plans are.

Finally, there is also a general upgrading requirement to the charity area/store if it is to be used.

ANTICIPATED COST: From what we can see of the lease document your costs would relate to the re-roofing. The other areas may be costs and you can get that from the Leaseholders. We would estimate the costs for the re-roofing and redesigning to be in the region of £20,000 but quotations need to be obtained.

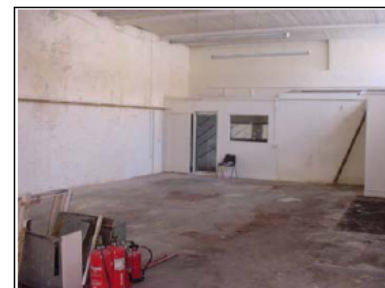
Flooring

The general condition and standard of flooring needs to be improved and the associated offices need upgrading, all of course depending upon the future use.
