RESIDENTIAL BUILDING SURVEY
OF
Kempston Near Bedford Bedfordshire

Mr & Mrs I Brown

1st Associated

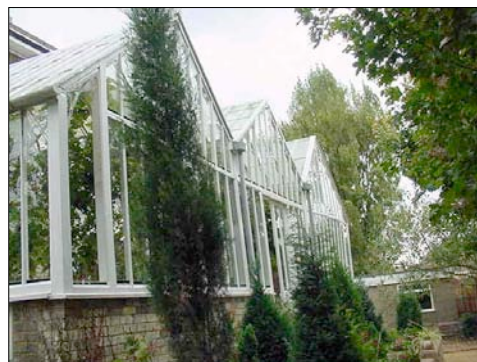
This was about the best photo we could get of the left hand side elevation.

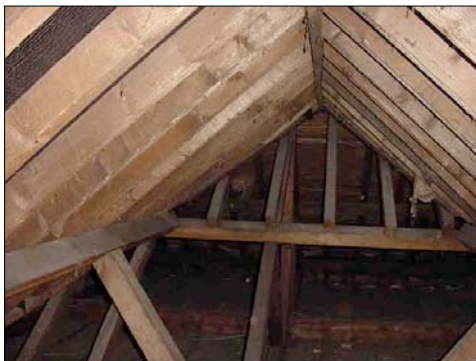
A general view through the roof. To the left hand side you can see the purlin.

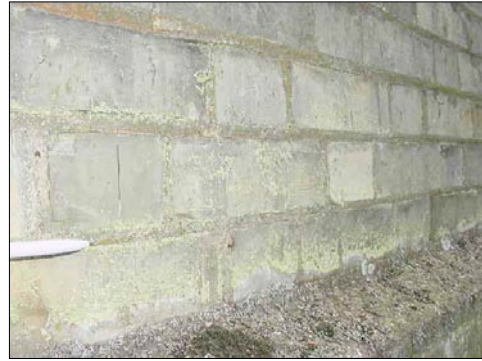
A close up of the brickwork. The pen is indicating where the pointing is.

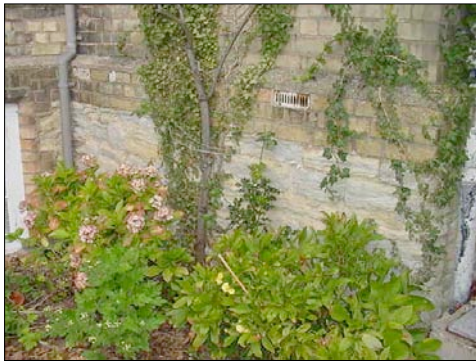
In this case the airbricks are also the vents to the cellar they are of a good size; therefore there should be good airflow providing they are not blocked.

Airbricks/vents to the cellar.

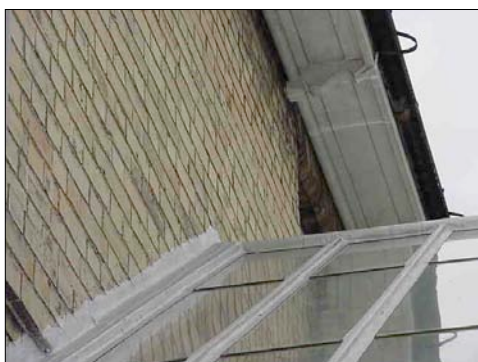
The property has a nicely detailed fascias and soffit board. These looked in reasonable condition, although we are aware that some of the gutters are leaking we therefore would expect there to be some repairs. We would estimate redecoration would be required in about two to three years time.

Looking up at the fascia board from the side of the conservatory.

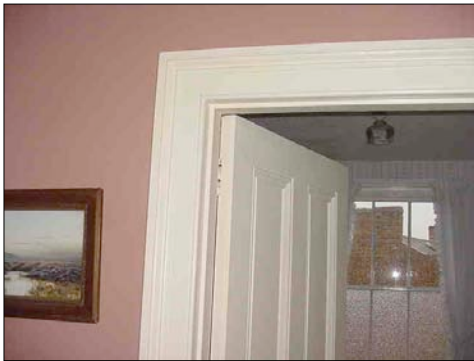
The property has panel doors throughout which looked original, with the exception of some of the ground floors which have, as is fashionable, the doors have been dipped and stripped of their paint. Often unfortunately the process also effects the glue that has been used and ironically the timber used in these doors would not have been considered good enough to be exposed in the way it is today. We would term these doors to be in average condition for their age, type and style.

An example of the door frame and architrave.

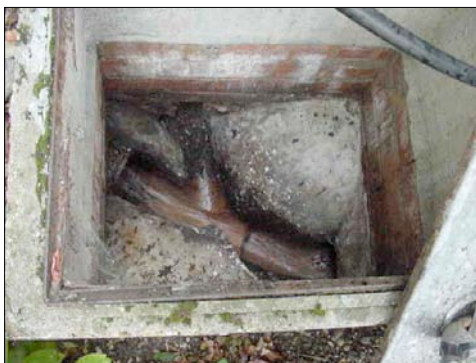
Manhole One

This manhole is adjacent to the property, this looked like it was recently added and it was free flowing at the time of our inspection. The tap was on within the cloakroom.

From what we could see it is brickwork built.
